LIMITED ASBESTOS SURVEY

Ascarate Lake Pavillion
6900 Delta
El Paso, Texas 79905

LEAD-BASED PAINT SAMPLING EVENT

Lead-Based Paint Sampling Event
Ascarate Lake Pavillion

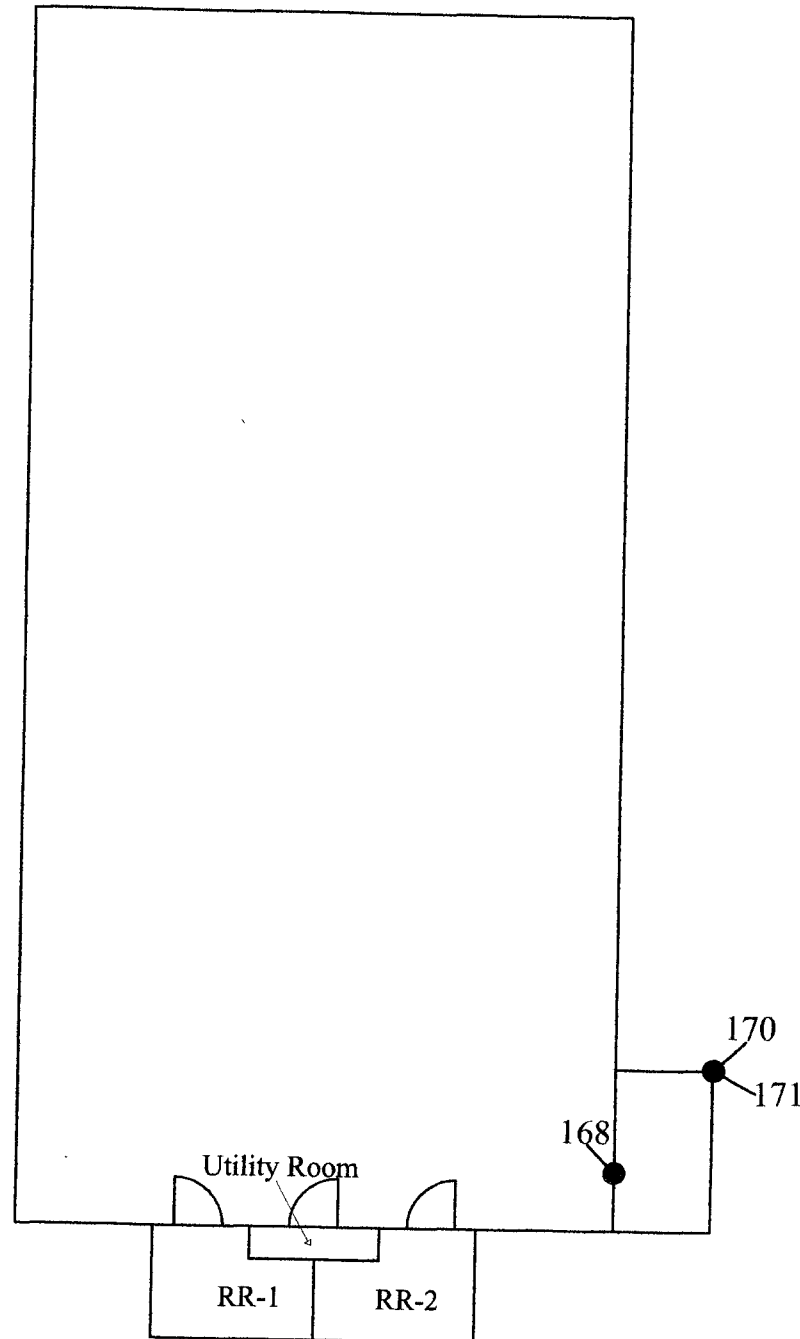
FLOOR PLAN

- Positive Lead-Based Paint Components
