**COUNTY OF EL PASO PUBLIC WORKS
PLANNING & DEVELOPMENT DEPARTMENT**
DEVELOPMENT SERVICES DIVISION

***Re: Phase II MS4 Annual Report Transmittal for the County of El Paso TPDES Permit Authorization:
TXR040202***

Phase II (Small) MS4 Annual Report Form

Authorization Number: TXR040202

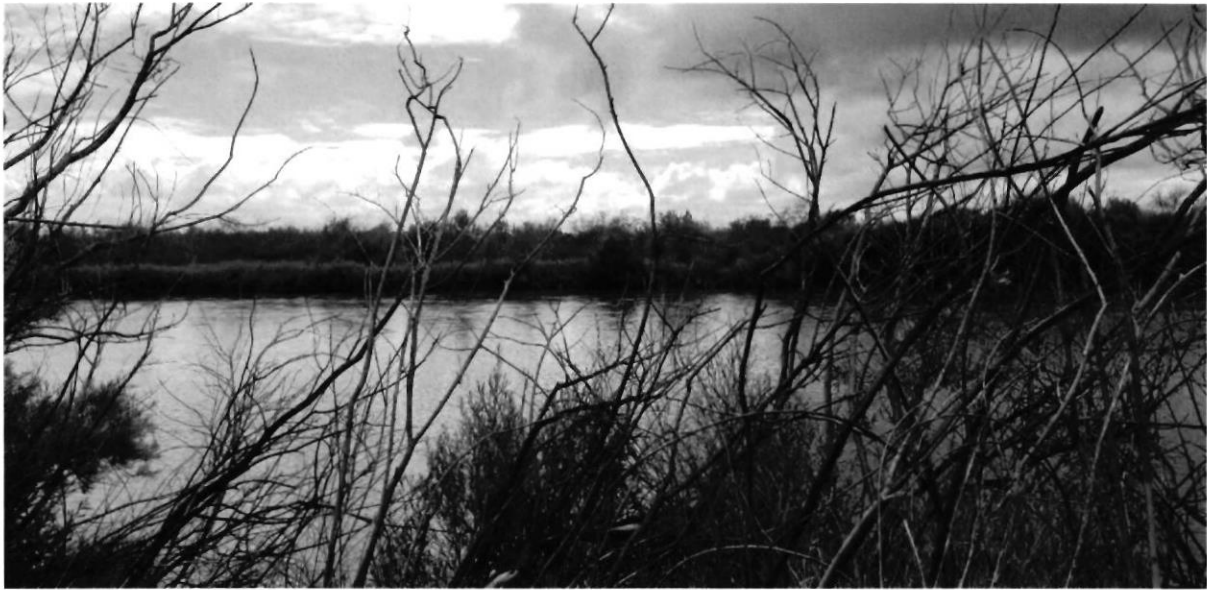
Photograph 1. Upstream sample location.

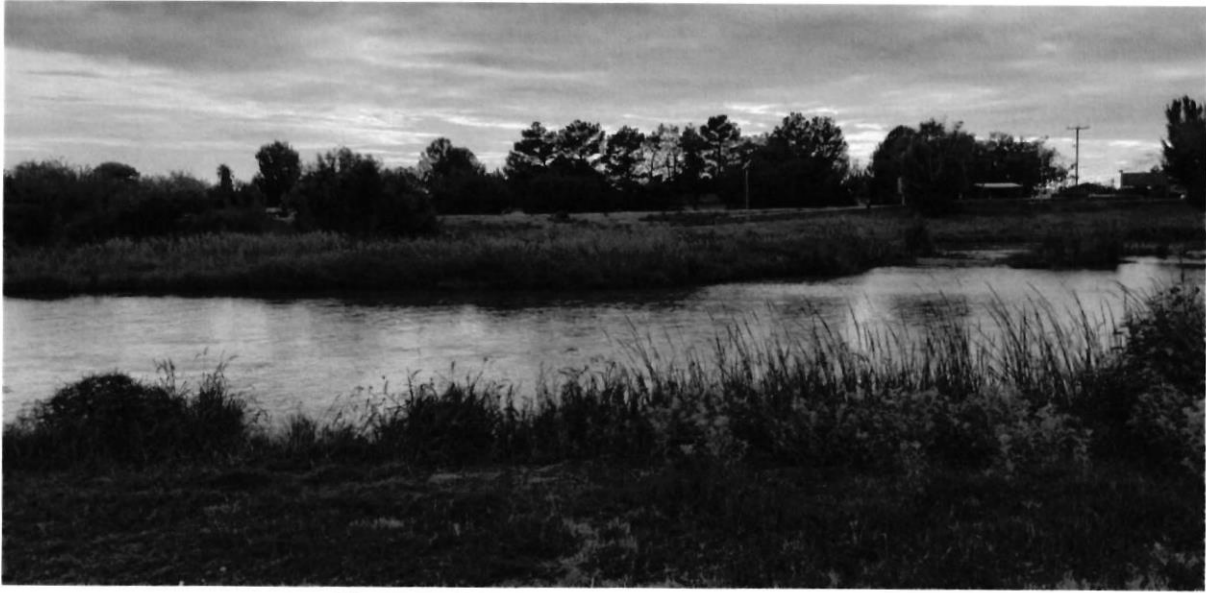
Photograph 3. Downstream sample location.

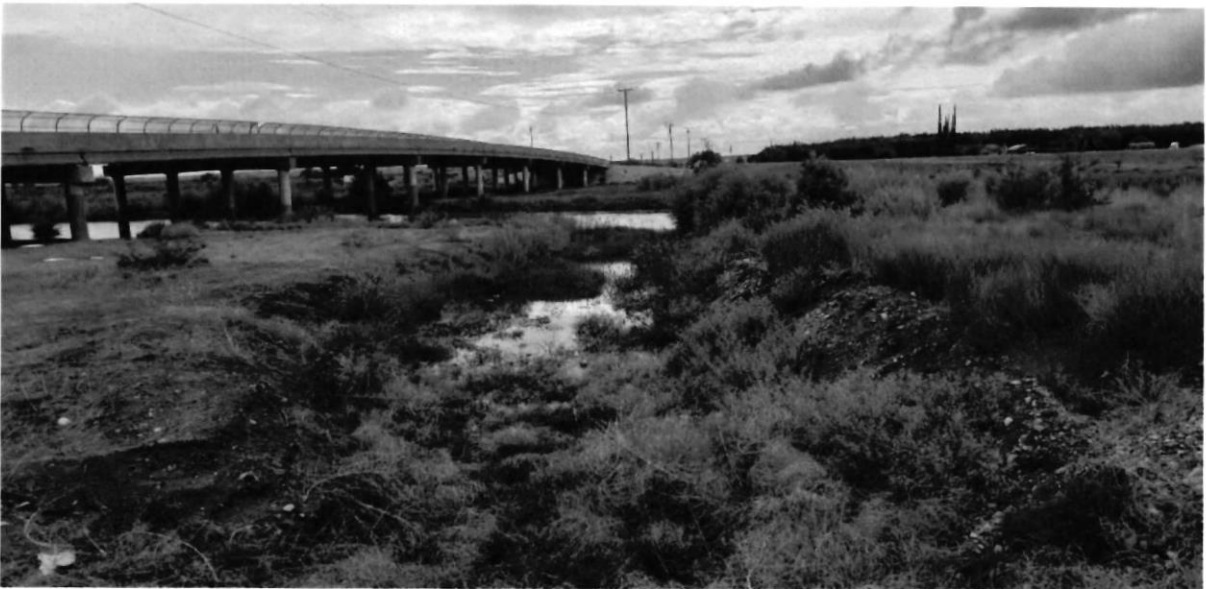
Photograph 4. Representative image of backflow from Rio Grande into arroyos to disqualify DN locations from being sampled.

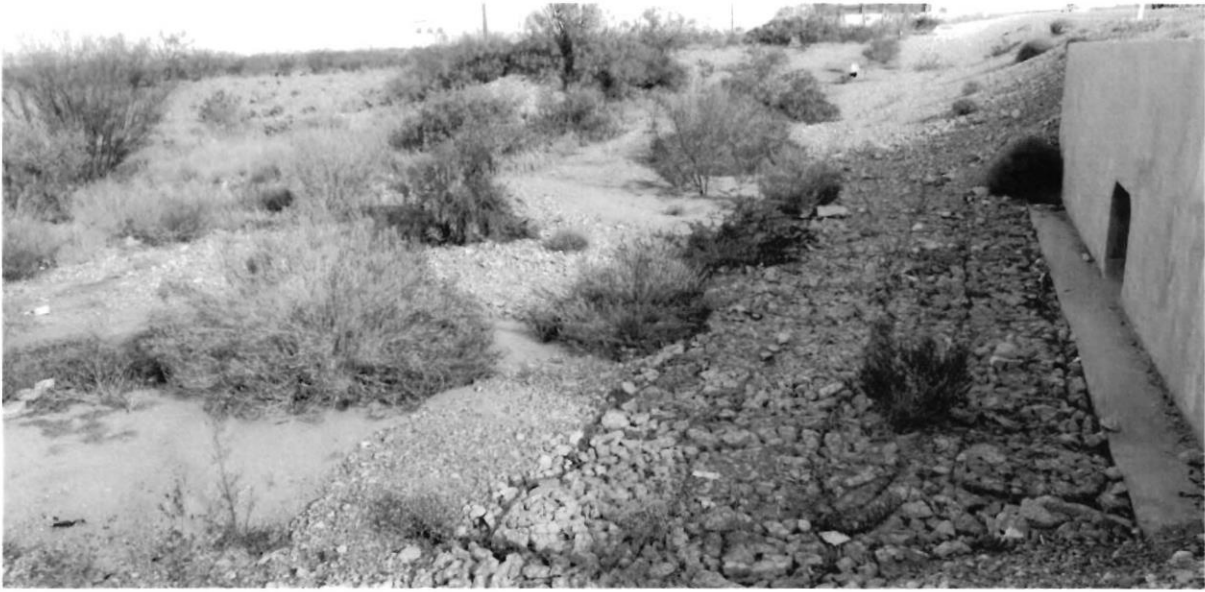
Photograph 5. Representative of arroyos (dry) during October 24, 2023 false start.
