## TEST HOLE DATA SHEET

Project Name Hillcrest Center  
 Project No. 2006-105-01  
 Location N Zaragoza Rd. and Augusta Dr.

SUBSURFACE UTILITY ENGINEERING

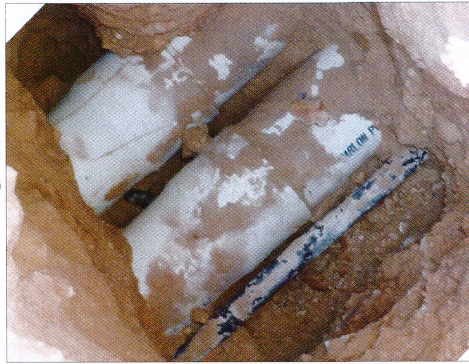
TOP

Test Hole No. 01  
 Utility Fiber Optic  
 Date 10 / 19 / 2020  
 Weather Sunny

A. Northing	<u>10672549.04</u>	
Easting	<u>469828.04</u>	
B. Depth of Utility	<u>3.31'</u>	
C. Reference Marker (RM)	<u>Nail / Disc</u>	
Elevation @ RM	<u>4015.97</u>	
D. Elev. @ Top of Utility	<u>4012.66</u>	
E. Elev. @ Bottom of Utility	<u>4012.33</u>	(Calc.)
F. Width or Dia. of Utility	<u>0.33'</u>	
G. Material of Utility	<u>PVC</u>	
H. General Condition	<u>Good</u>	
I. Thickness of Pvmt.	<u>0.10'</u>	
Pvmt. Material	<u>Asphalt</u>	
J. Description of Soil	<u>Sand / Rock</u>

Remarks DBC Tel/F.O. line next to F.O. PVC lines

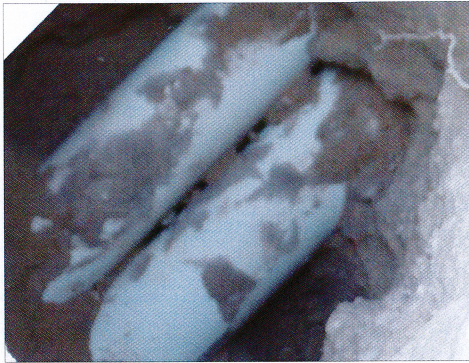
TOP

Test Hole No. 02  
 Utility Fiber Optic  
 Date 10 / 19 / 2020  
 Weather Sunny

A. Northing 10672881.61  
 Easting 470164.79  
 B. Depth of Utility 4.42'  
 C. Reference Marker (RM) Rebar / Cap  
 Elevation @ RM 4017.42  
 D. Elev. @ Top of Utility 4013.00  
 E. Elev. @ Bottom of Utility 4012.67 (Calc.)  
 F. Width or Dia. of Utility 0.33'  
 G. Material of Utility PVC  
 H. General Condition Good  
 I. Thickness of Pvmt. N / A'  
 Pvmt. Material Natural Ground  
 J. Description of Soil Sand / Rock
