EMPLOYEE FITNESS & WELLNESS CENTER
500 E SAN ANTONIO ST. EL PASO, TEXAS

ISSUED FOR CONSTRUCTION

DATE: OCTOBER 17 - 2018

2016-25 EMPLOYEE FITNESS & WELLNESS CENTER - CONSTRUCTION DOCUMENTS

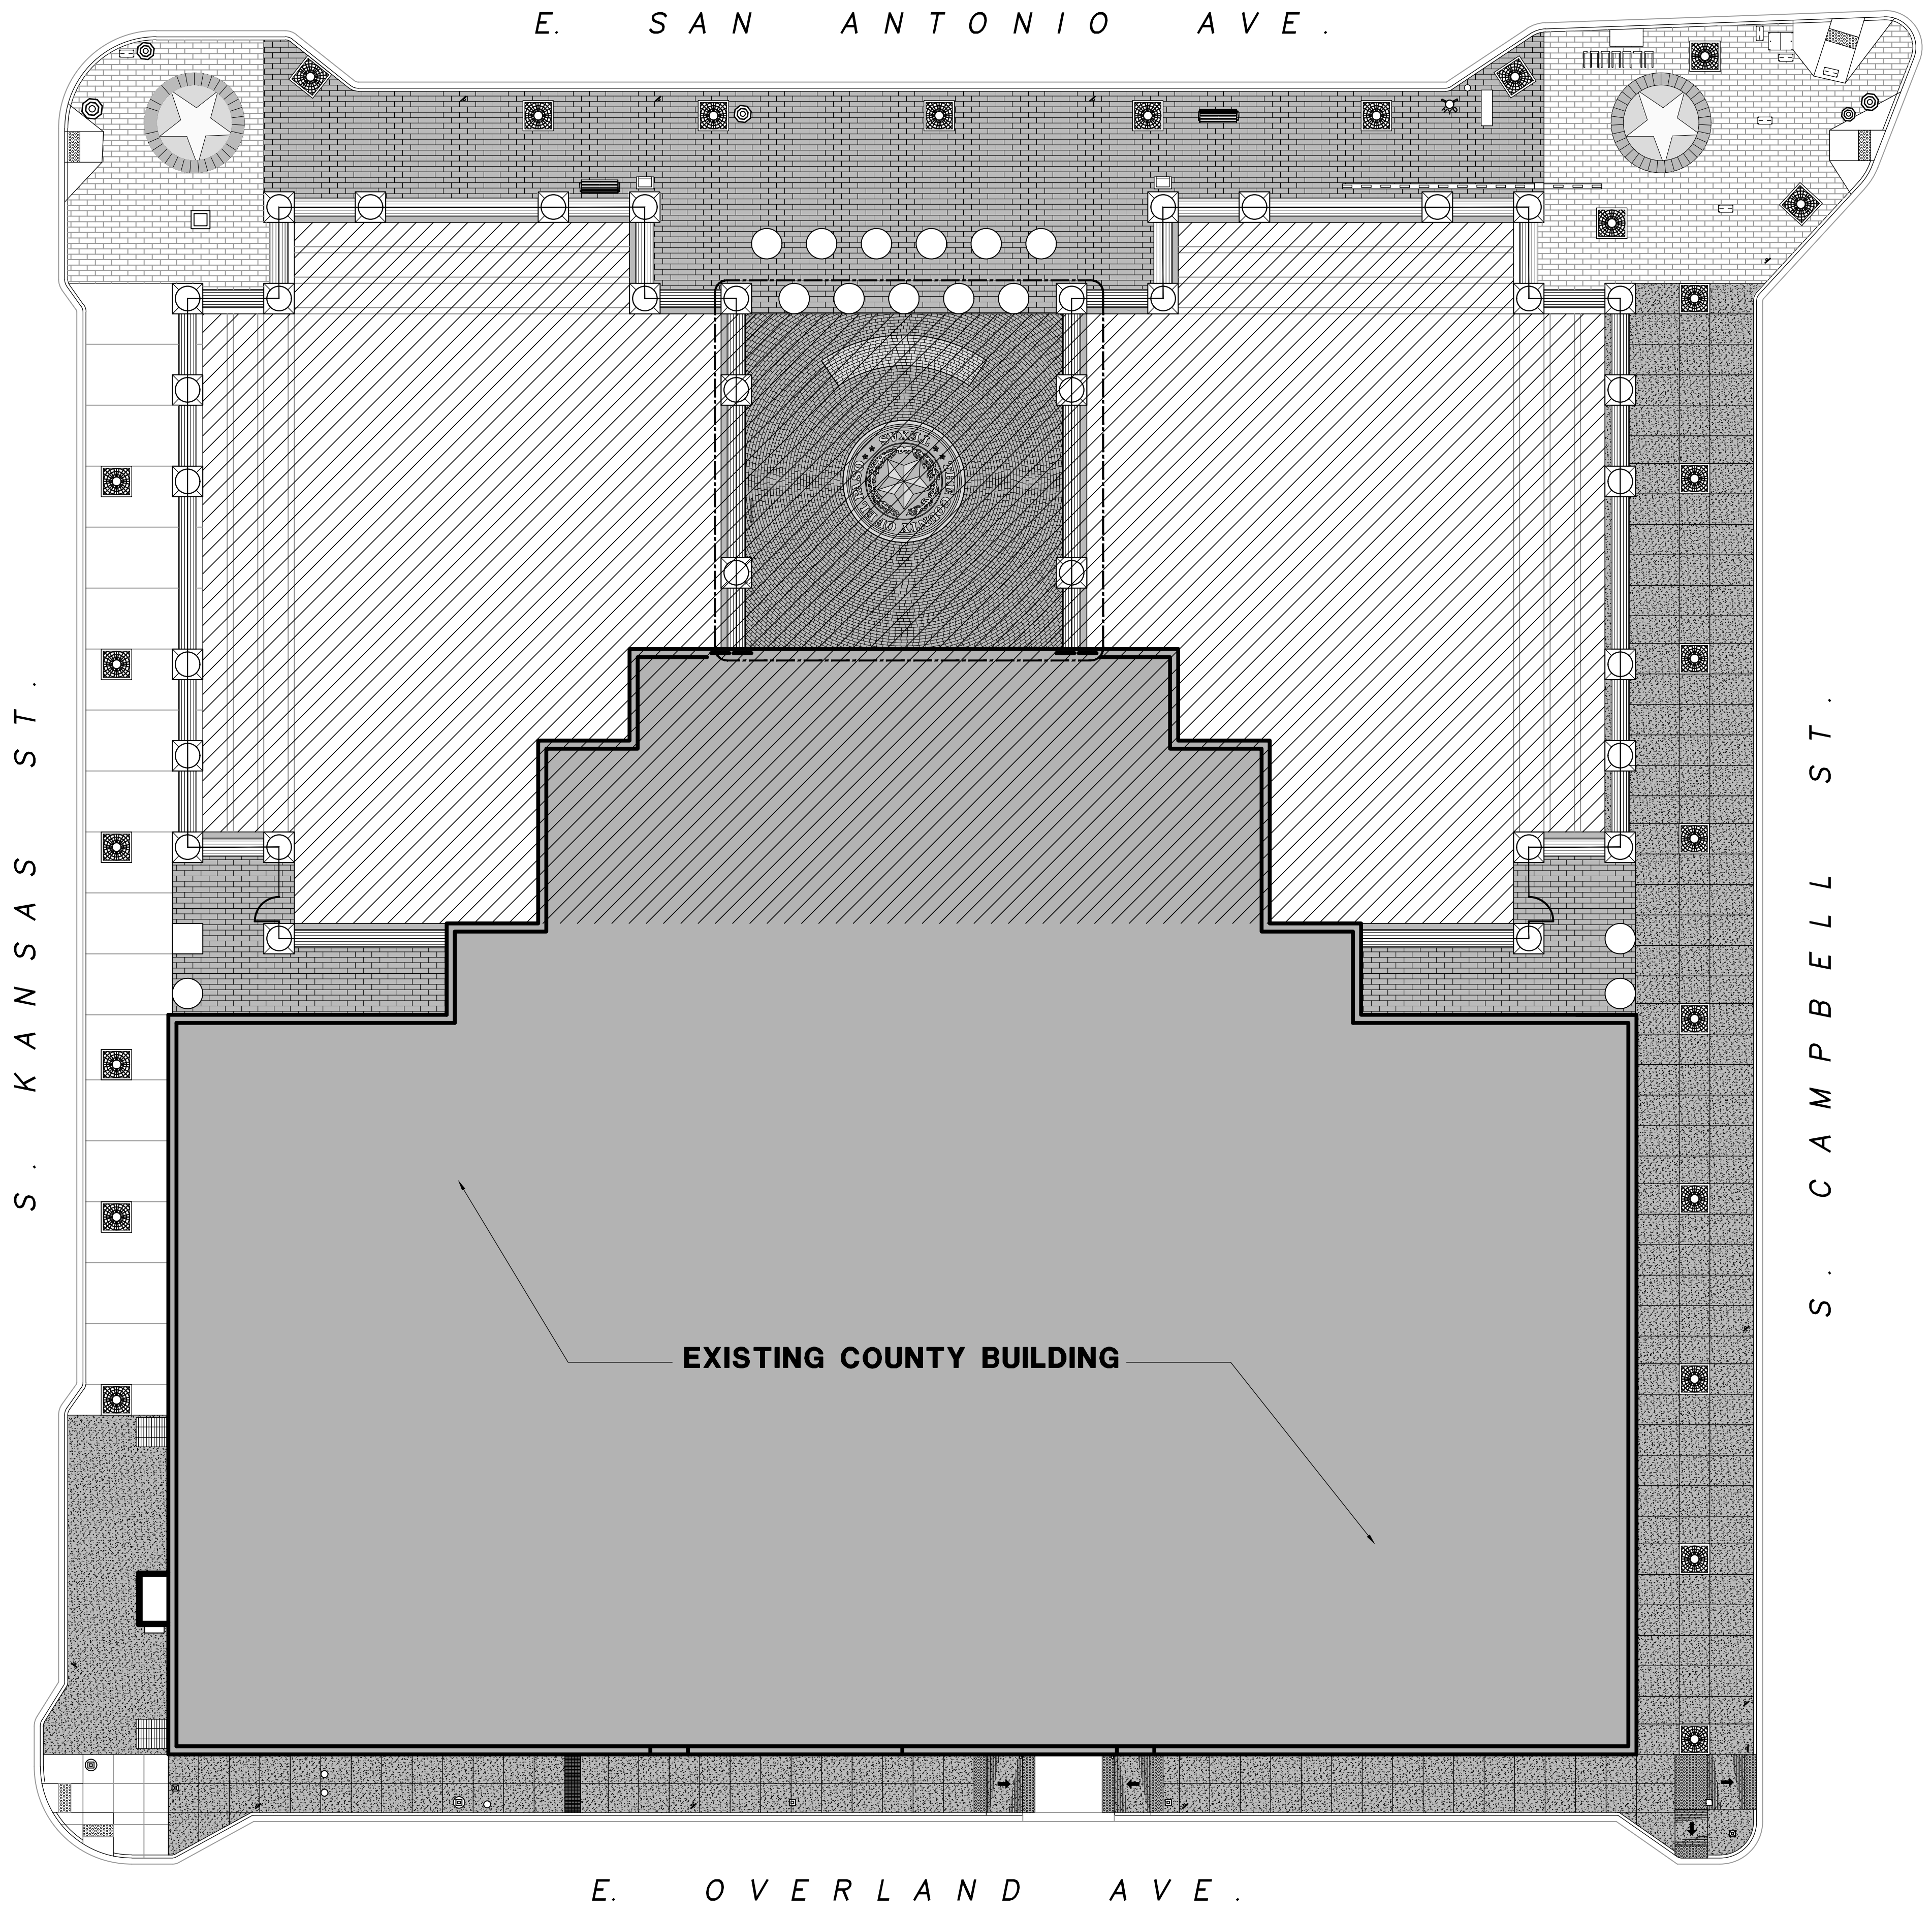
SHEET:
A0.1
SCOPE OF WORK

**1** SCOPE OF WORK

- 1 REMODELED COURTYARD AREA

- 2 EXISTING COURTHOUSE

- 3 EXISTING STAMPED CONCRETE TO REMAIN

- 4 NEW STAMPED CONCRETE

- 5 NEW BRICK PAVERS

- 6 EXISTING CONCRETE TO REMAIN

- 6 NEW CONCRETE SIDEWALKS

- 7 NEW NAME BRICK PAVERS

- 8 NEW FITNESS CENTER BELOW

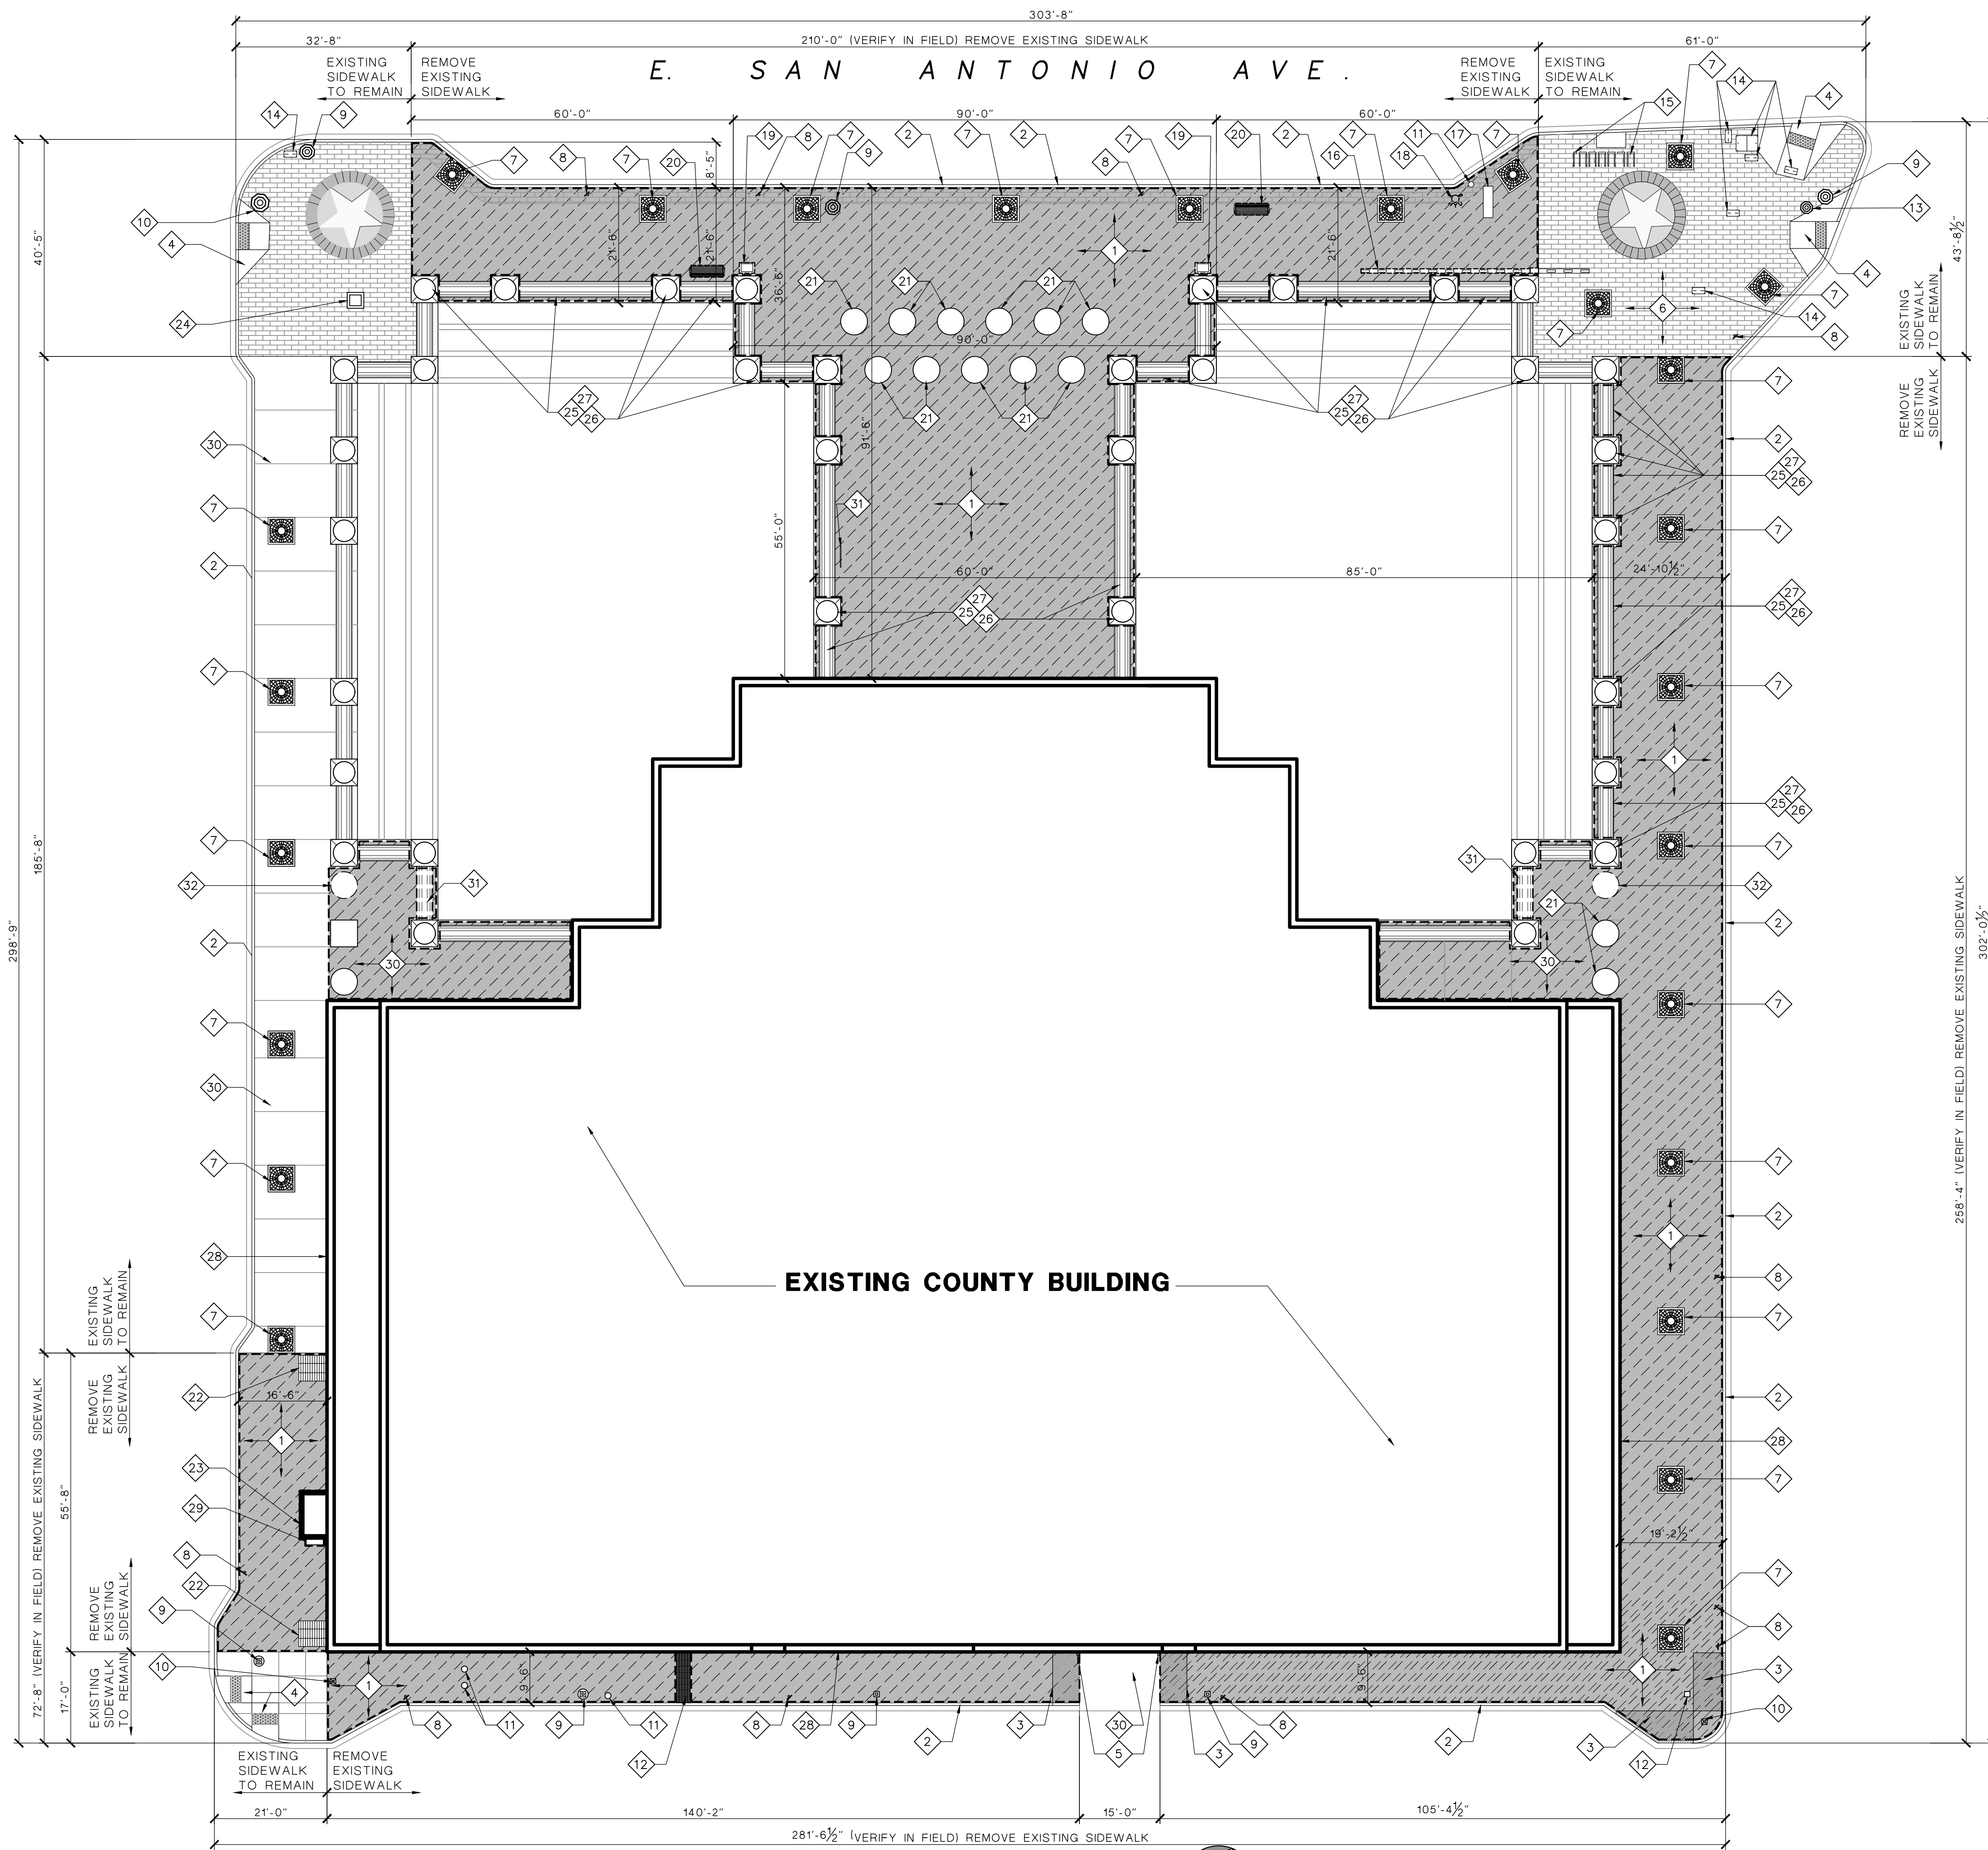
SHEET:
A1.0
EXISTING/DEMO
SIDEWALKS

- ### DEMOLITION NOTES
- 1 REMOVE EXISTING SIDEWALK COMPLETELY TO LIMITS AS SHOWN
 - 2 EXISTING CONCRETE CURB AND GUTTER TO REMAIN. PROTECT DURING CONSTRUCTION. PATCH AND REPAIR AS REQUIRED.

- 3 REMOVE EXISTING RAMP COMPLETELY TO LIMITS AS SHOWN
 - 4 EXISTING H/C RAMP TO REMAIN
 - 5 EXISTING PIPE BOLLARD TO REMAIN
 - 6 EXISTING BOMANITE CONCRETE FINISH TO REMAIN. PROTECT DURING CONSTRUCTION. PATCH AND REPAIR AS REQUIRED.

- 7 EXISTING TREE WELLS TO REMAIN. CONTRACTOR SHALL VERIFY EXISTING IRRIGATION SYSTEM TO ENSURE SYSTEM IS OPERATIONAL AT EVERY TREE WELL. REPLACE ANY MISSING TREE TO MATCH EXISTING.

- 8 EXISTING SIGN TO REMAIN. PROTECT DURING CONSTRUCTION.
 - 9 EXISTING LIGHT POLE TO REMAIN. PROTECT DURING CONSTRUCTION.
 - 10 EXISTING TRAFFIC LIGHT TO REMAIN. PROTECT DURING CONSTRUCTION.

- 11 EXISTING CLEAN OUTS TO REMAIN
 - 12 EXISTING METAL PLATE TO REMAIN
 - 13 EXISTING CROSS WALK SIGN TO REMAIN
 - 14 EXISTING FLOOR BOX TO REMAIN
 - 15 EXISTING METAL BIKE RACK TO REMAIN

- 16 EXISTING BIKE SHARING STATION TO BE REMOVED BY OTHERS
 - 17 EXISTING BACKFLOW PREVENTER TO REMAIN
 - 18 EXISTING FIRE HYDRANT TO REMAIN
 - 19 EXISTING TRASH CAN TO BE REMOVED BY OTHERS

- 20 EXISTING BENCH TO REMAIN
 - 21 EXISTING SAFETY BOLLARDS TO REMAIN. PROTECT DURING CONSTRUCTION
 - 22 EXISTING MECHANICAL METAL GRID TO REMAIN
 - 23 EXISTING UTILITY ENCLOSURE TO REMAIN

- 24 EXISTING CITY MAP POLE TO REMAIN. PROTECT DURING CONSTRUCTION
 - 25 EXISTING ORNAMENTAL SPHERES TO REMAIN. PROTECT DURING CONSTRUCTION
 - 26 EXISTING RED CYLINDERS TO REMAIN. PROTECT DURING CONSTRUCTION.

- 27 EXISTING BRICK COLUMNS TO REMAIN. PROTECT DURING CONSTRUCTION.
 - 28 EXISTING BUILDING. PROTECT DURING CONSTRUCTION.
 - 29 EXISTING ELECTRICAL BOX TO REMAIN

- 30 EXISTING CONCRETE SIDEWALK TO REMAIN. PROTECT DURING CONSTRUCTION
 - 31 REMOVE EXISTING RED CYLINDER. PATCH AND REPAIR COLUMNS AND ADJACENT AREAS AS REQUIRED.

- 32 REMOVE EXISTING SAFETY BOLLARD PATCH AND REPAIR ADJACENT AREAS AS REQUIRED.

NOTE: CONCRETE SIDEWALKS SHALL NOT EXCEED 2% SLOPE IN ANY DIRECTION.

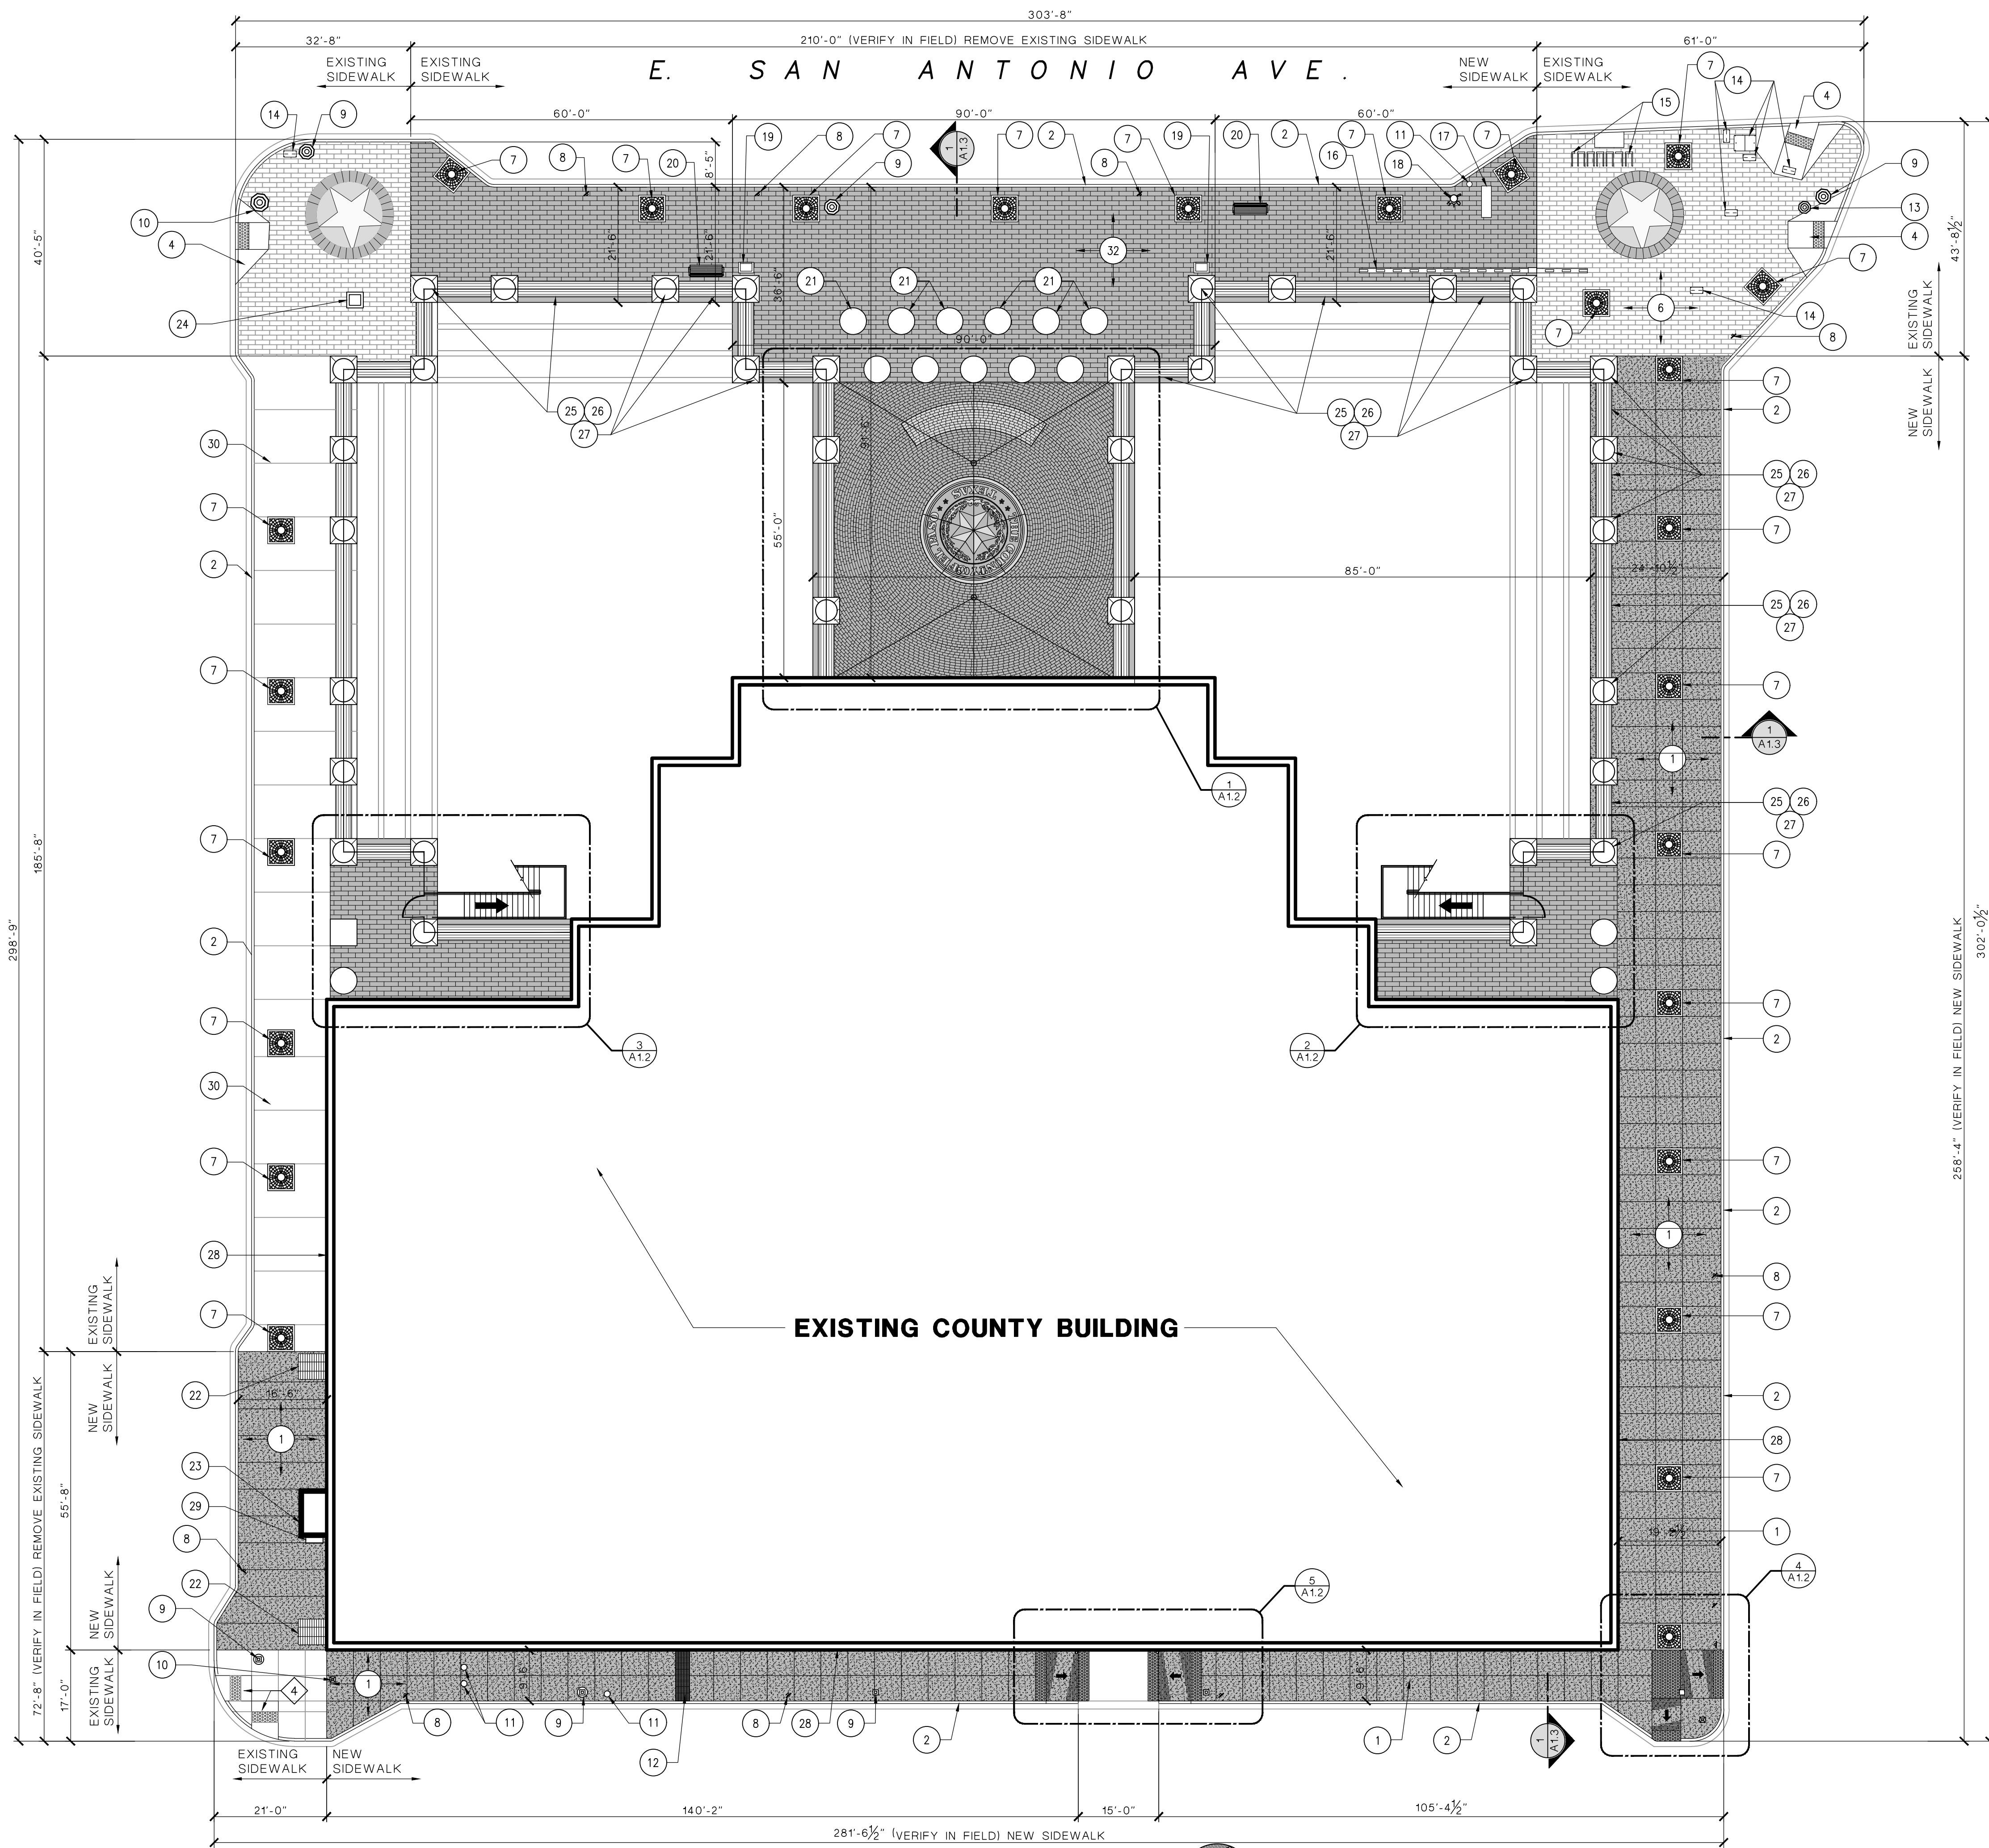
SHEET:
A1.1
REVISED SIDEWALKS LAYOUT

- 1 NEW CONCRETE SIDEWALK
- 2 EXISTING CONCRETE CURB AND GUTTER
- 3 NEW H/C CONCRETE RAMP, SEE X/AX
- 4 EXISTING H/C RAMP
- 5 EXISTING PIPE BOLLARD
- 6 EXISTING BOMANITE CONCRETE FINISH

- 7 EXISTING TREE WELLS
- 8 EXISTING SIGN
- 9 EXISTING LIGHT POLE
- 10 EXISTING TRAFFIC LIGHT
- 11 EXISTING CLEAN OUTS
- 12 EXISTING METAL PLATE
- 13 EXISTING CROSS WALK SIGN

- 14 EXISTING FLOOR BOX
- 15 EXISTING METAL BIKE RACK
- 16 EXISTING BIKE SHARING STATION
- 17 EXISTING BACKFLOW PREVENTER
- 18 EXISTING FIRE HYDRANT
- 19 EXISTING TRASH CAN

- 20 EXISTING BENCH
- 21 EXISTING SAFETY BOLLARDS
- 22 EXISTING MECHANICAL METAL GRID
- 23 EXISTING UTILITY ENCLOSURE
- 24 EXISTING CITY MAP POLE
- 25 EXISTING ORNAMENTAL SPHERES

- 26 EXISTING RED CYLINDERS
- 27 EXISTING BRICK COLUMNS
- 28 EXISTING BUILDING
- 29 EXISTING ELECTRICAL BOX
- 30 EXISTING CONCRETE SIDEWALK
- 31 EXISTING METAL BIKE RACK

- 32 NEW BOMANITE CONCRETE FINISH

NOTE: CONCRETE SIDEWALKS SHALL NOT EXCEED 2% SLOPE IN ANY DIRECTION.
