EMPLOYEE FITNESS & WELLNESS CENTER
500 E SAN ANTONIO ST. EL PASO, TEXAS

ISSUED FOR CONSTRUCTION

DATE: OCTOBER 17 - 2018

2016-25 EMPLOYEE FITNESS & WELLNESS CENTER - CONSTRUCTION DOCUMENTS

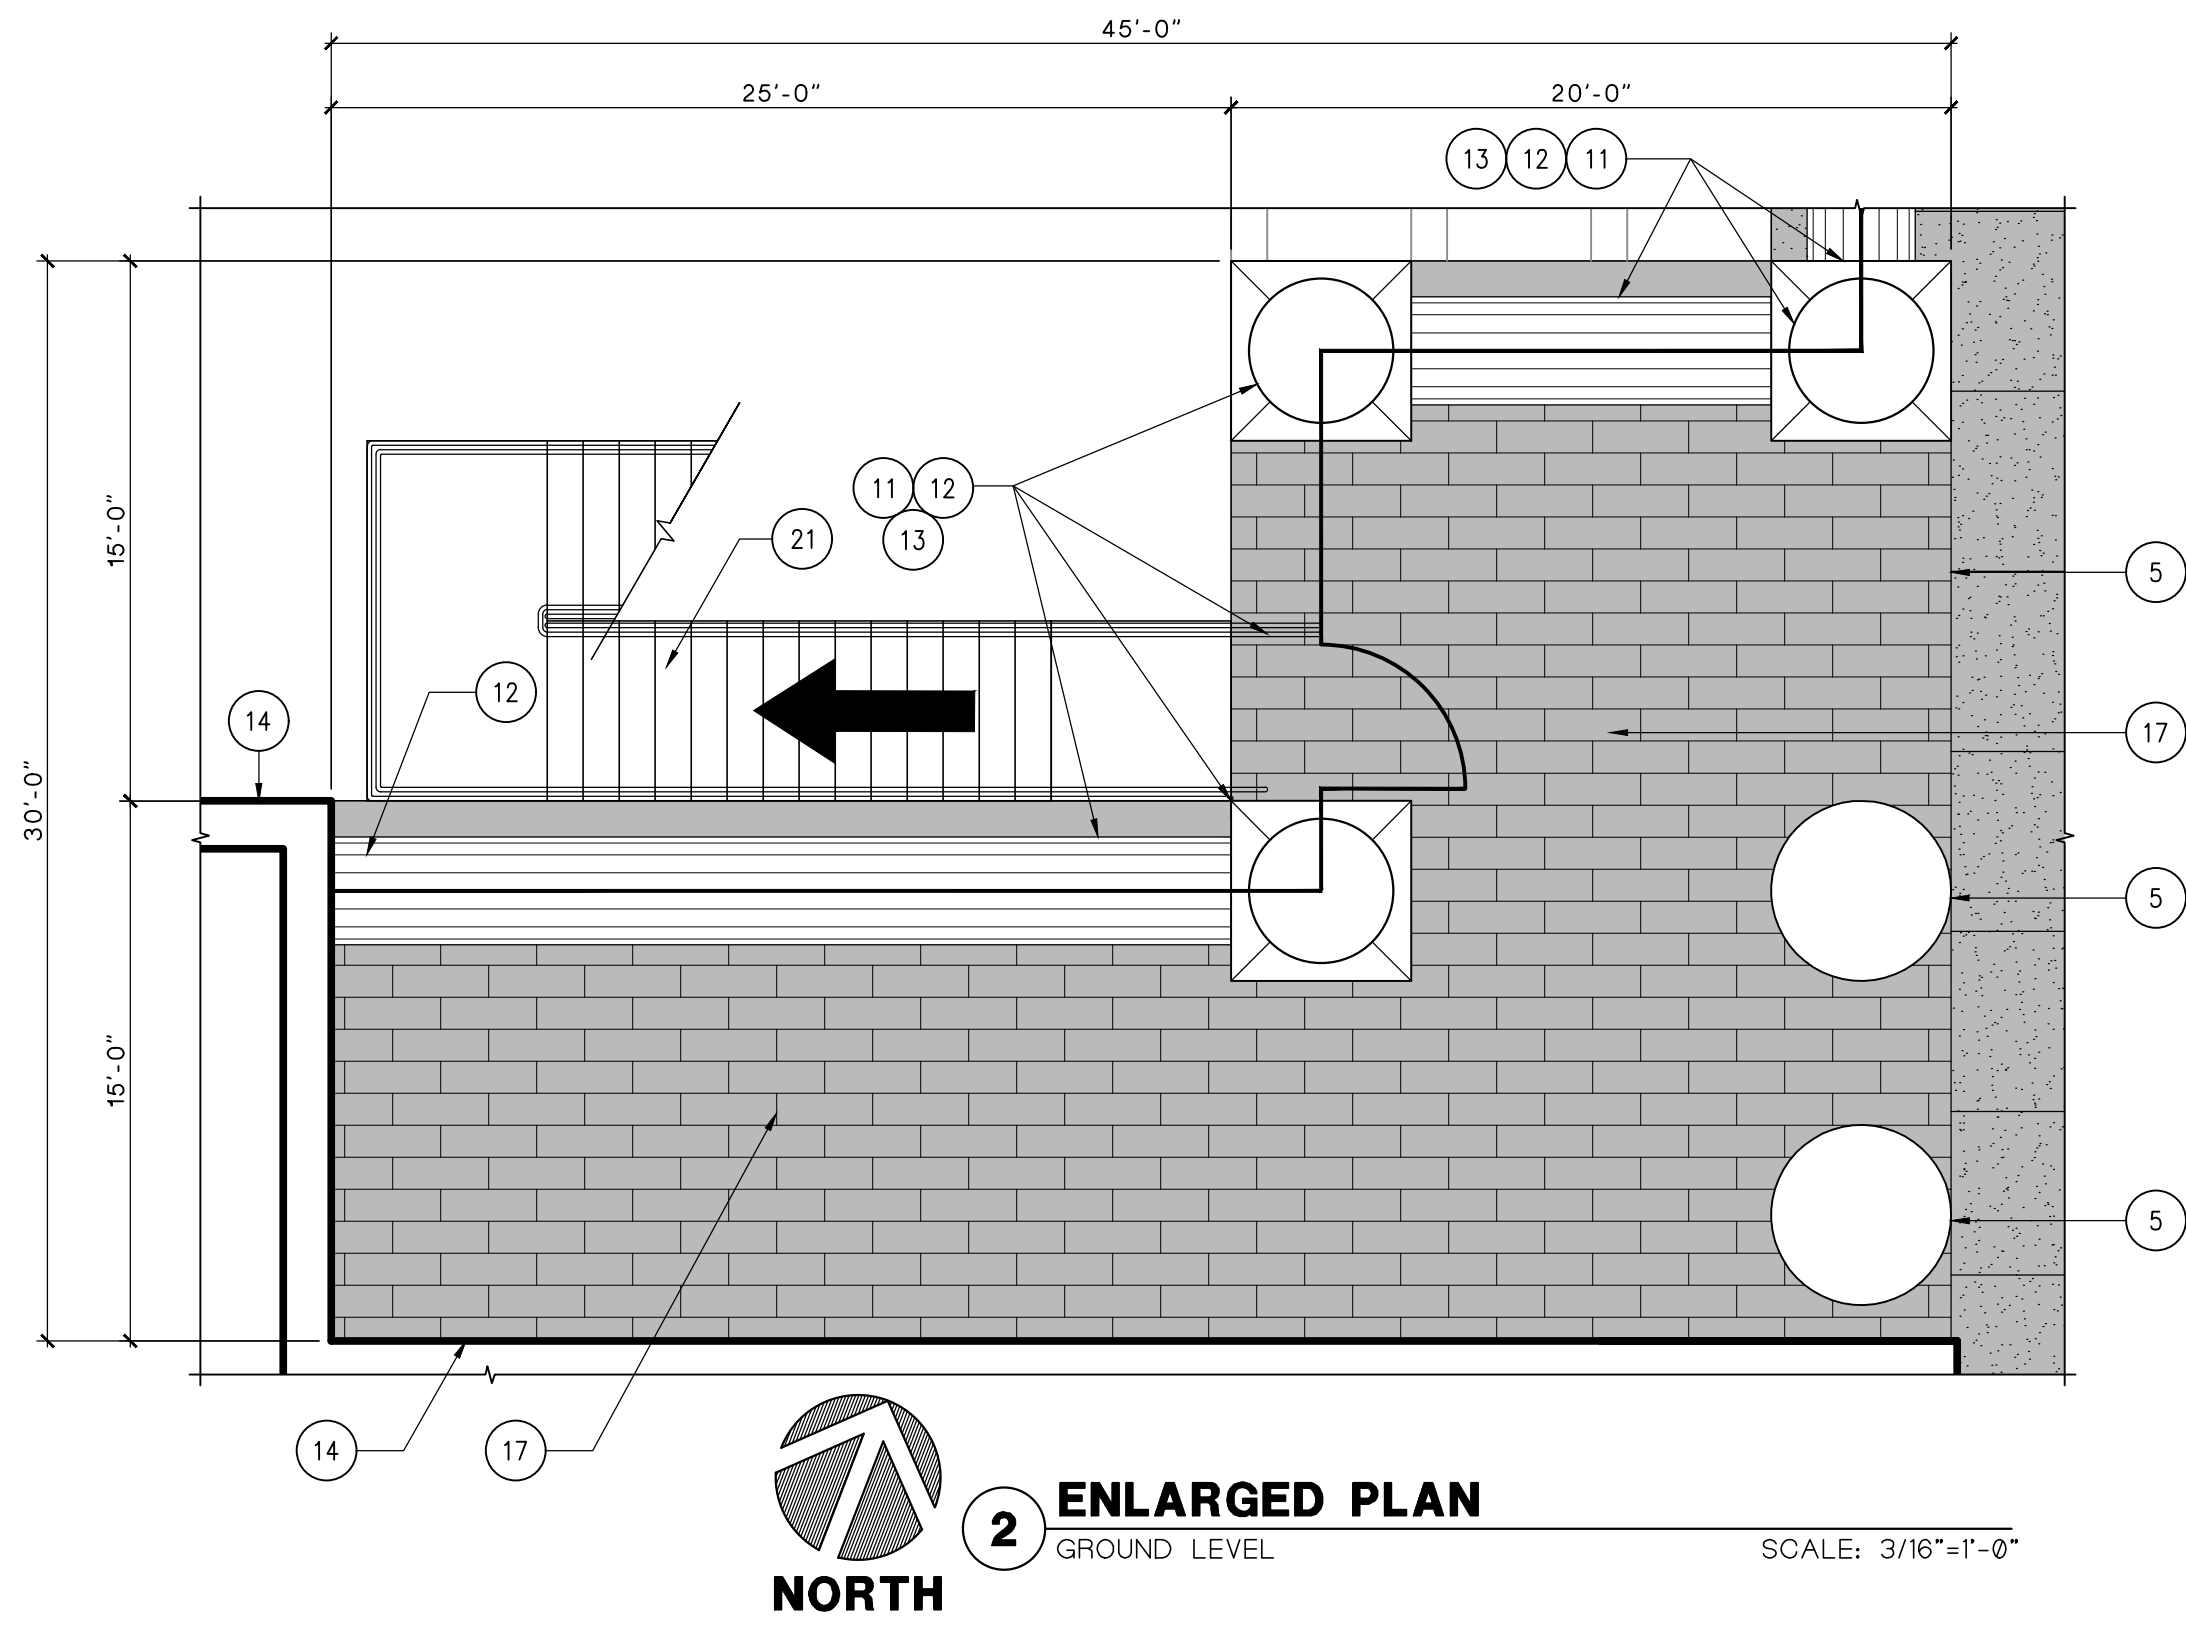
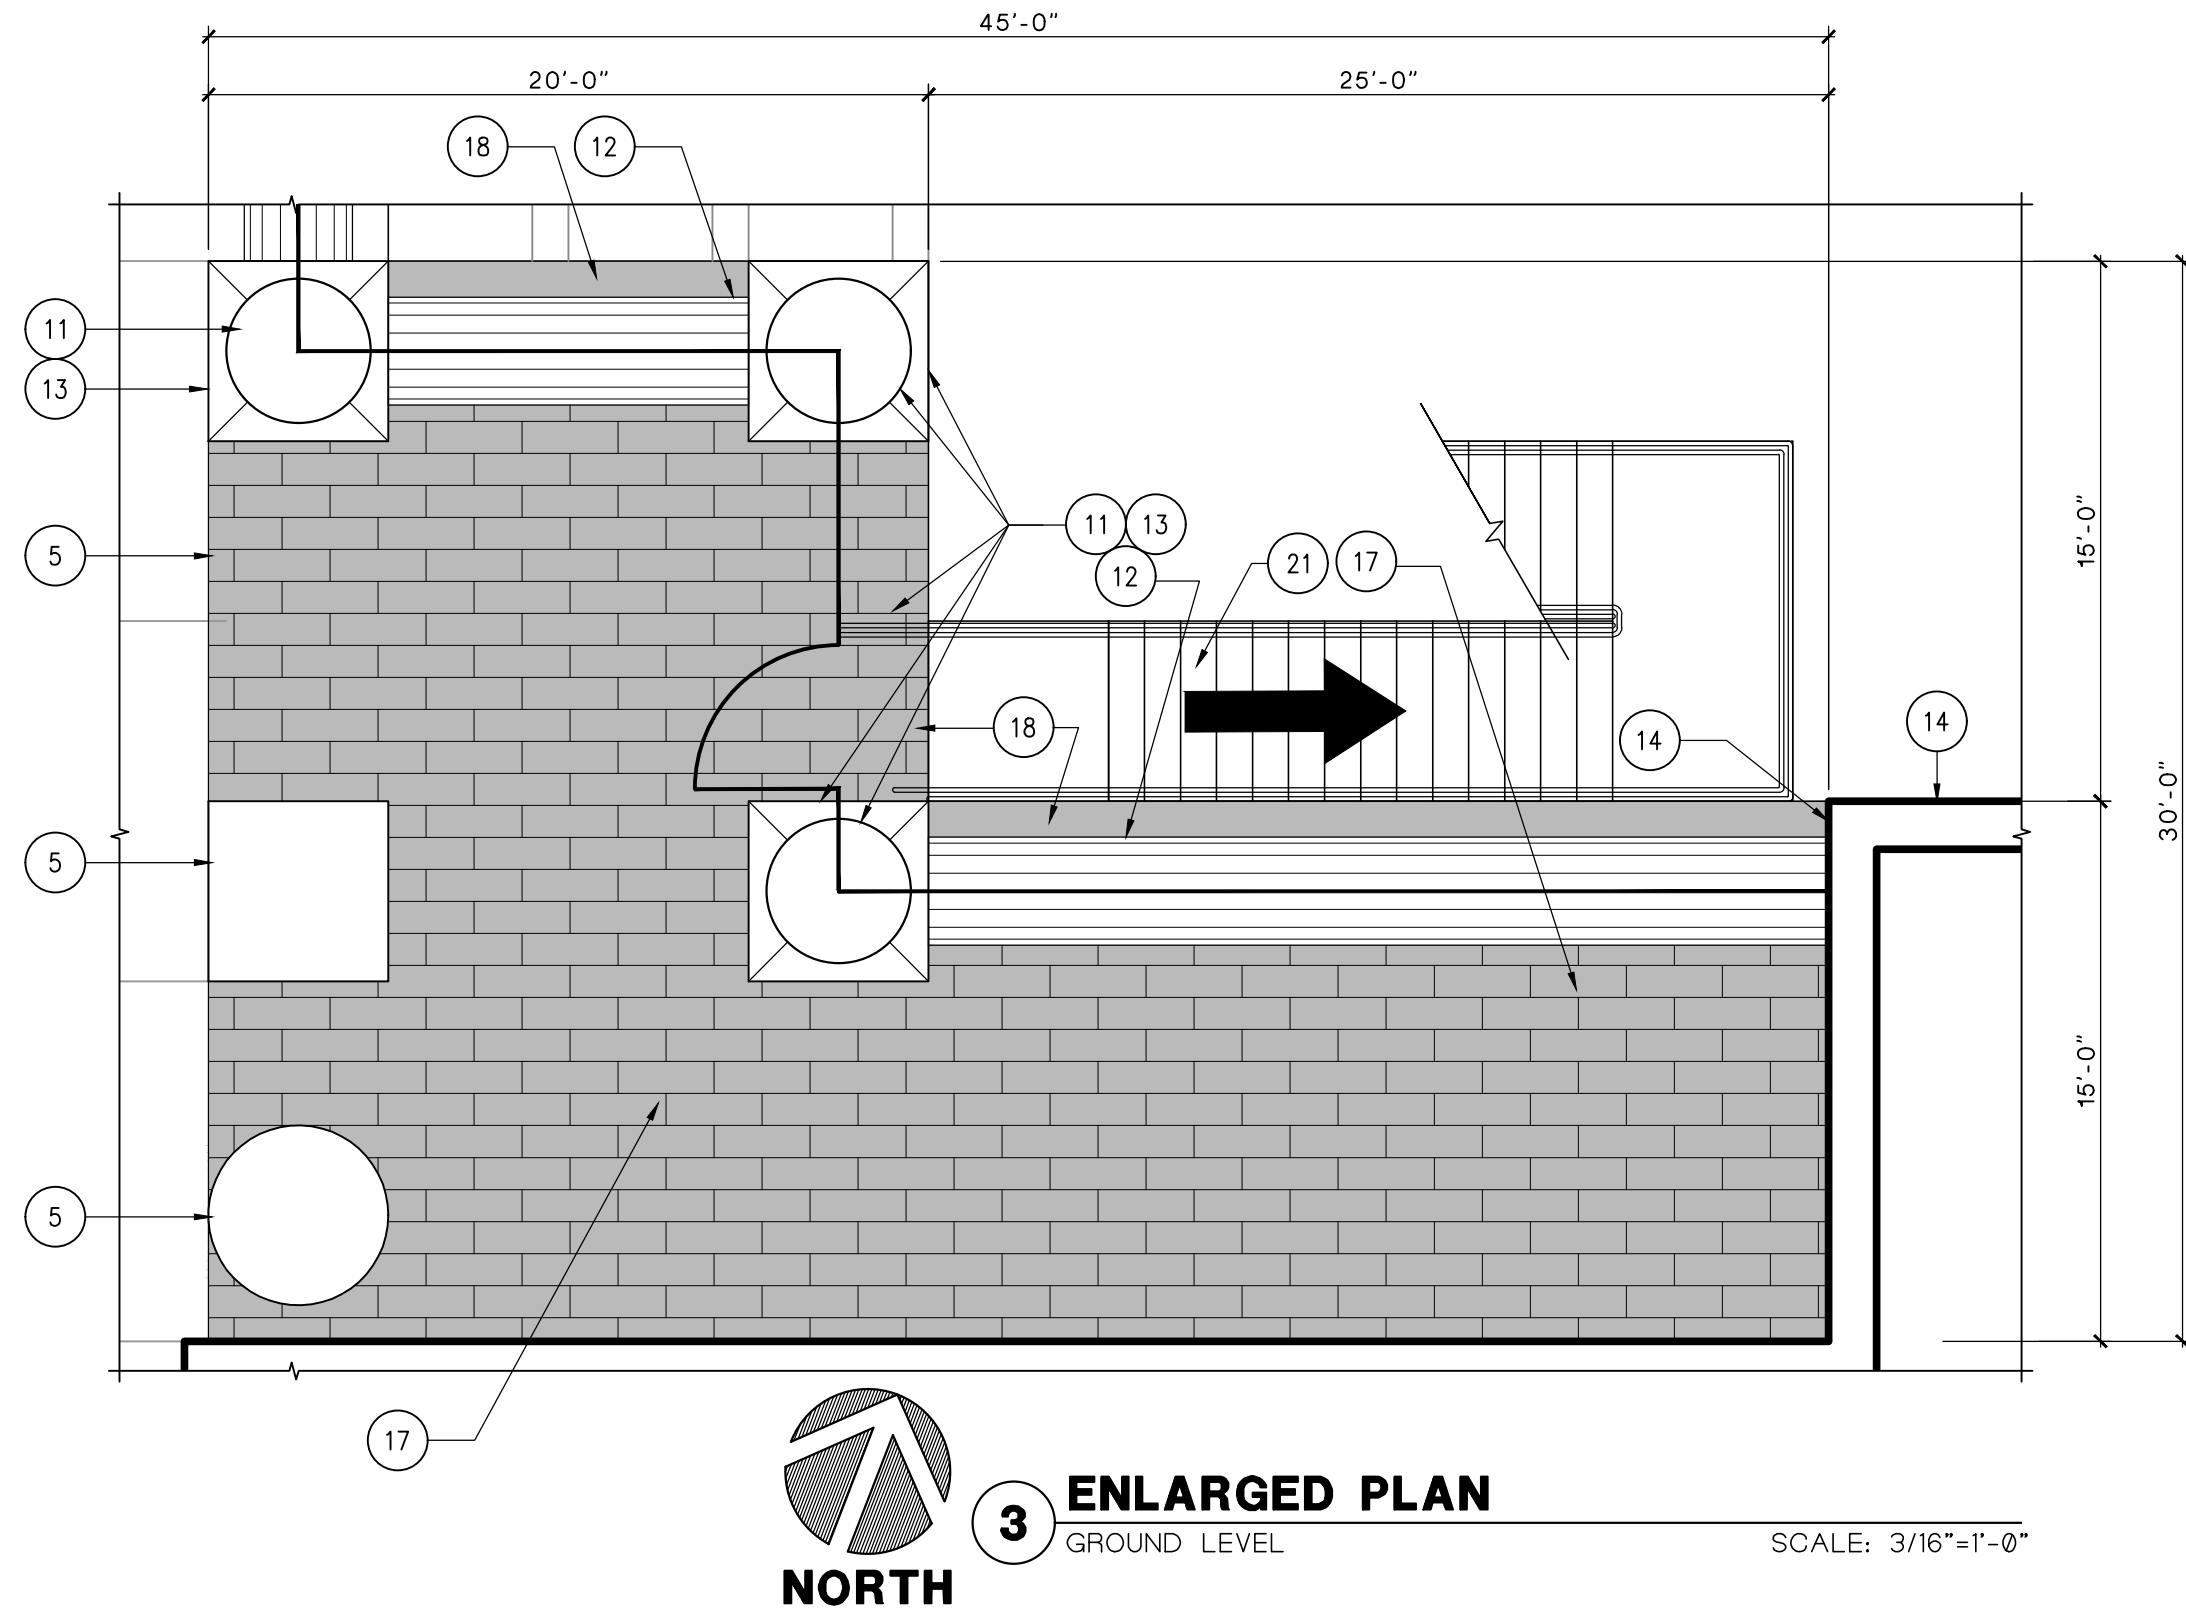
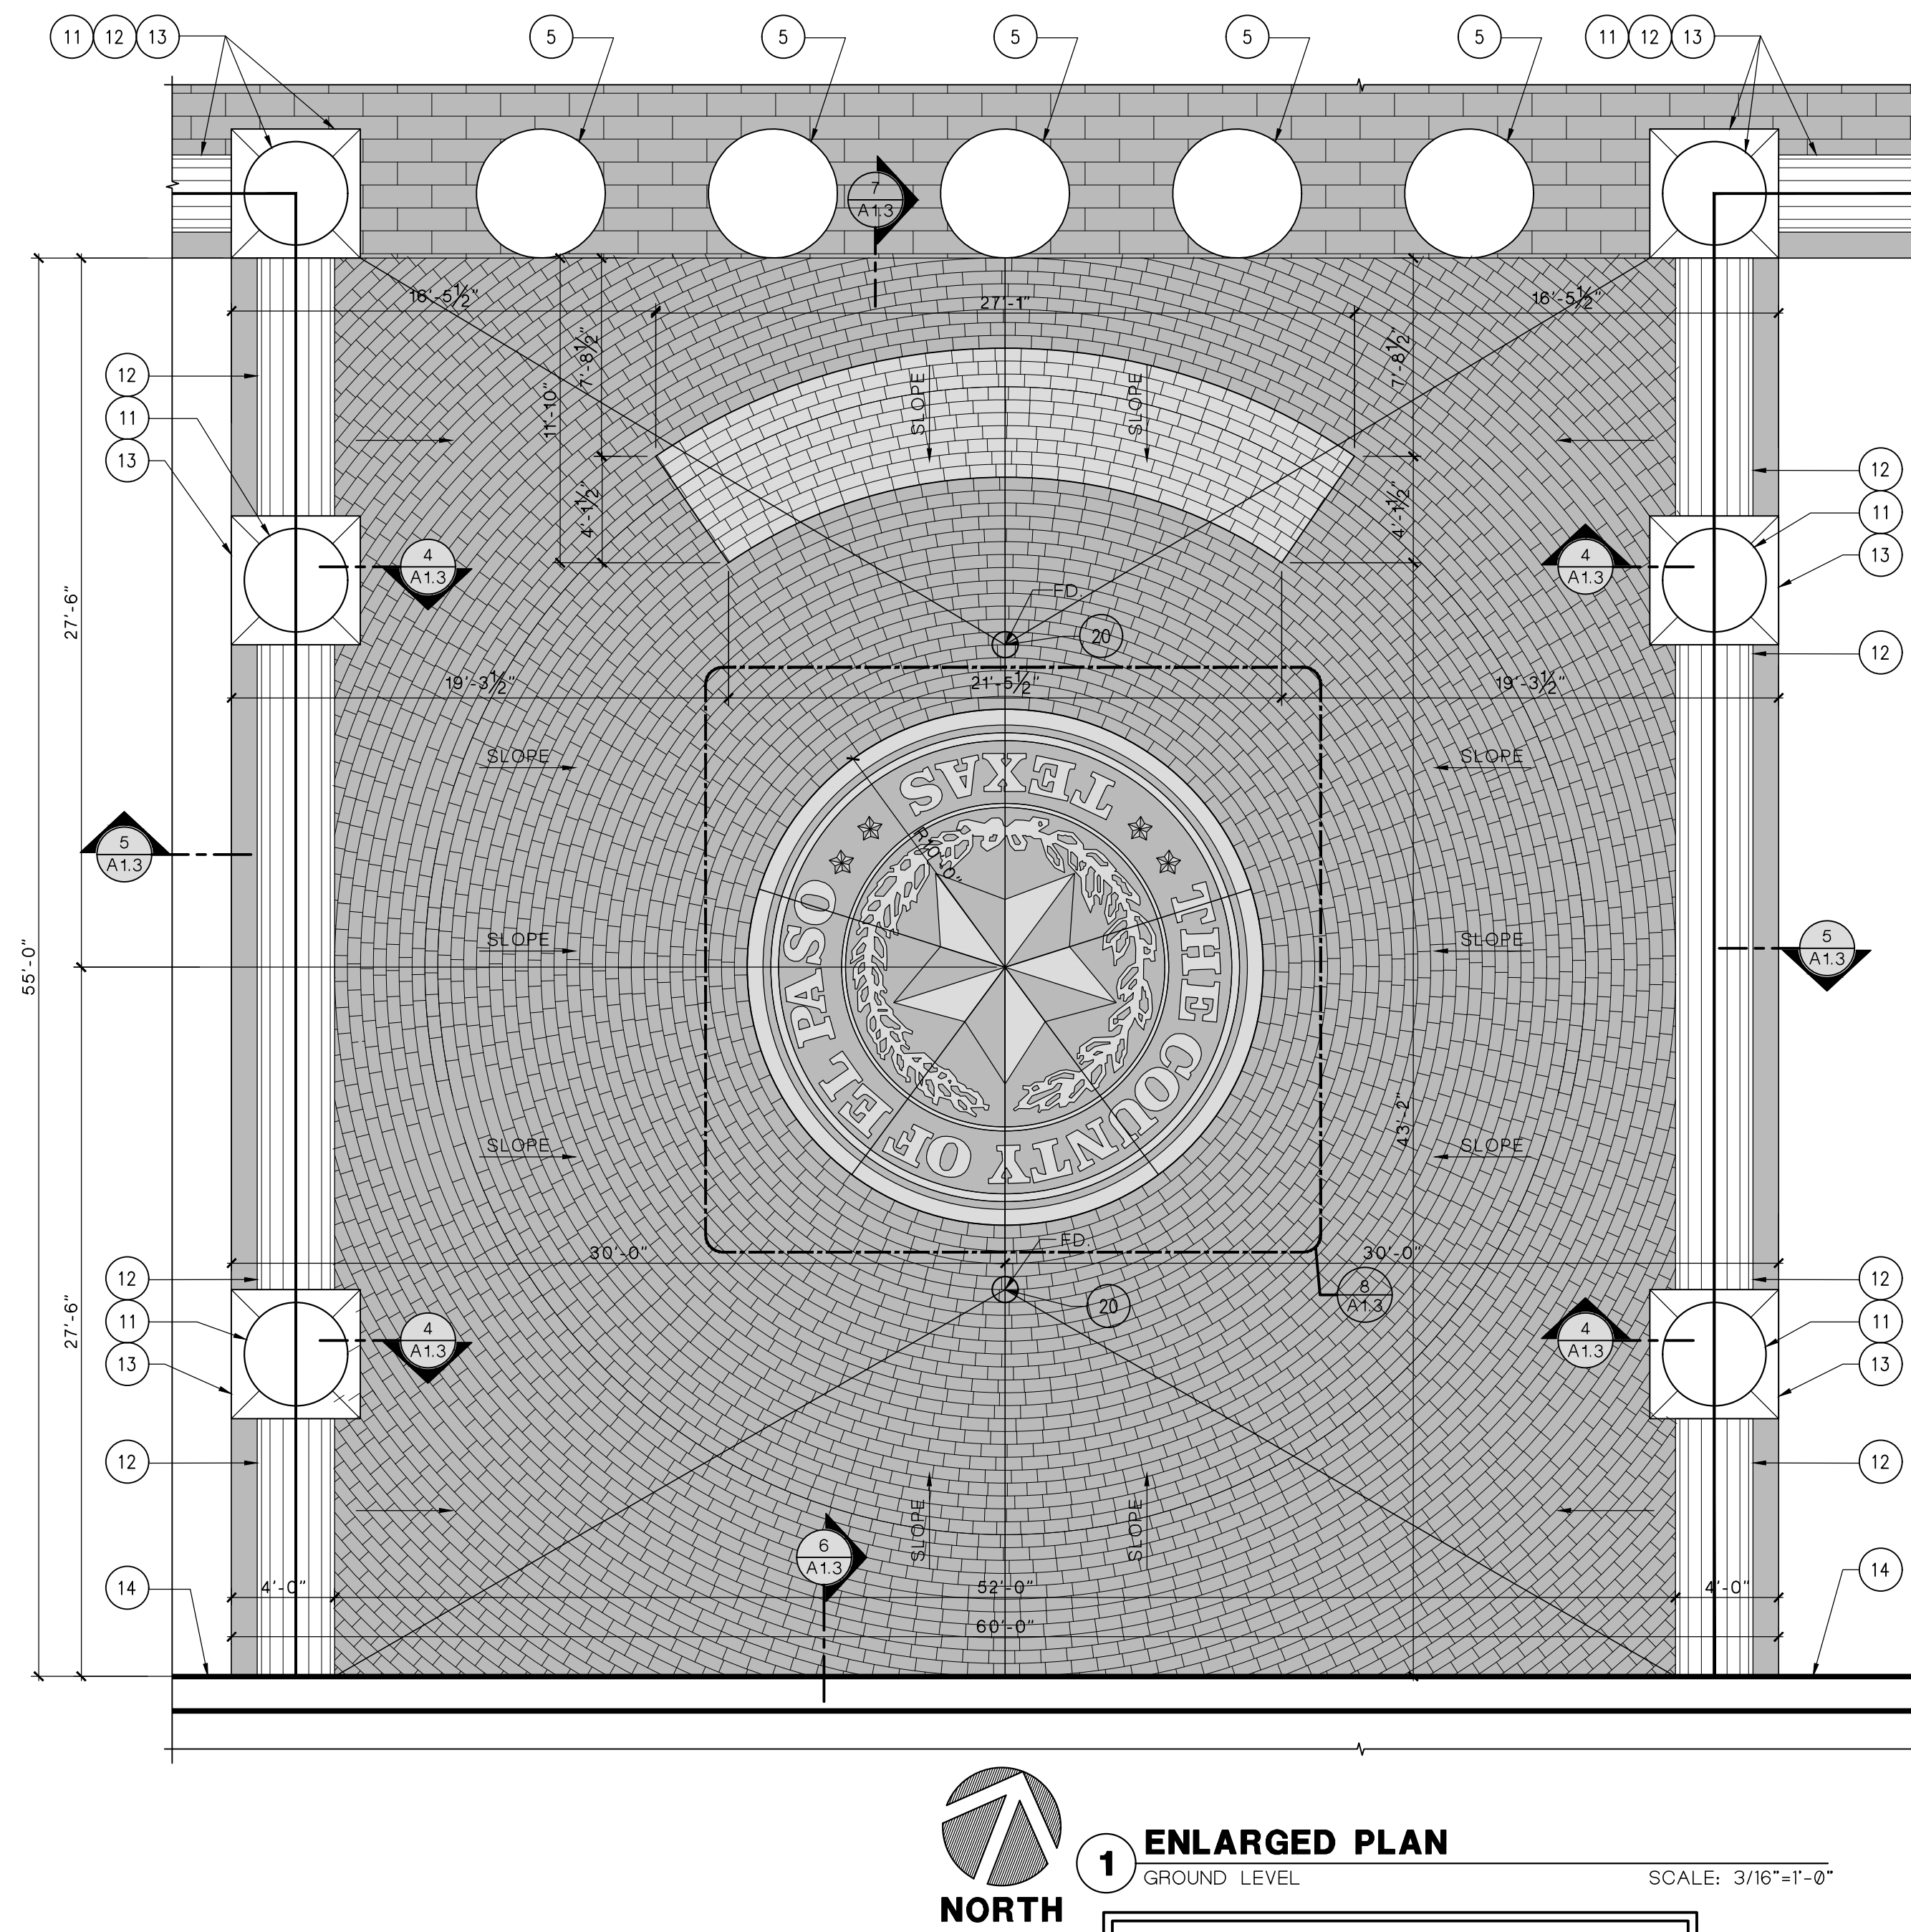
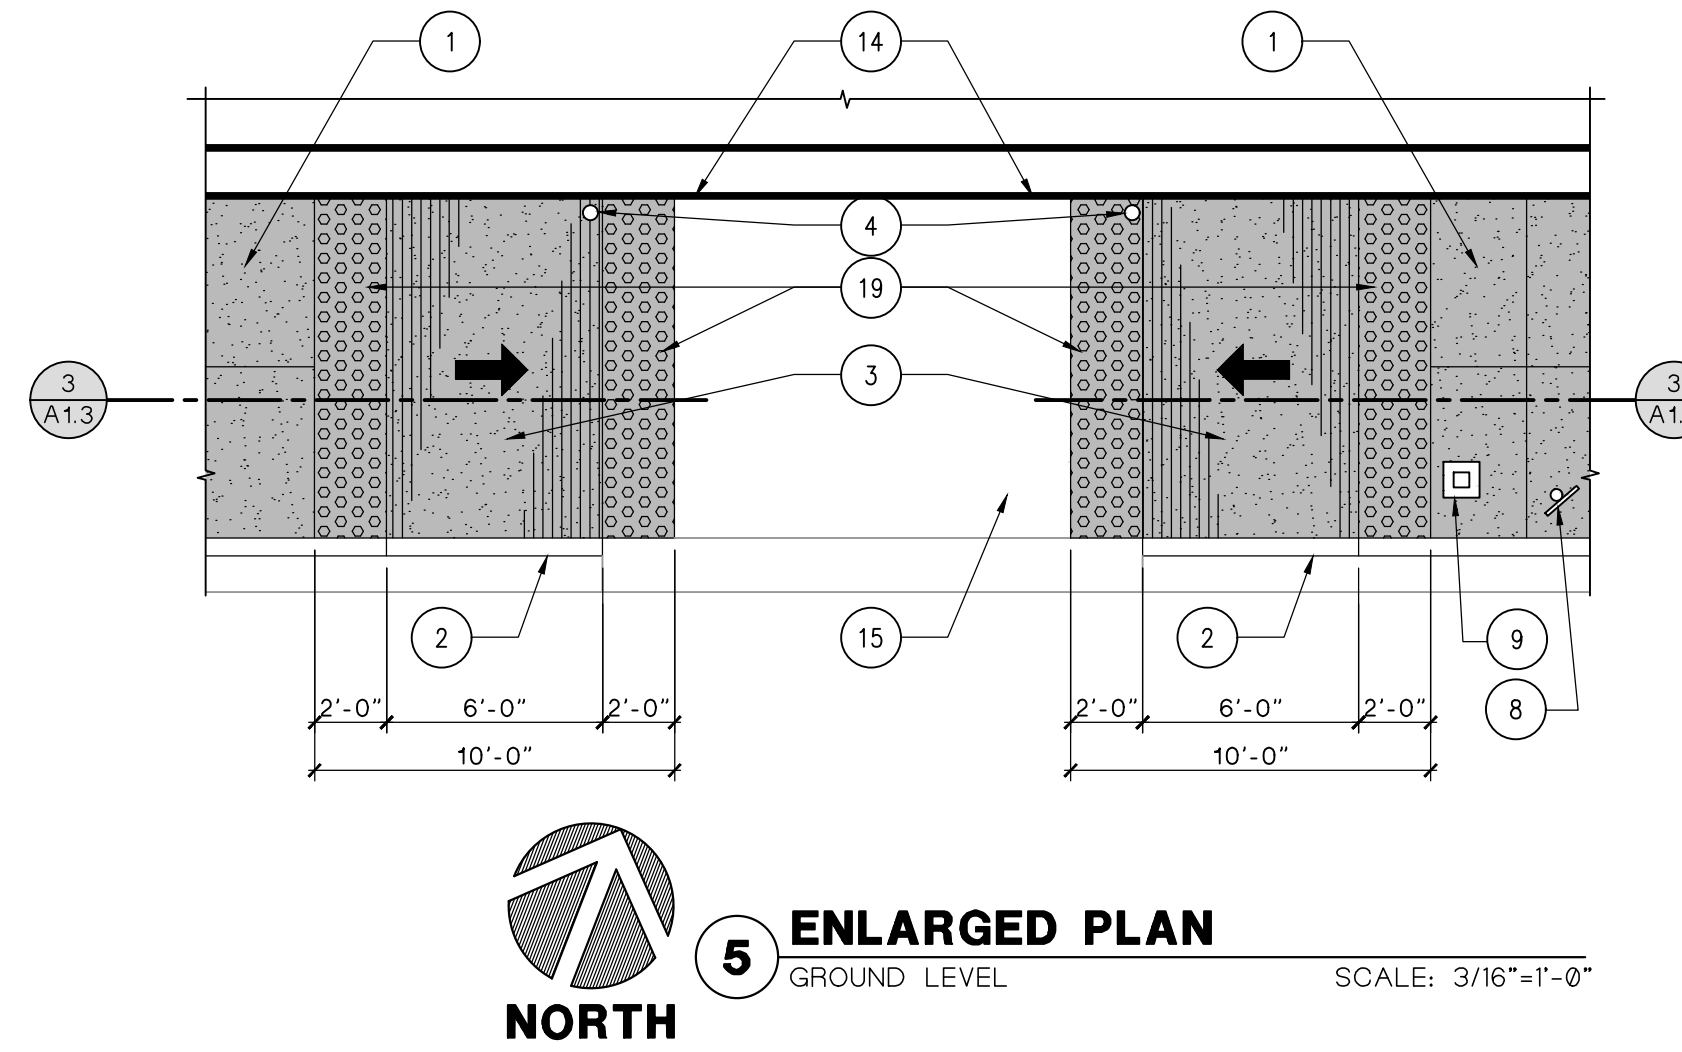
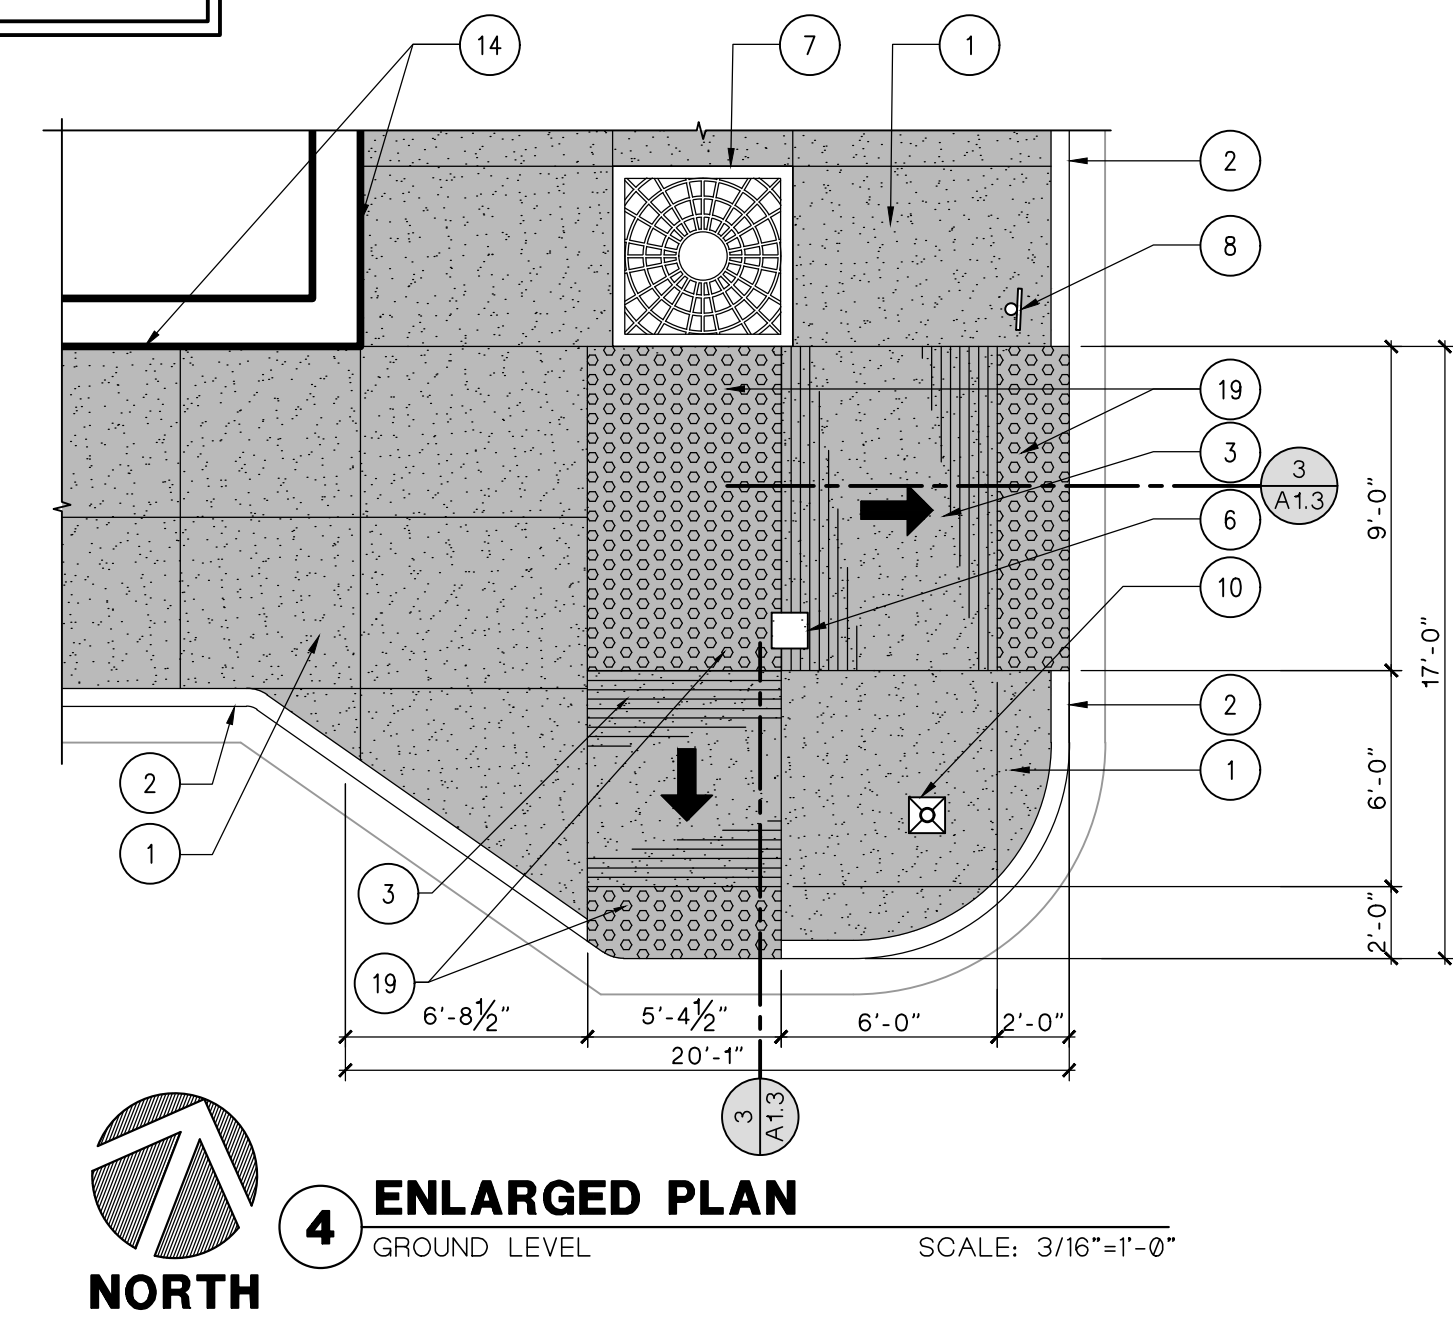
SHEET:
A1.2
ENLARGED PLANS

- ### REVISED NOTES
- 1 NEW CONCRETE SIDEWALK
 - 2 EXISTING CONCRETE CURB AND GUTTER
 - 3 NEW H/C CONCRETE RAMP, SEE X/AX
 - 4 EXISTING PIPE BOLLARD PAINT
 - 5 EXISTING SAFETY BOLLARDS REPAIR
 - 6 EXISTING METAL PLATE
 - 7 EXISTING TREE WELLS
 - 8 EXISTING SIGN
 - 9 EXISTING LIGHT POLE
 - 10 EXISTING TRAFFIC LIGHT
 - 11 EXISTING ORNAMENTAL SPHERES
 - 12 EXISTING RED CYLINDERS
 - 13 EXISTING BRICK COLUMNS
 - 14 EXISTING BUILDING
 - 15 EXISTING CONCRETE SIDEWALK
 - 16 EXISTING METAL BIKE RACK
 - 17 NEW BOMANITE CONCRETE FINISH
 - 18 NEW CONCRETE FINISH
 - 19 NEW DETECTABLE/TACTILE SURFACE TILE
 - 20 ADD NEW FLOOR DRAINS, SEE PLUMBING PLANS
 - 21 NEW STAIRS-SEE 1/A8.1
- ALTERNATE NO. 1:
SIDEWALK RENOVATION.

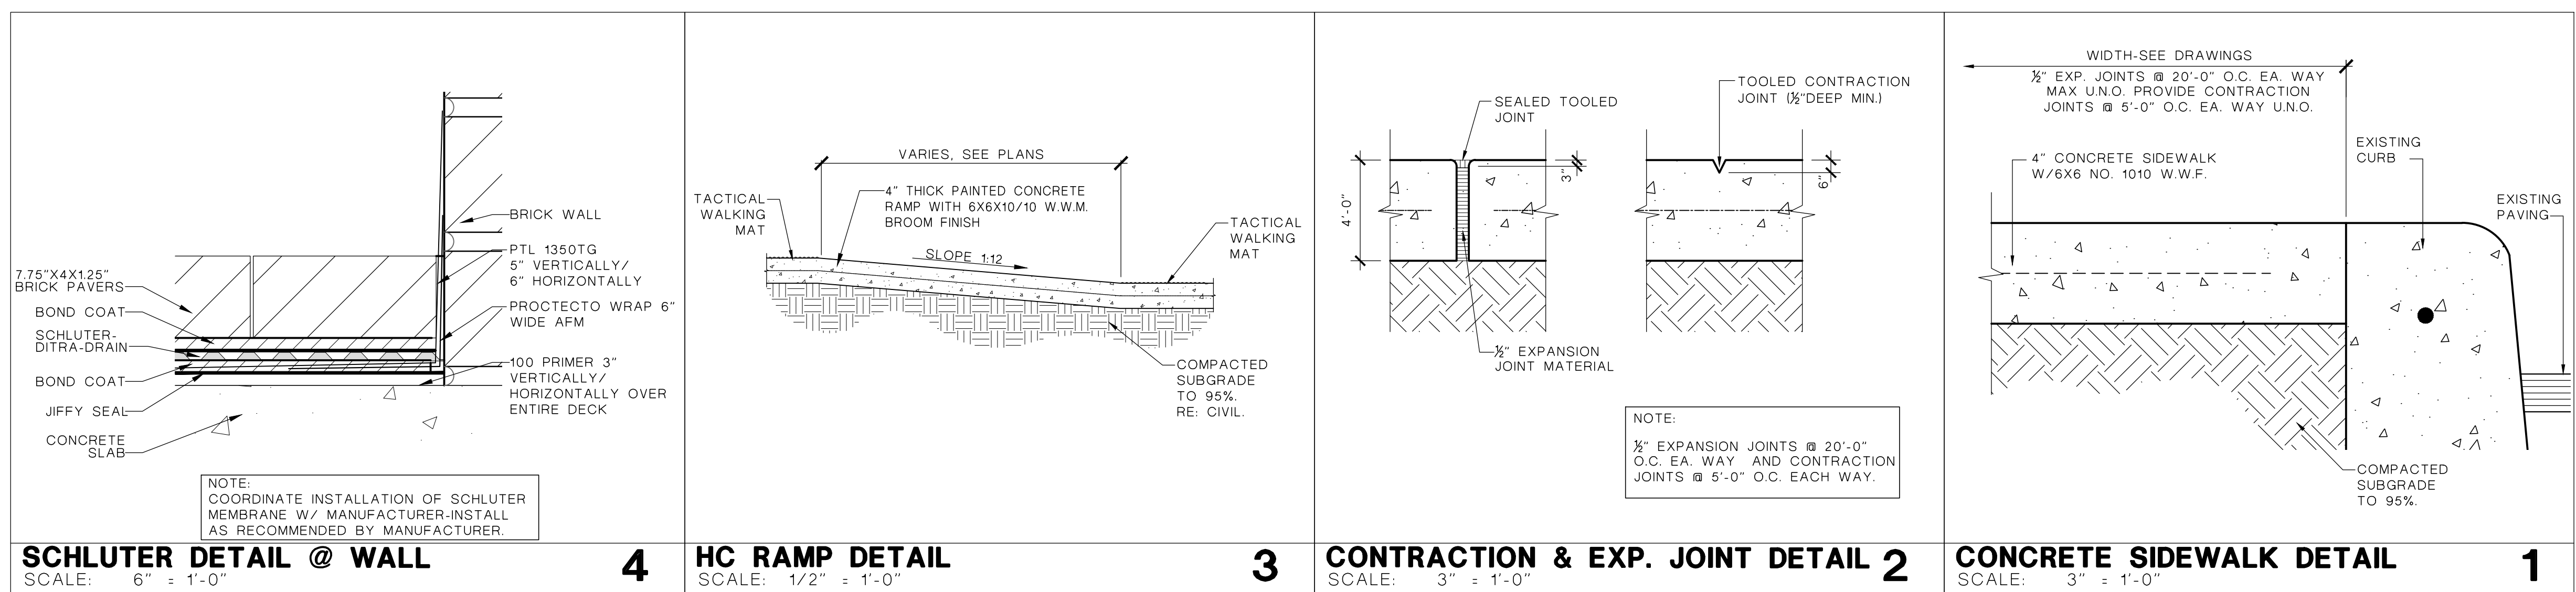
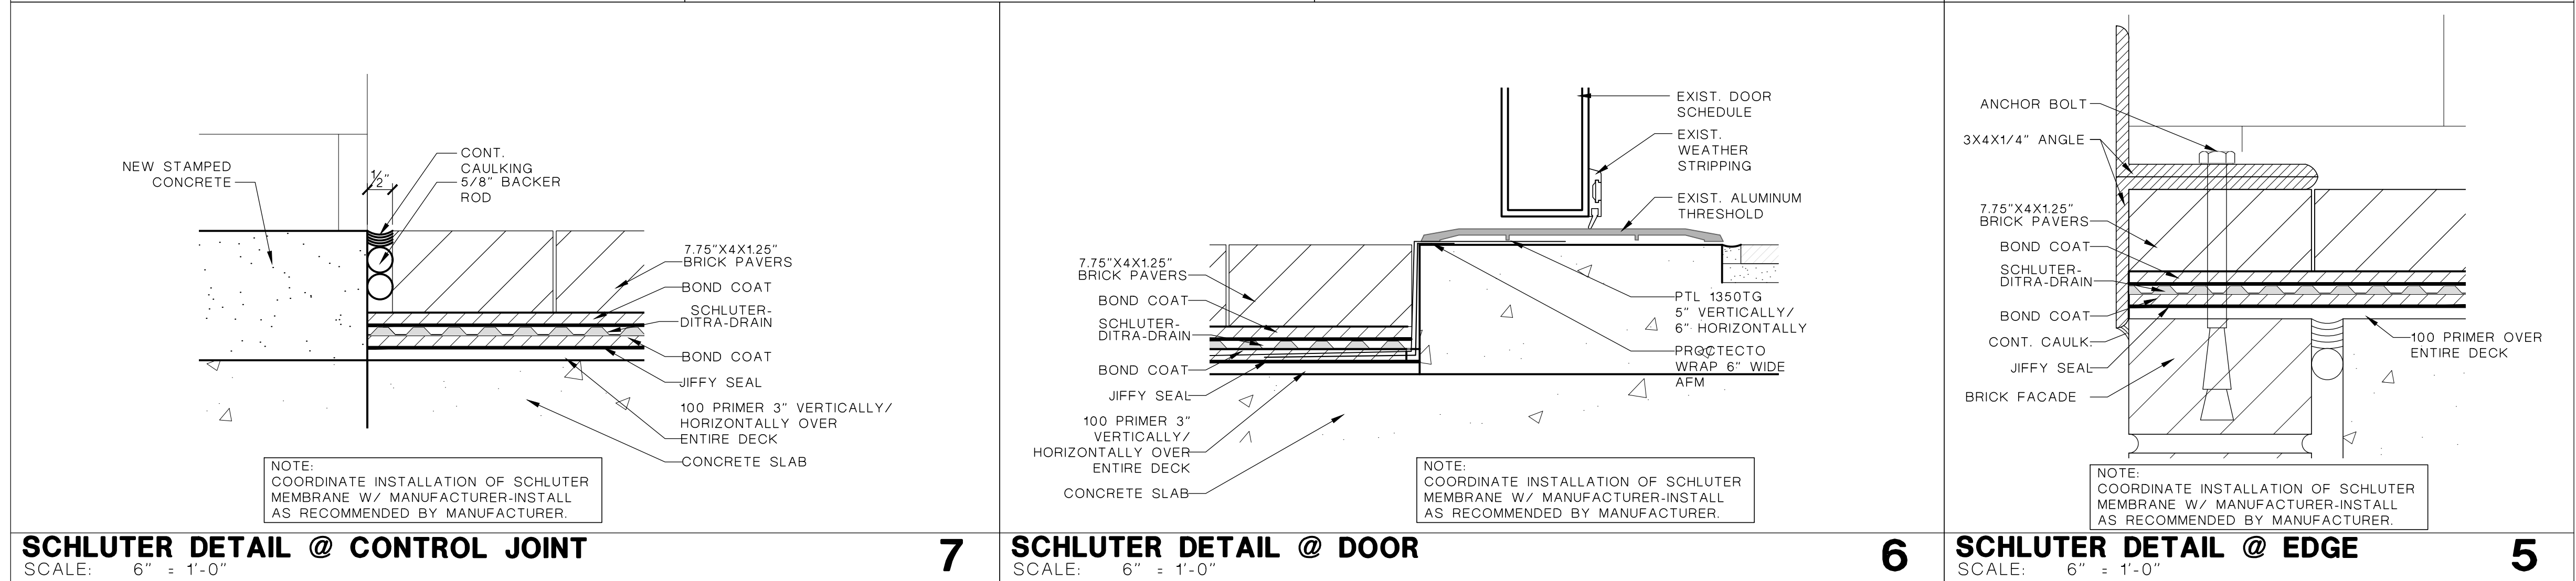
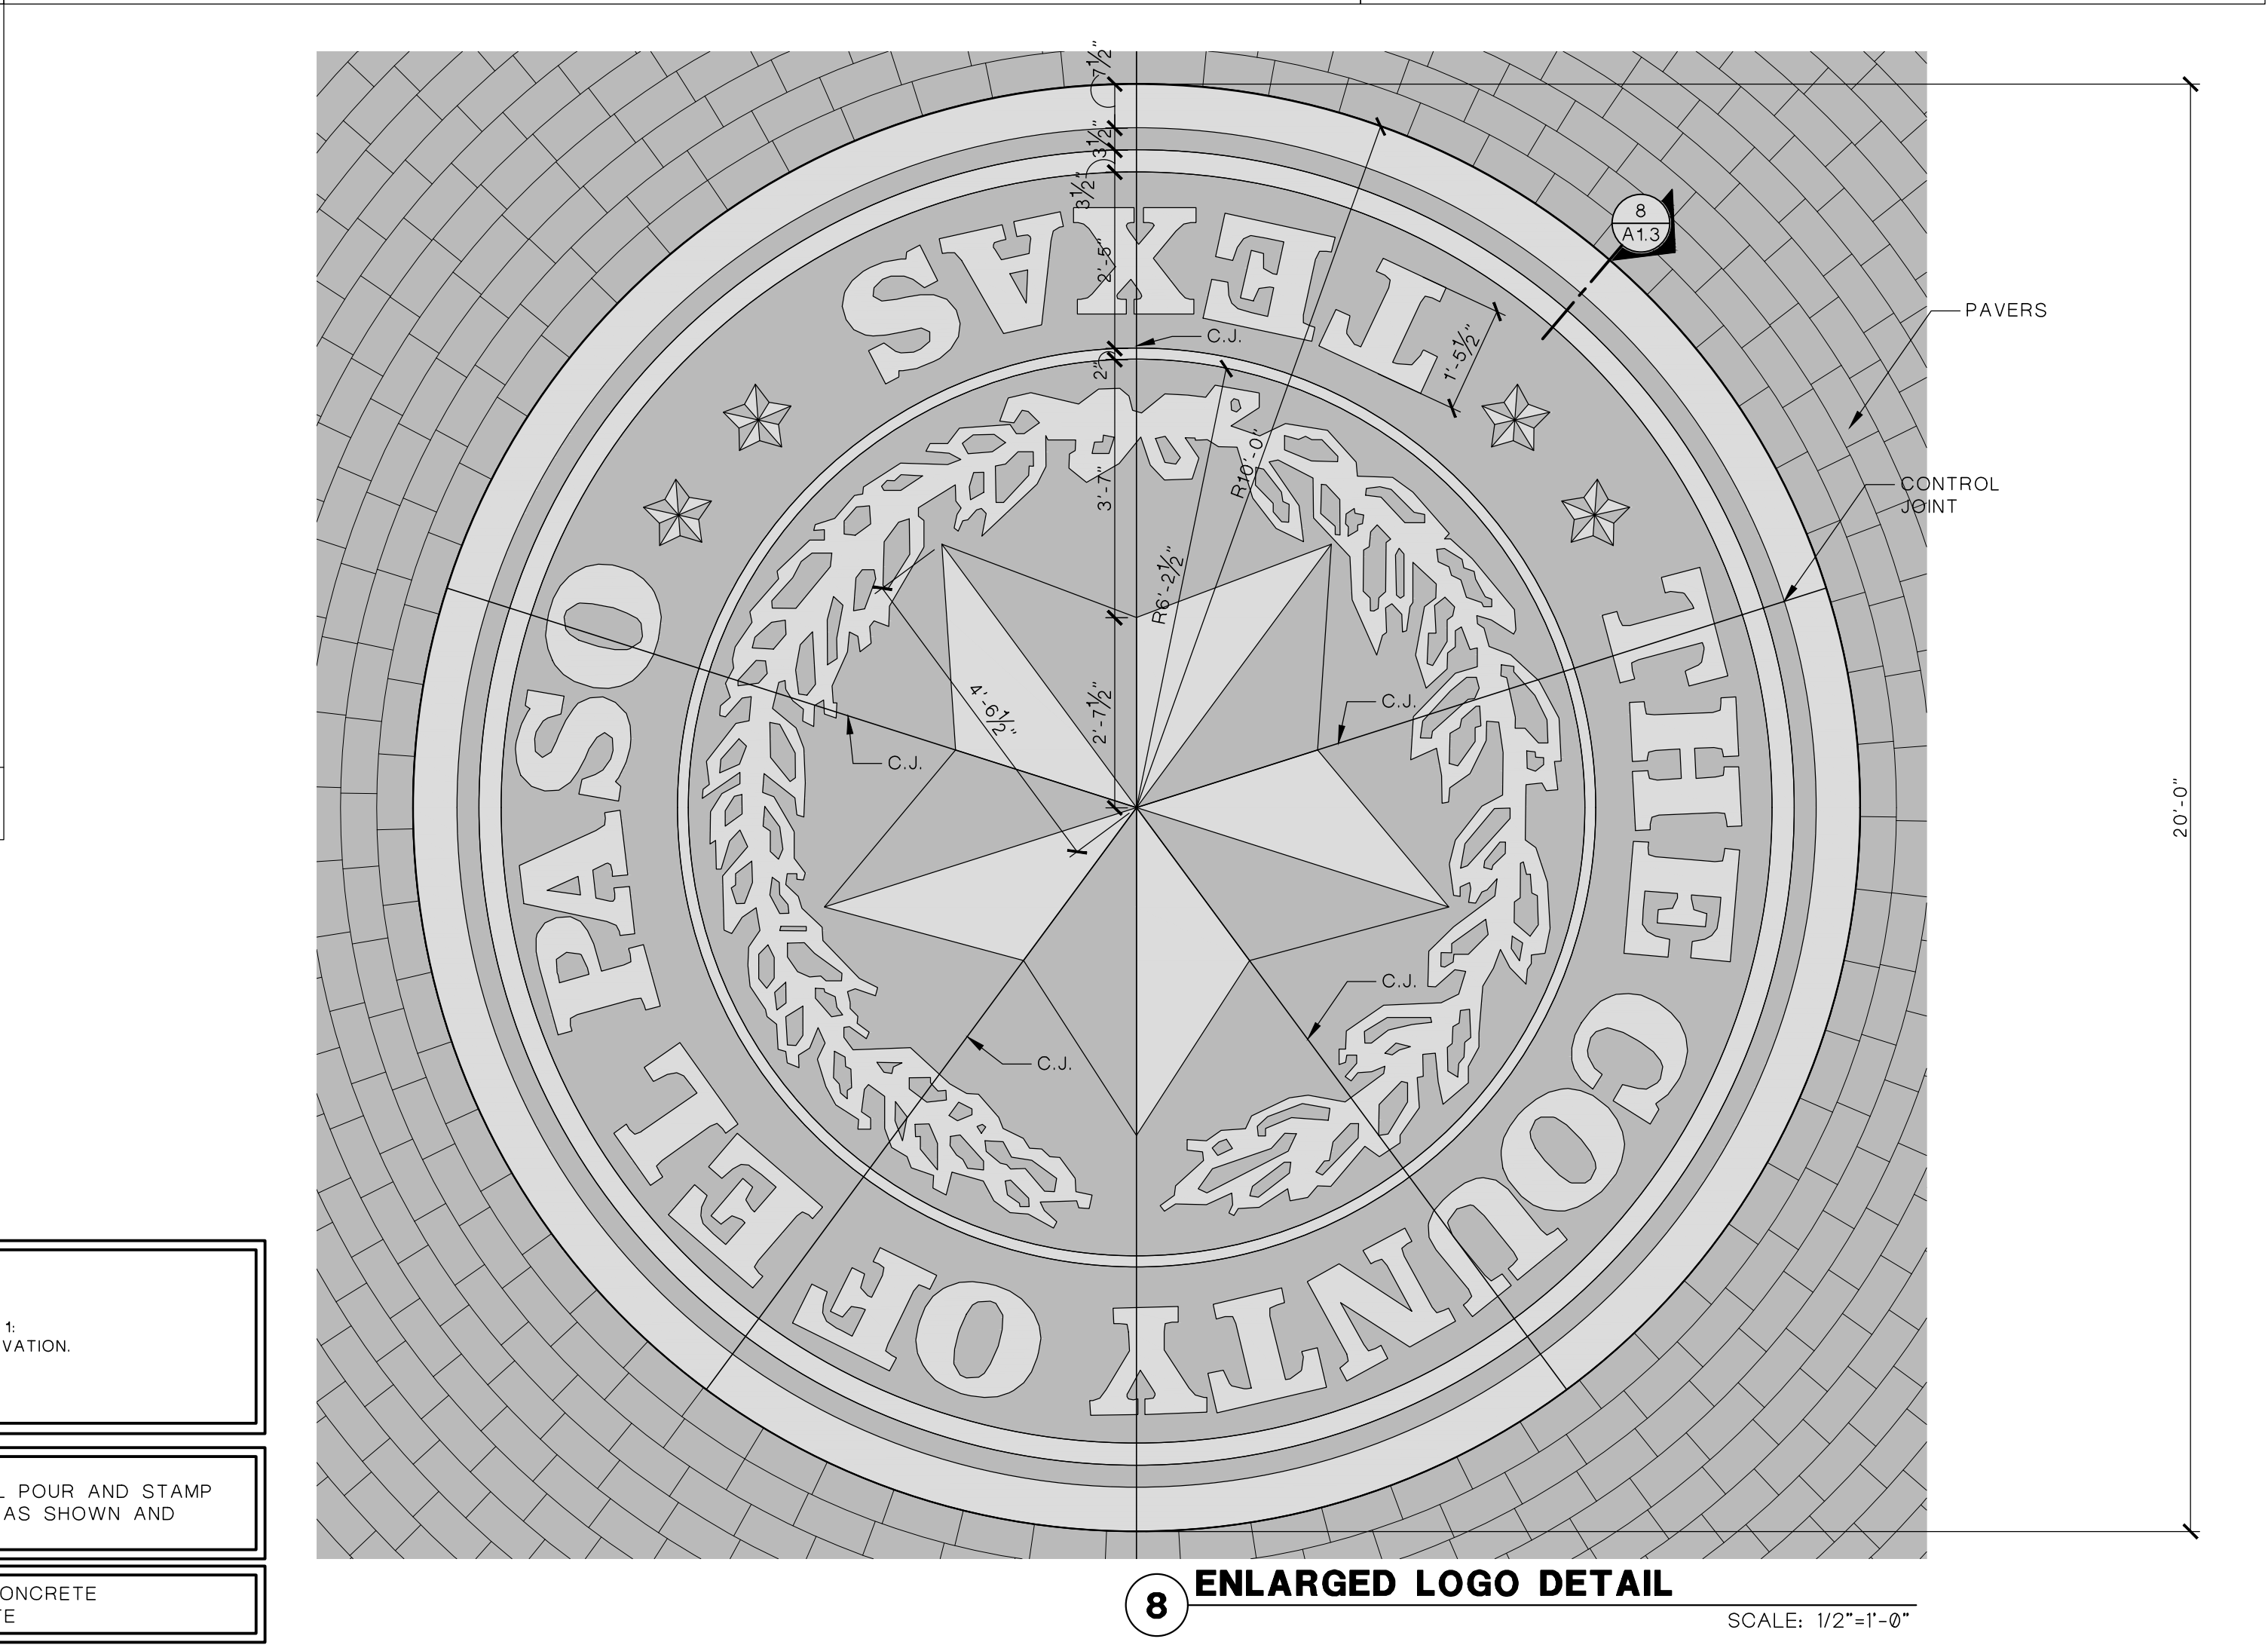
SHEET:
A1.3
 MISCELLANEOUS
 DETAILS

NOTE:
 CONTRACTOR SHALL POUR AND STAMP
 THE COUNTY LOGO AS SHOWN AND
 DETAILED.

NOTE: 5,000 P.S.I. CONCRETE
 W/ 3/8" AGGREGATE
