EMPLOYEE FITNESS & WELLNESS CENTER
500 E SAN ANTONIO ST. EL PASO, TEXAS

ISSUED FOR CONSTRUCTION

DATE: OCTOBER 17 - 2018

2016-25 EMPLOYEE FITNESS & WELLNESS CENTER - CONSTRUCTION DOCUMENTS

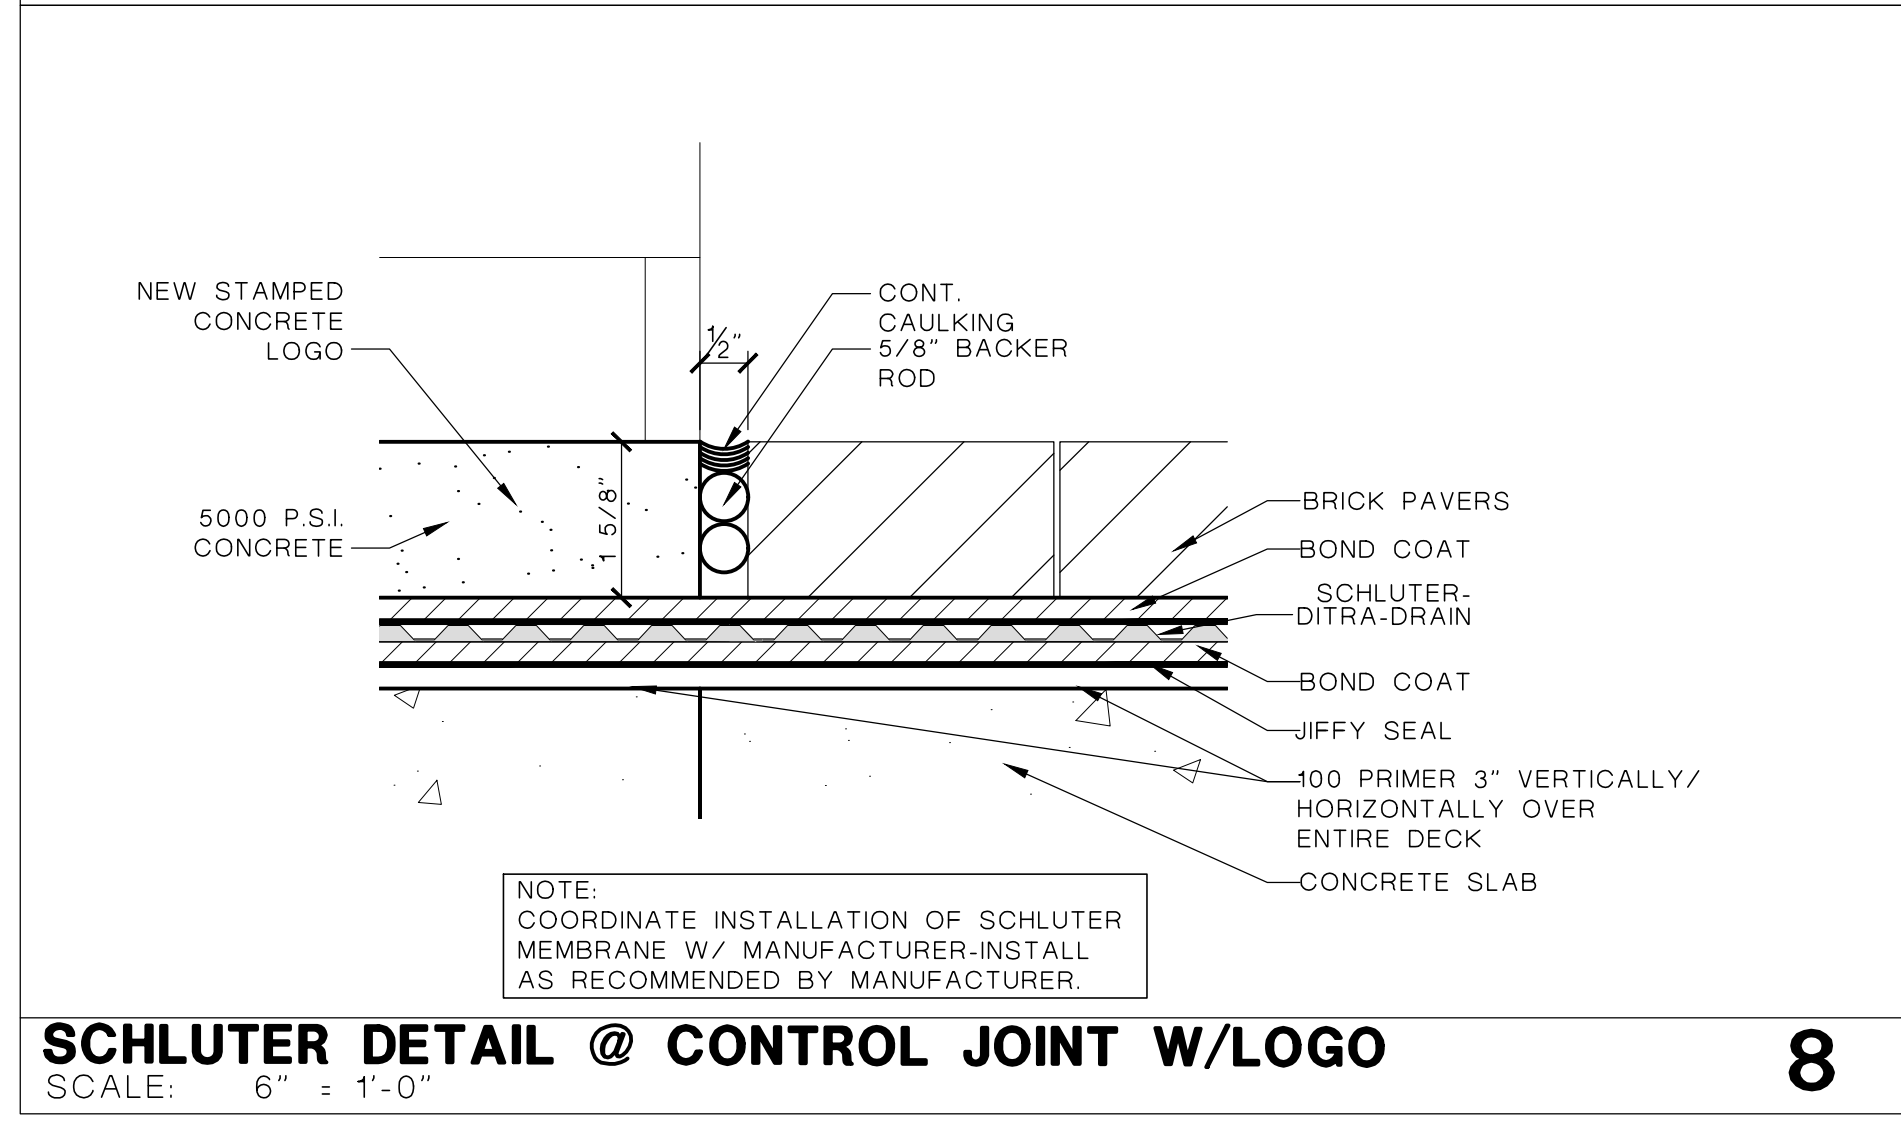
NOTE:
 CONTRACTOR SHALL POUR AND STAMP
 THE COUNTY LOGO AS SHOWN AND
 DETAILED.

NOTE: 5,000 P.S.I. CONCRETE
 W/ 3/8" AGGREGATE

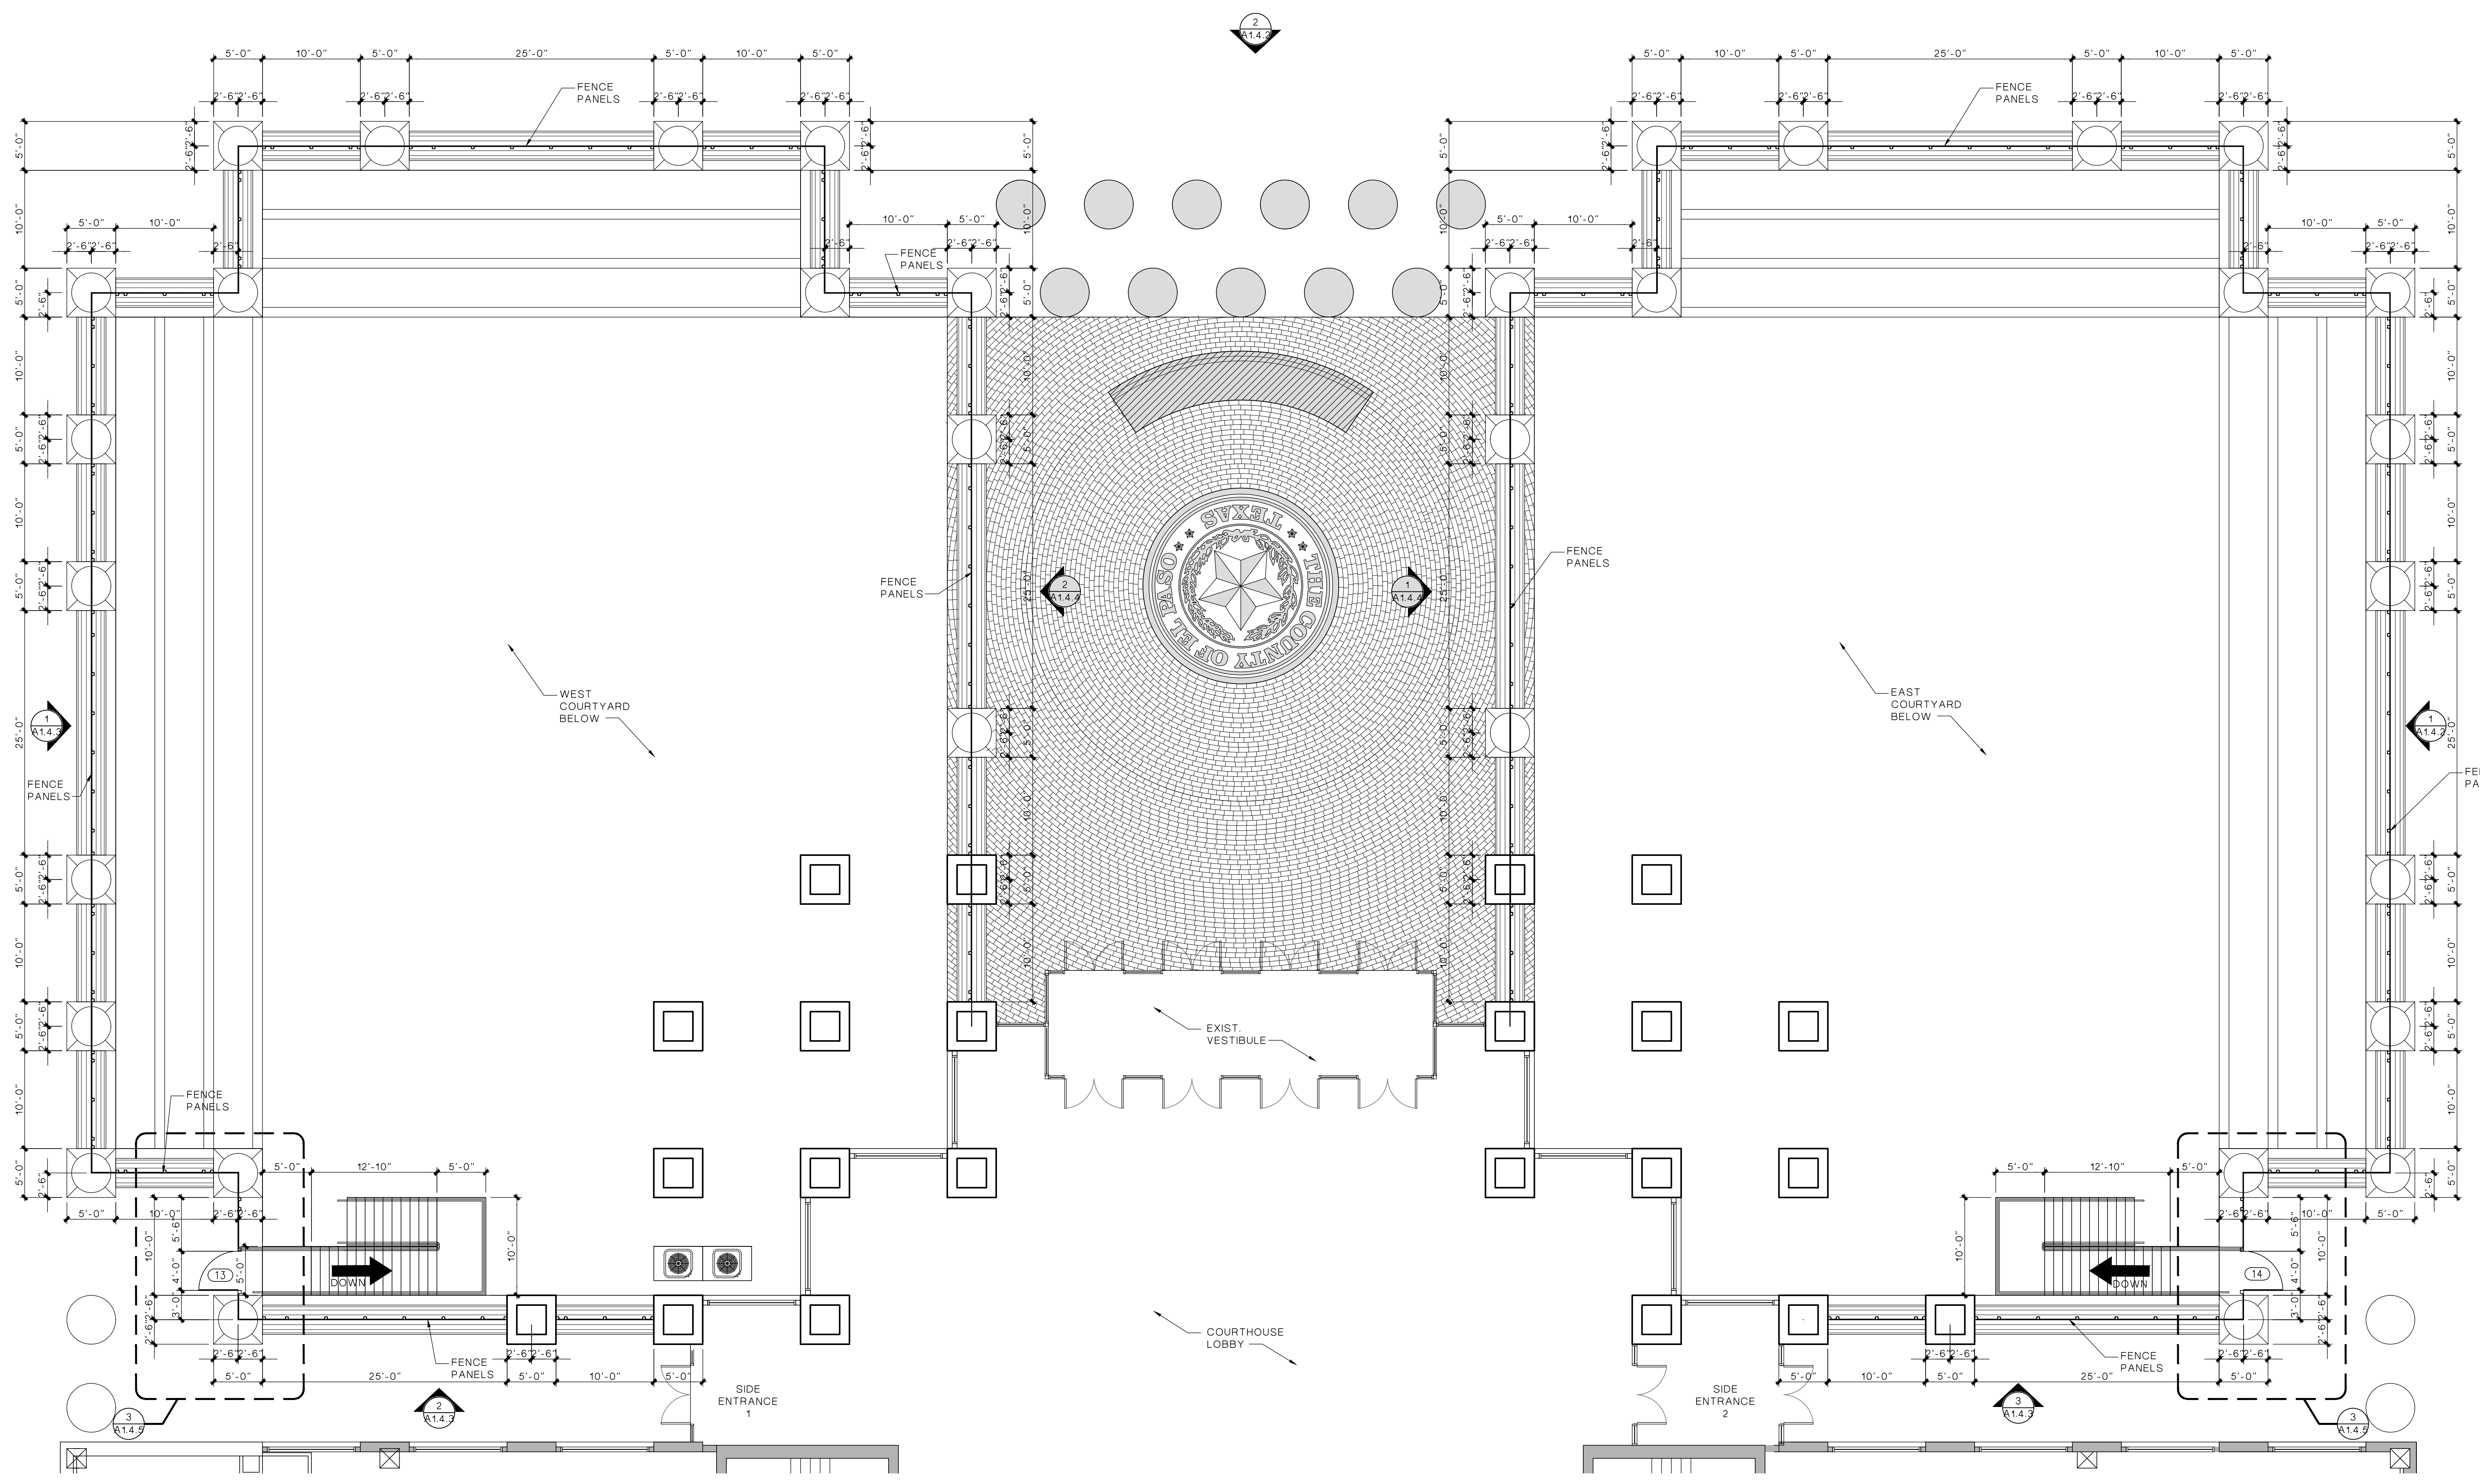
1 OUTDOOR FENCING LAYOUT
 GROUND LEVEL SCALE: 1/8"=1'-0"
 NORTH

ALTERNATE NO. 2
 EXTERIOR SECURITY FENCE

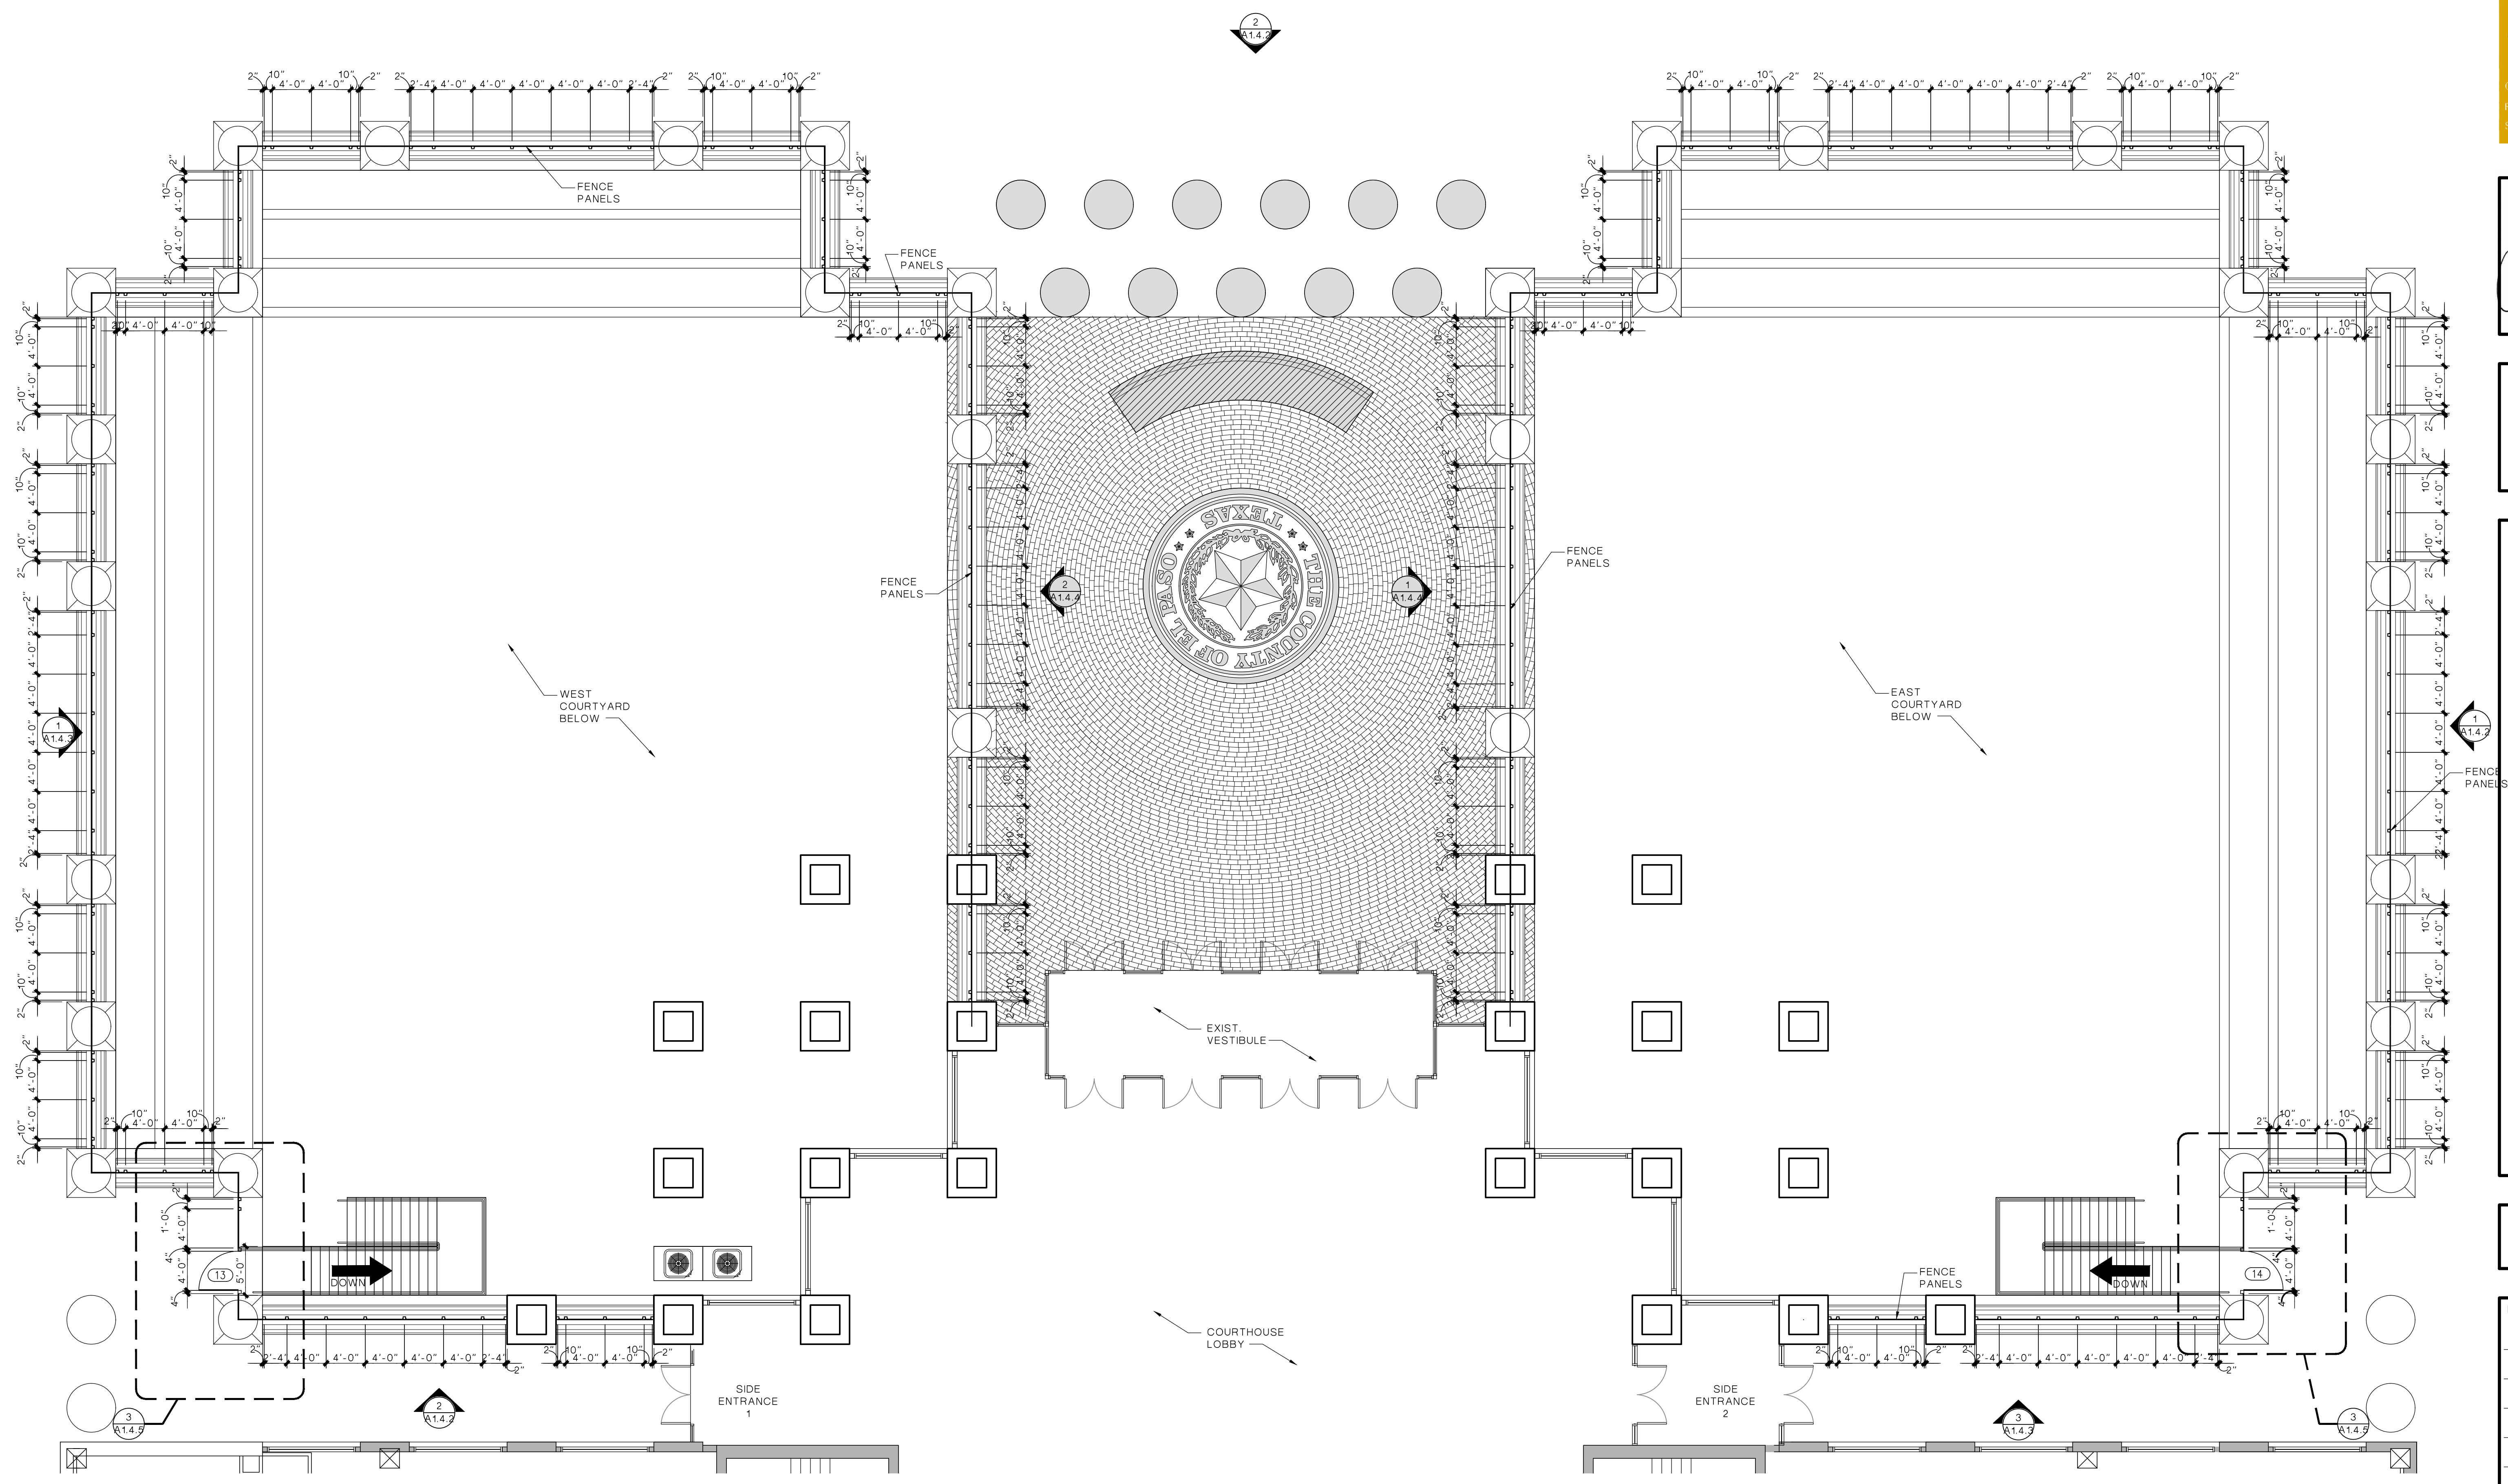
1 **OUTDOOR FENCE POST LAYOUT**
 GROUND LEVEL
 SCALE: 1/8"=1'-0"
 NORTH

NOTE:
 CONTRACTOR SHALL FIELD VERIFY ALL DIMENSIONS AND DO ANY ADJUSTMENTS AS NECESSARY.

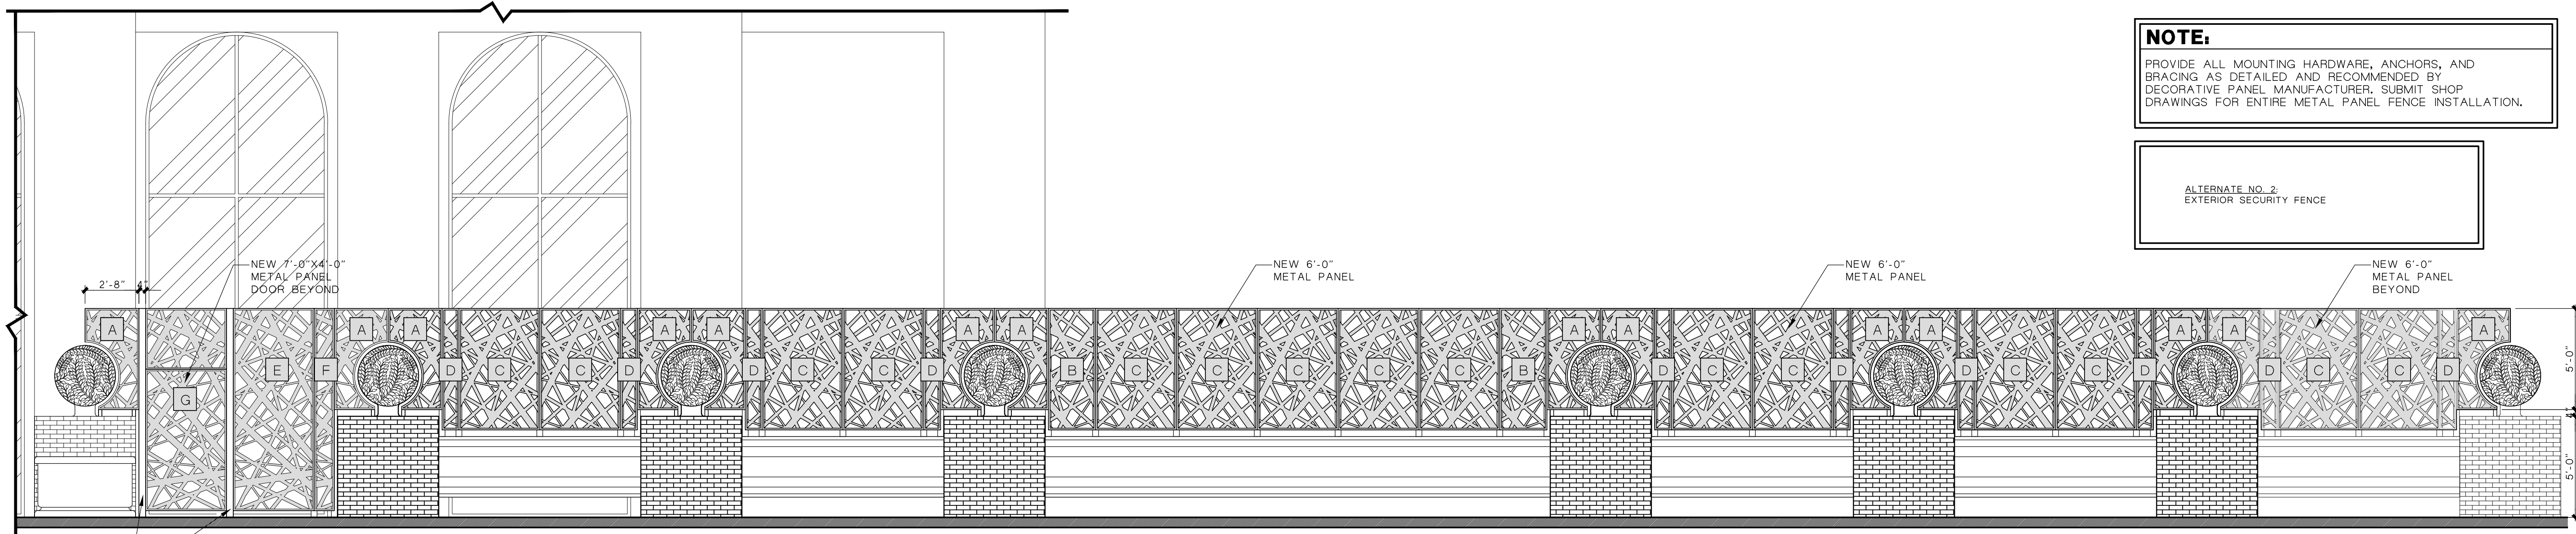
1 FENCE ELEVATION
 EAST COURTYARD SCALE: 1/4"=1'-0"

NOTE:
 PROVIDE ALL MOUNTING HARDWARE, ANCHORS, AND BRACING AS DETAILED AND RECOMMENDED BY DECORATIVE PANEL MANUFACTURER. SUBMIT SHOP DRAWINGS FOR ENTIRE METAL PANEL FENCE INSTALLATION.

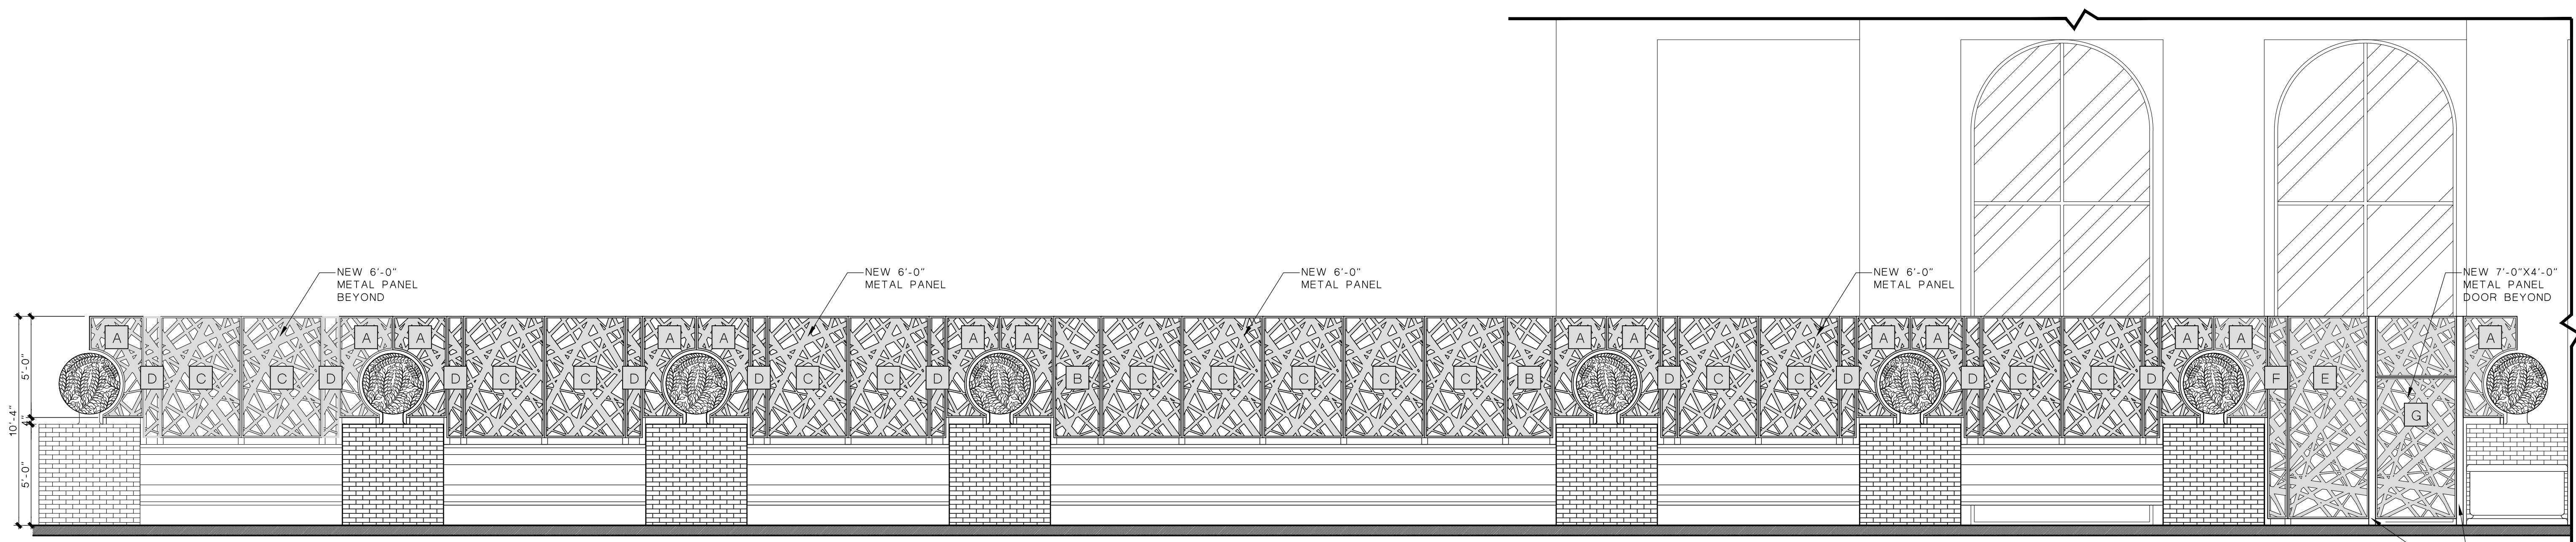
1 FENCE ELEVATION
 WEST COURTYARD SCALE: 1/4"=1'-0"

NOTE:
 PROVIDE ALL MOUNTING HARDWARE, ANCHORS, AND BRACING AS DETAILED AND RECOMMENDED BY DECORATIVE PANEL MANUFACTURER. SUBMIT SHOP DRAWINGS FOR ENTIRE METAL PANEL FENCE INSTALLATION.

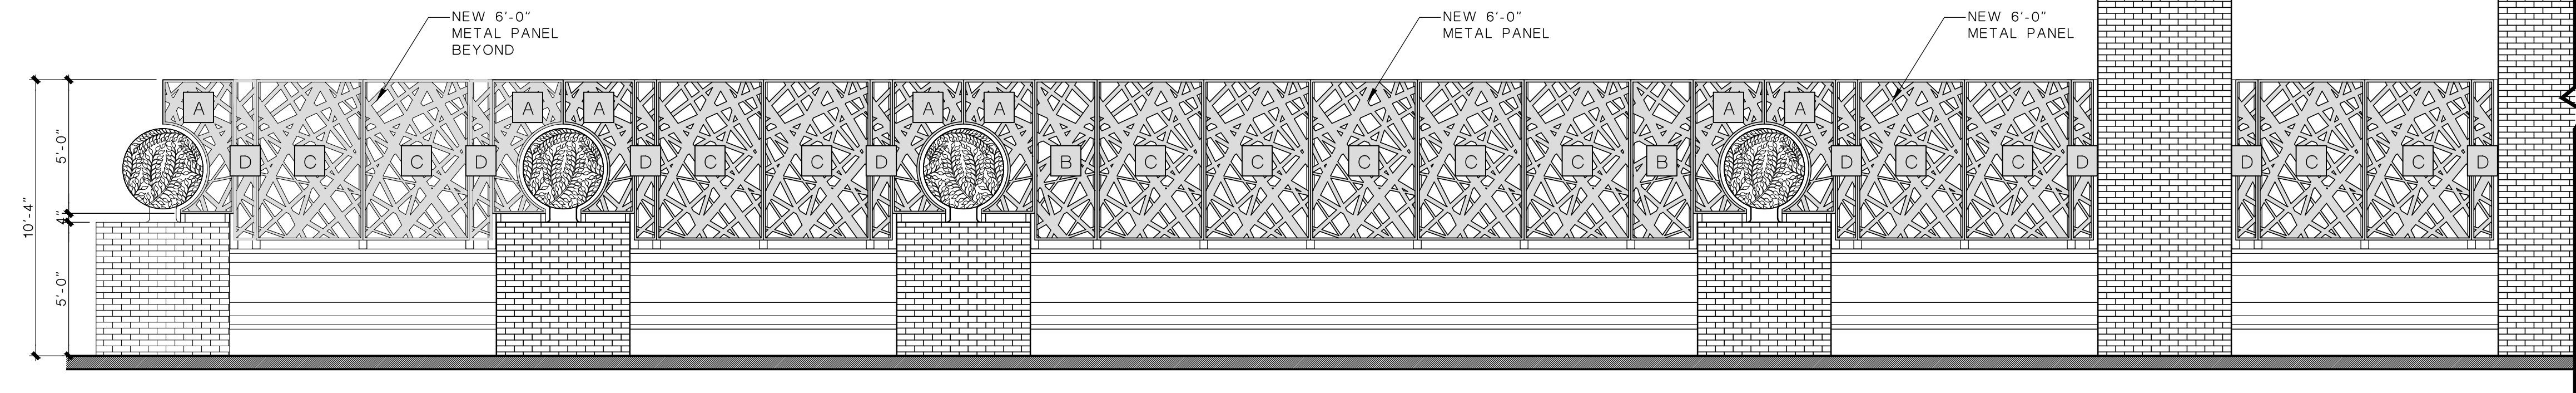
1 FENCE ELEVATION
 EAST COURTYARD SCALE: 1/4"=1'-0"

NOTE:
 PROVIDE ALL MOUNTING HARDWARE, ANCHORS, AND BRACING AS DETAILED AND RECOMMENDED BY DECORATIVE PANEL MANUFACTURER. SUBMIT SHOP DRAWINGS FOR ENTIRE METAL PANEL FENCE INSTALLATION.

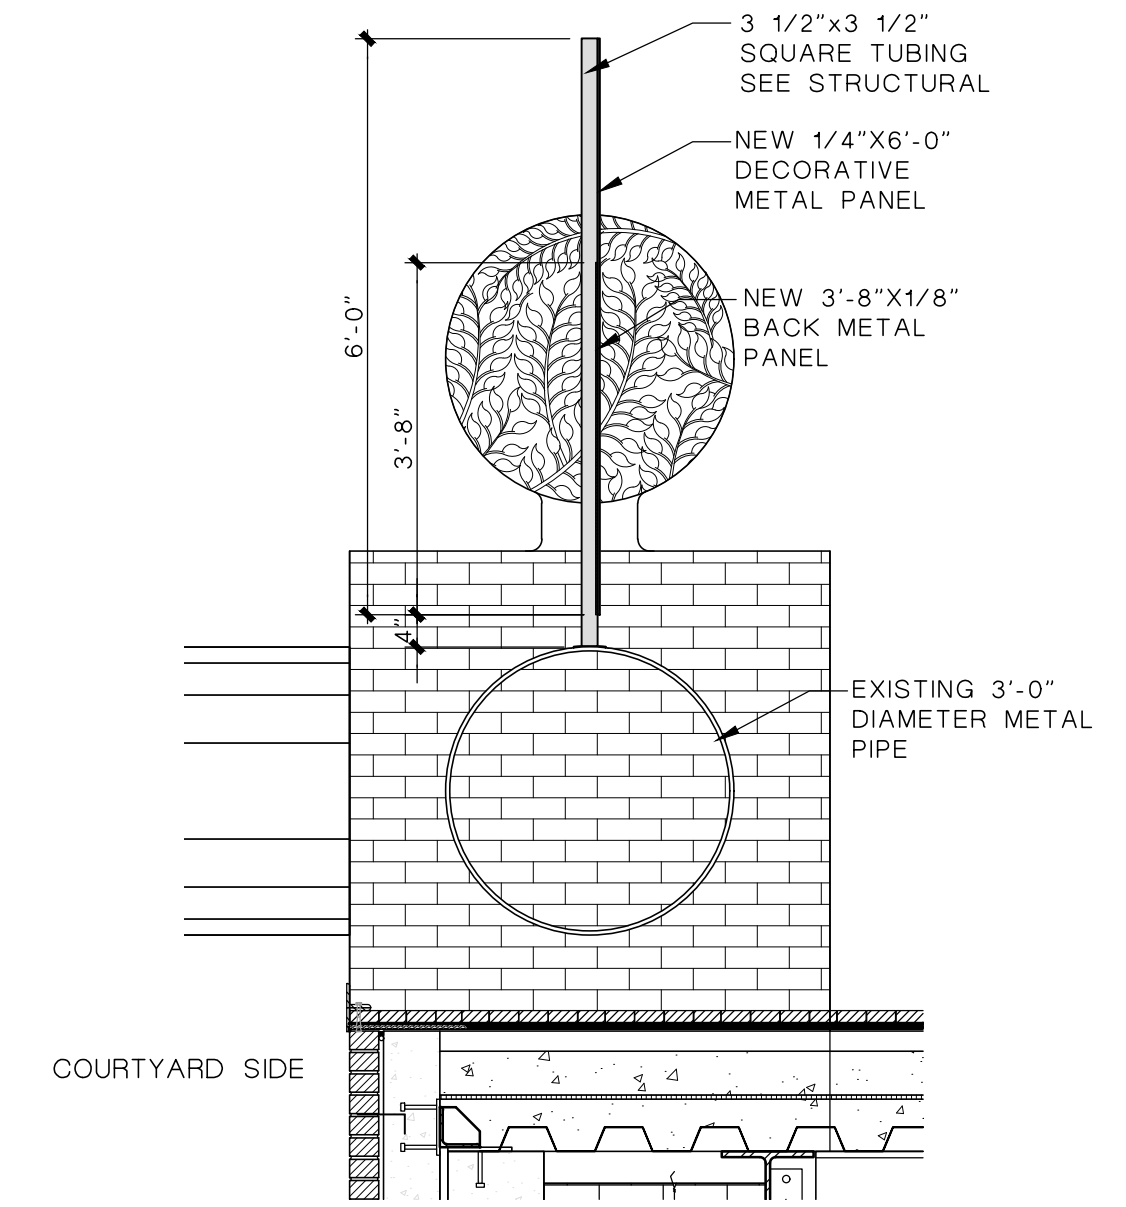
2 DETAIL SCALE: 1/2"=1'-0"

NOTE:
 PROVIDE ALL MOUNTING HARDWARE, ANCHORS, AND BRACING AS DETAILED AND RECOMMENDED BY DECORATIVE PANEL MANUFACTURER. SUBMIT SHOP DRAWINGS FOR ENTIRE METAL PANEL FENCE INSTALLATION.

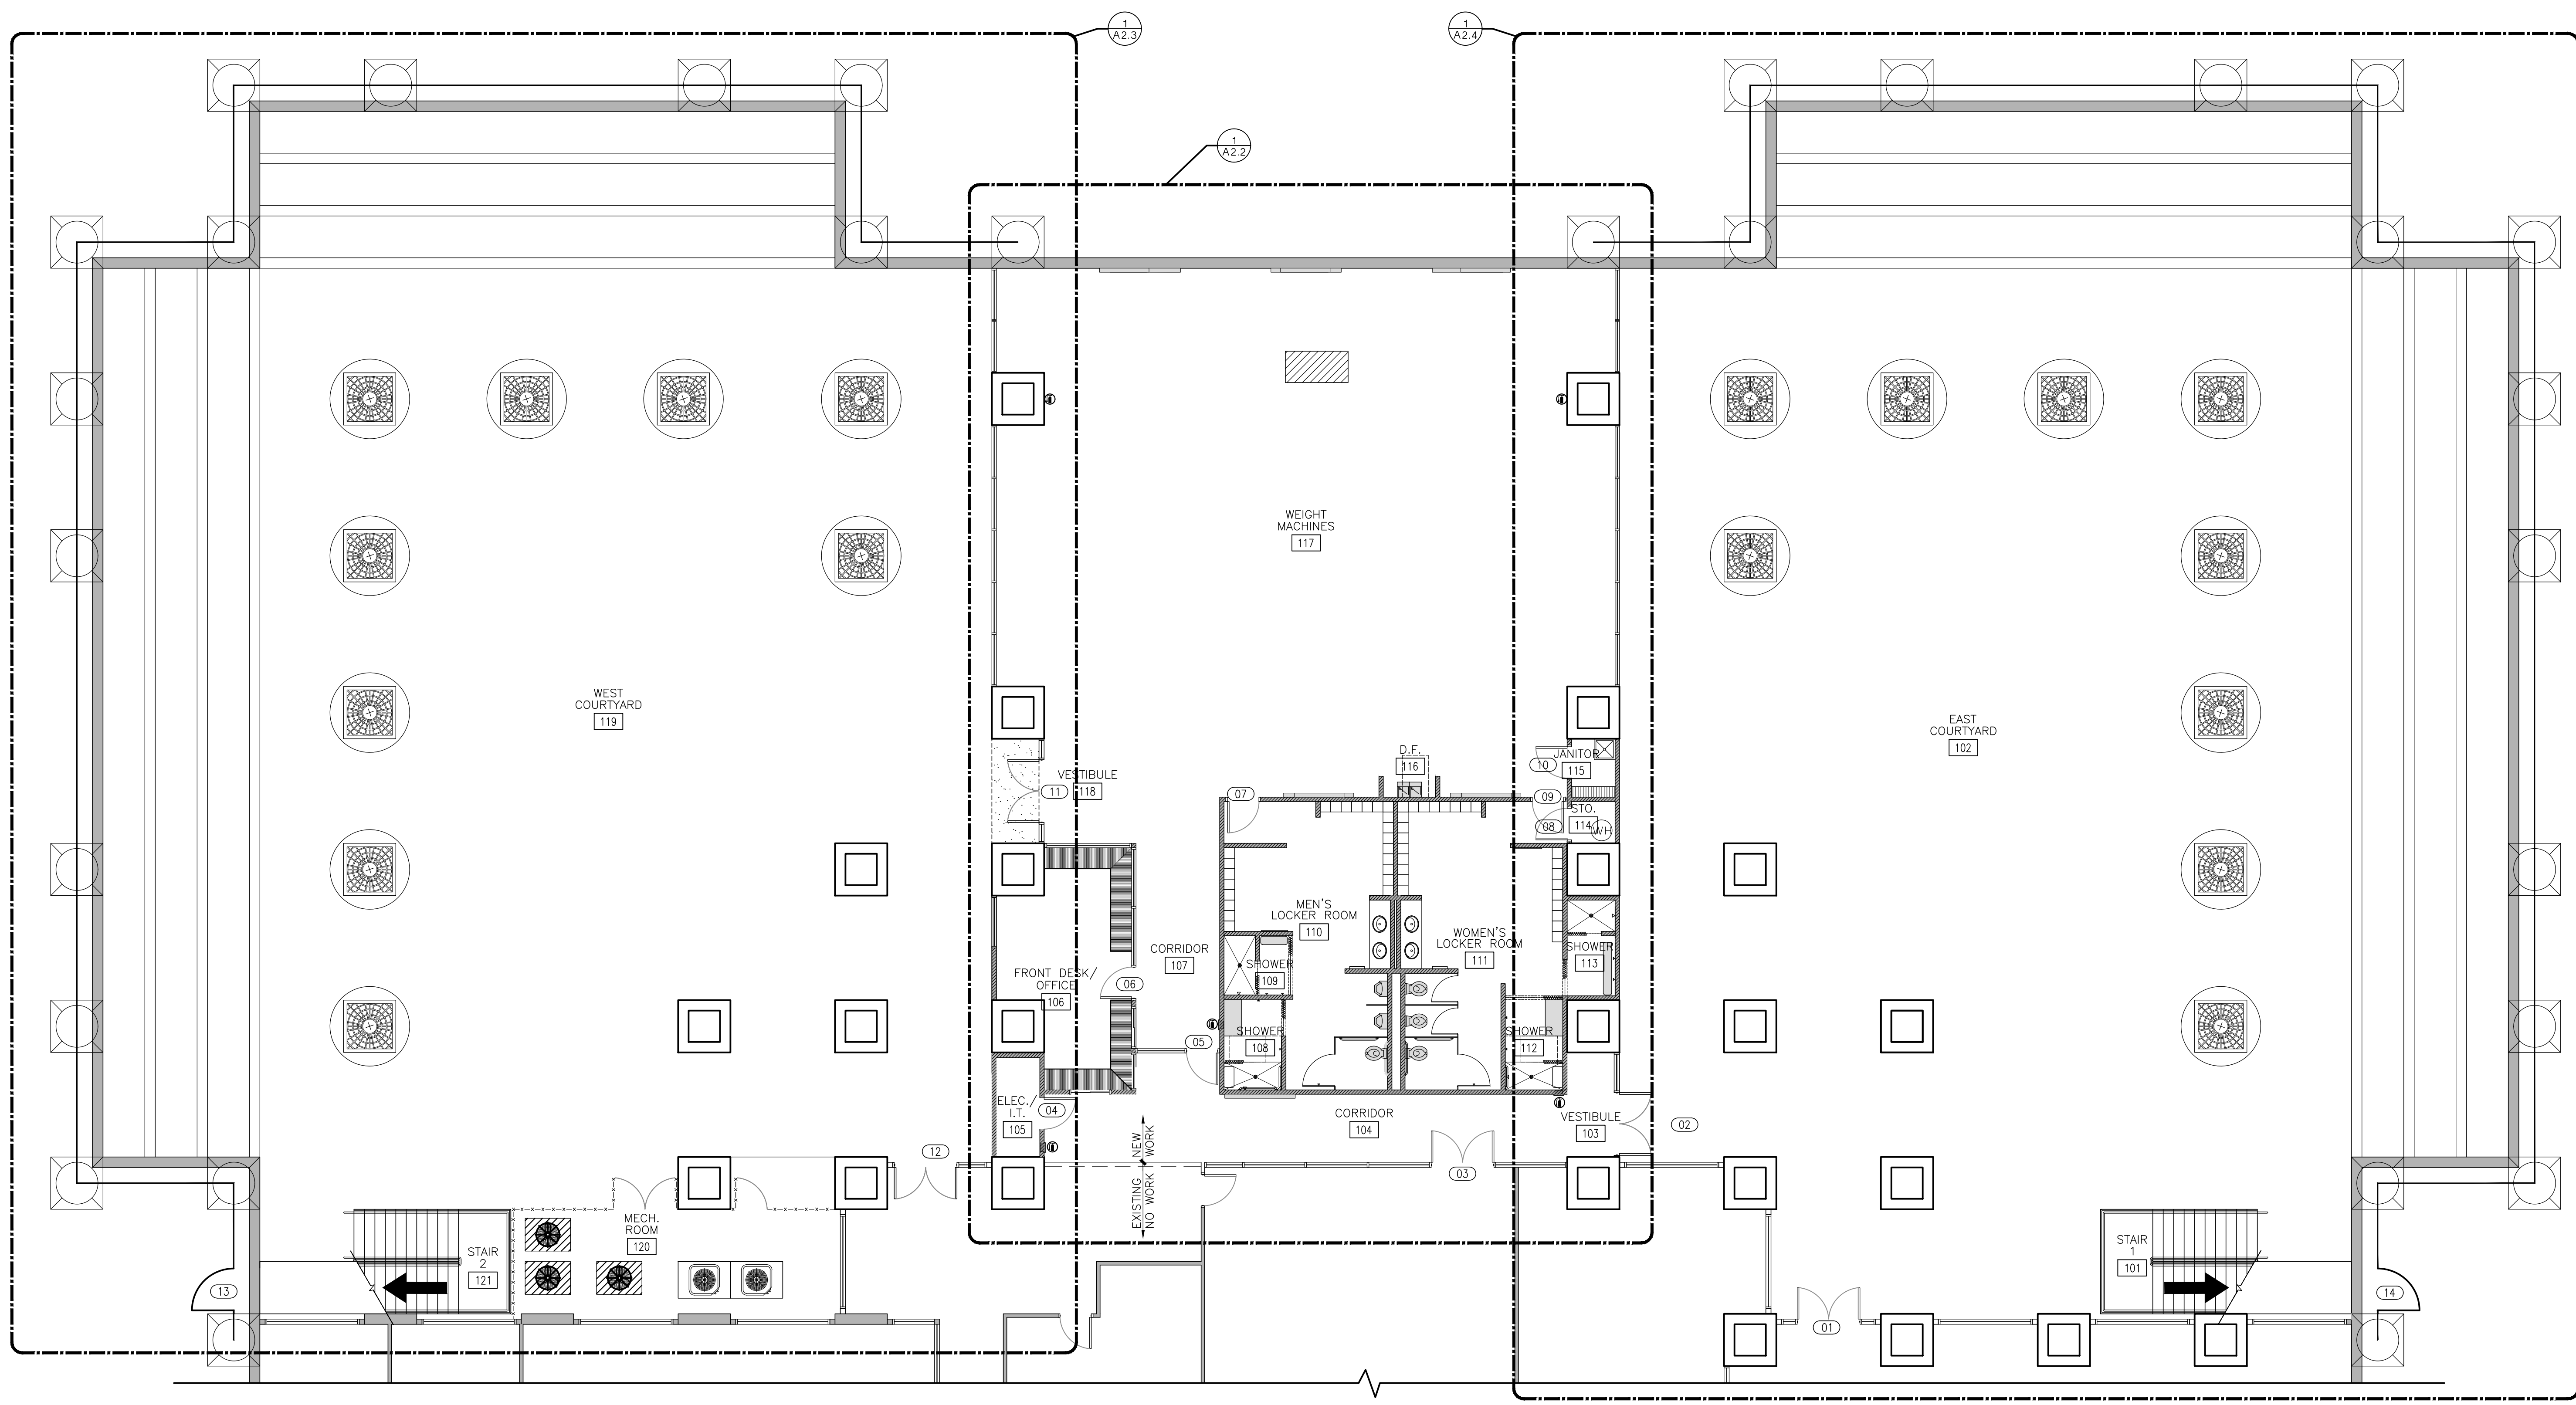
1 REVISED LOWER LEVEL FLOOR PLAN
 SCALE: 1/8"=1'-0"
 NORTH

ALT. No. 3
 REMOVE 1/2" CONCRETE TOPPING OVERLAY IN ITS ENTIRETY THROUGHOUT ENTIRE WEST & EAST COURTYARD AREA. WEST-INSTALL RUBBER FLOORING. EAST-FLOAT AND ADD EXTERIOR GRADE TILE.

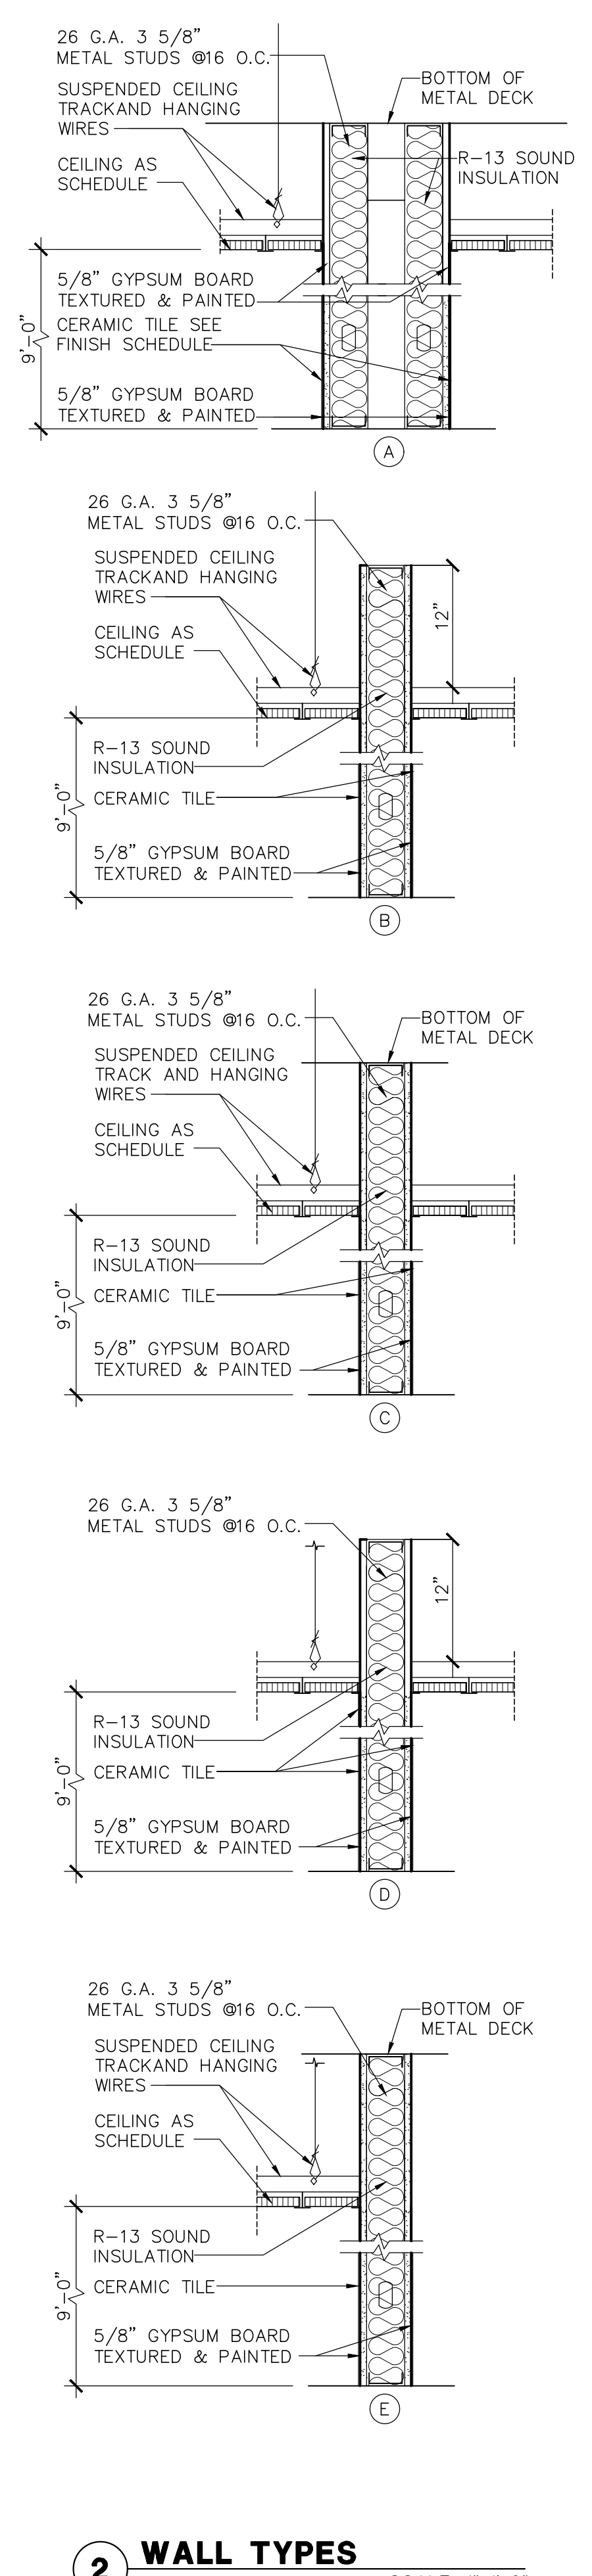
2 WALL TYPES
SCALE: 1"=1'-0"

WALL TYPE	
NEW PARTITION	
EXISTING PARTITION
