EMPLOYEE FITNESS & WELLNESS CENTER
500 E SAN ANTONIO ST. EL PASO, TEXAS

ISSUED FOR CONSTRUCTION

DATE: OCTOBER 17 - 2018

2016-25 EMPLOYEE FITNESS & WELLNESS CENTER - CONSTRUCTION DOCUMENTS

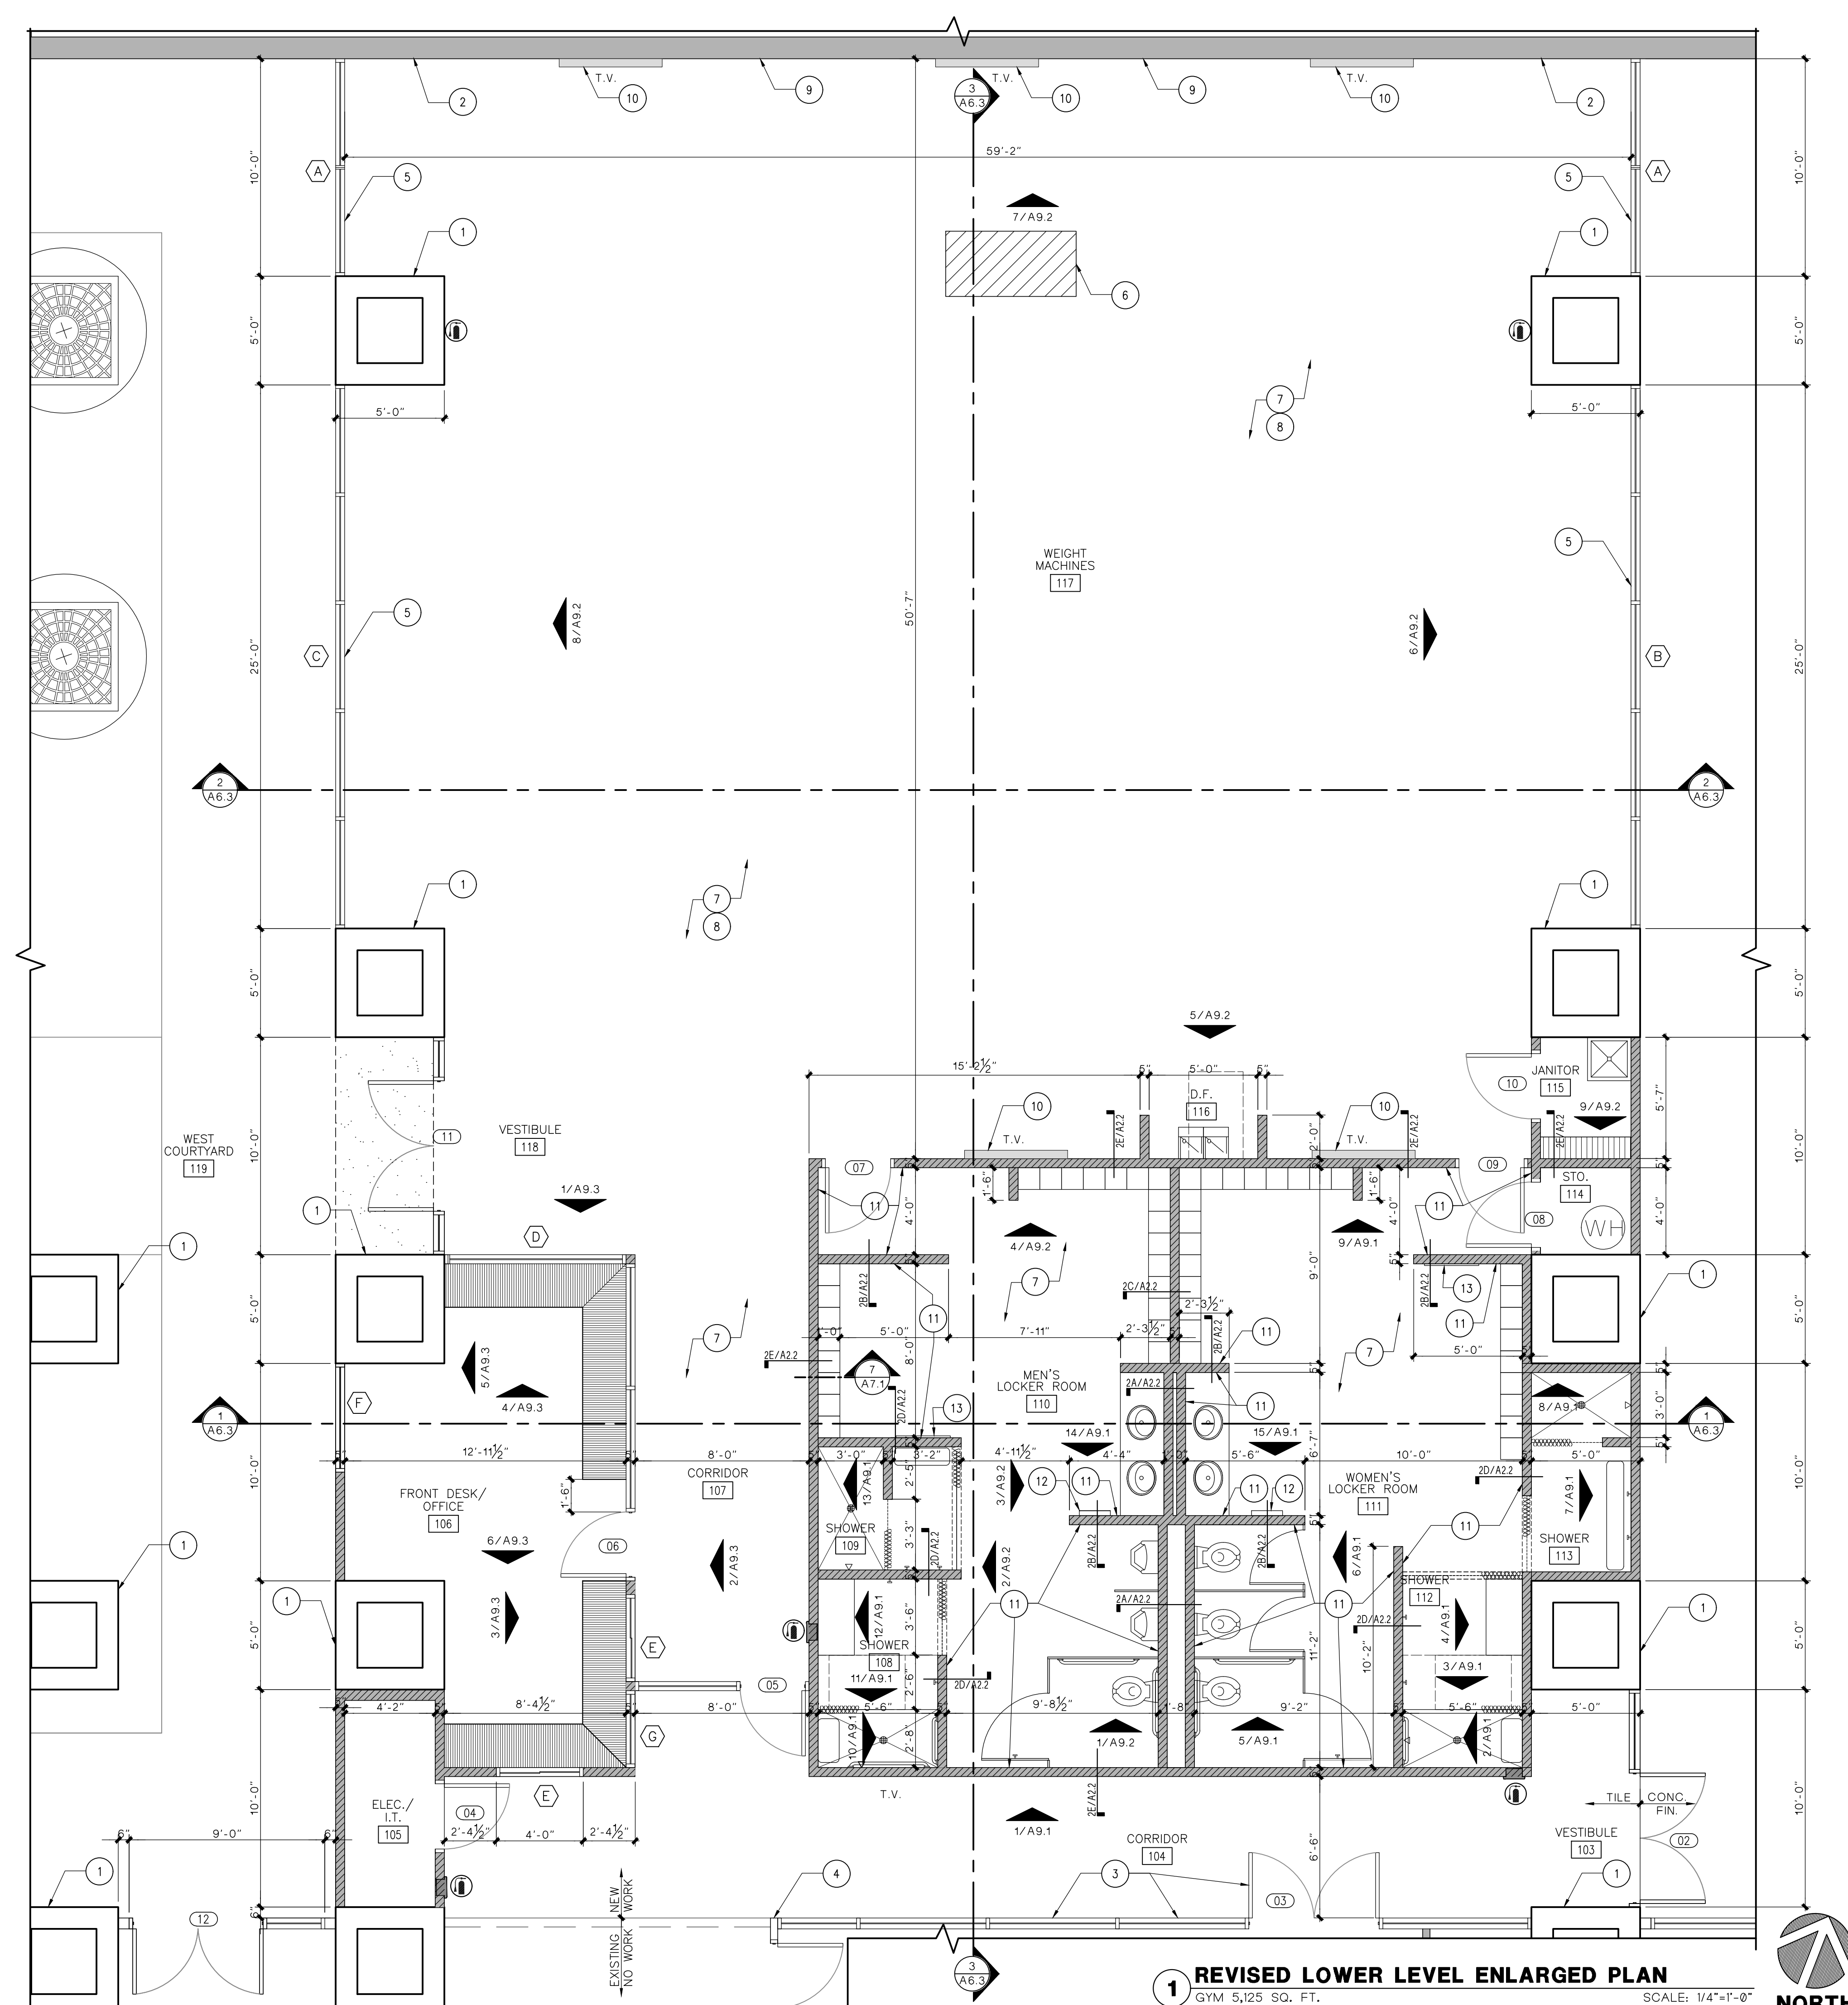
1 REVISED LOWER LEVEL ENLARGED PLAN
GYM 5,125 SQ. FT.
SCALE: 1/4"=1'-0"

- REVISED NOTES**
- EXISTING COLUMN-CLEAN AND CLEAR COAT ENTIRE AREA OF COLUMN INTERIOR ONLY.
 - EXISTING BRICK WALL-CLEAN AND CLEAR COAT ENTIRE WALL INTERIOR ONLY.

- EXISTING STOREFRONT TO REMAIN- CLEAN ALL SURFACES.
 - REPAIR EXISTING DOOR FRONT AFTER DEMOLITION OF STOREFRONT. EXTEND EXISTING WALL AS NEEDED TO TERMINATE STOREFRONT EDGE.

- PROVIDE WINDOW SHADES FULL LENGTH. EACH SHADE SHALL BE @ EACH WINDOW PANEL SECTION.
 - EXISTING SUMP PUMP COVER TO REMAIN PREPARE SURFACE FOR NEW FLOOR FINISH.

- EXISTING CONCRETE FLOOR SHALL BE PATCHED, REPAIRED, AND LEVELED TO RECEIVE NEW FLOOR FINISH.
 - REMAINING EXPOSED CEILING AREAS SHALL BE CLEANED OF NON-ESSENTIAL ITEMS AND PREPARE FOR NEW FINISHED PAINT AS SCHEDULED.

- INSTALL MIRRORS GLASS ALONG ENTIRE WALL.
 - INSTALL TV AND MOUNTING BRACKET (OWNER PROVIDED BOTH) PROVIDE WOOD BACKING WHERE NEEDED.
 - PROVIDE CERAMIC TILE ON ALL SURFACES TO 5'-4" EXCEPT AT SHOWER WHERE IT IS FULL HEIGHT.

- RECESSED WASTE CONTAINER AND PAPER TOWEL DISPENSER
 - 30"x6'-0" MIRROR ANCHORED TO WALL AS NECESSARY.

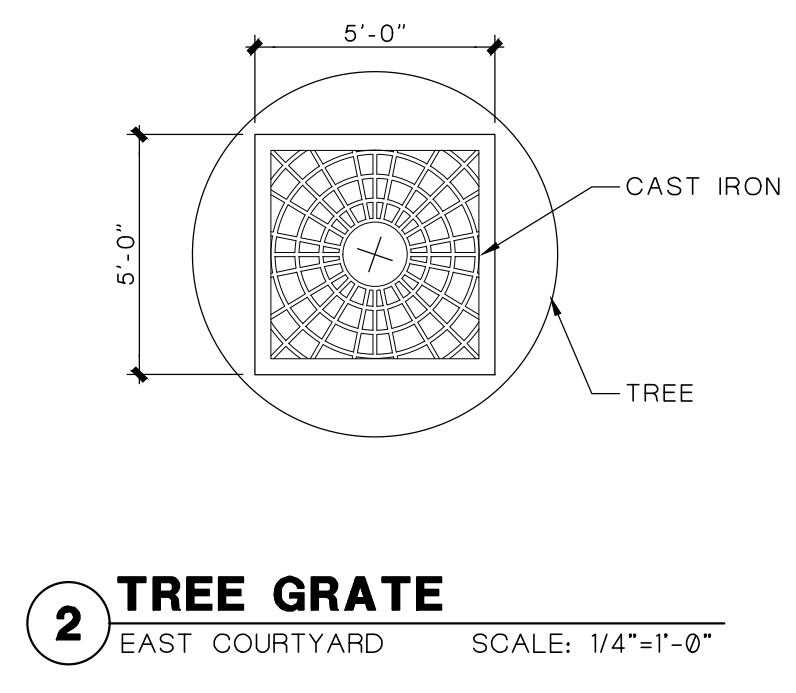
1 ENLARGED COURTYARD PLAN-WEST
 WEST COURTYARD SCALE: 1/8"=1'-0"
 NOTE:
 1 STEAM CLEAN ALL EXISTING BRICK.

ALT. No. 3
 REMOVE 1/2" CONCRETE TOPPING OVERLAY IN ITS ENTIRETY THROUGHOUT ENTIRE WEST & EAST COURTYARD AREA. WEST-FLOORING EAST-FLOAT AND ADD EXTERIOR GRADE TILE.

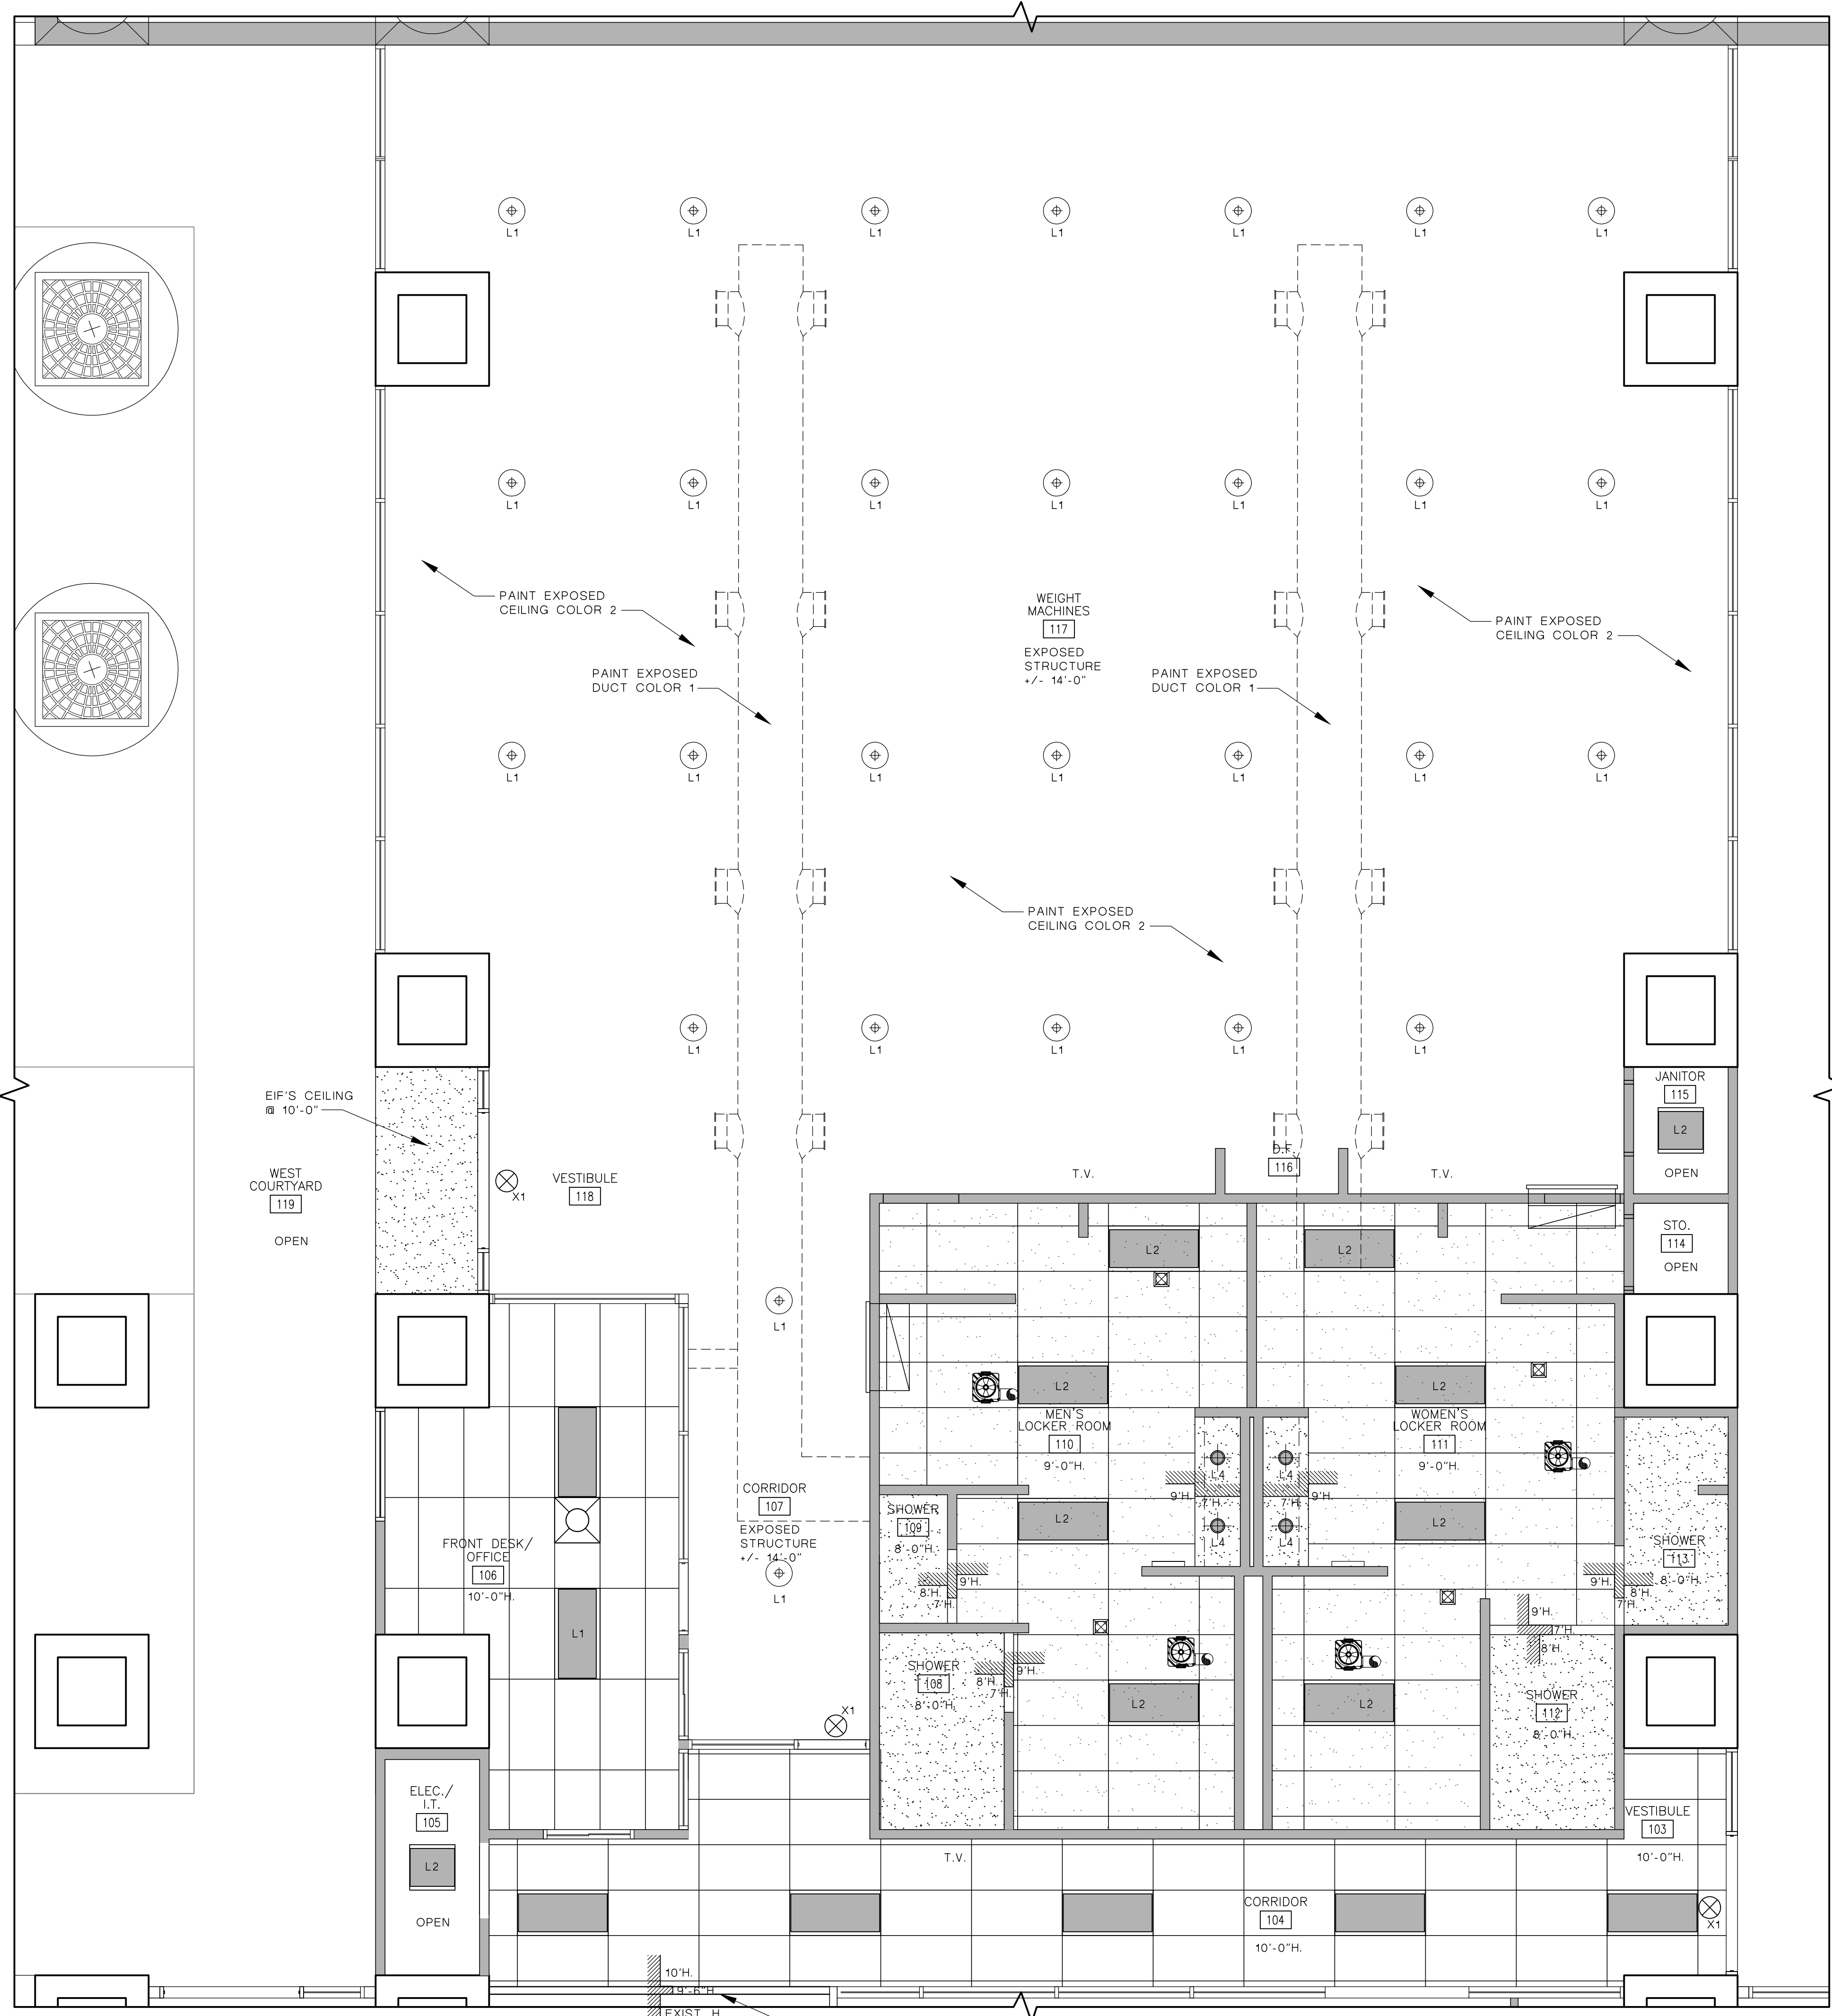
1 REFLECTIVE CEILING PLAN
GYM 5,125 SQ. FT. SCALE: 1/4"=1'-0" NORTH

L1 PENDANT LIGHTING FIXTURE

L2 2X4 LED LIGHT FIXTURE

L3 2X2 LED RECESSED LIGHT FIXTURE

L4 LED 6" RECESSED CAN LIGHT

X1 WALL MOUNT EXIT SIGN

2'X4' CEILING GRID W/ ACOUSTICAL CEILING TILES.

2'X4' CEILING GRID W/ VINYL FACED CEILING TILES.

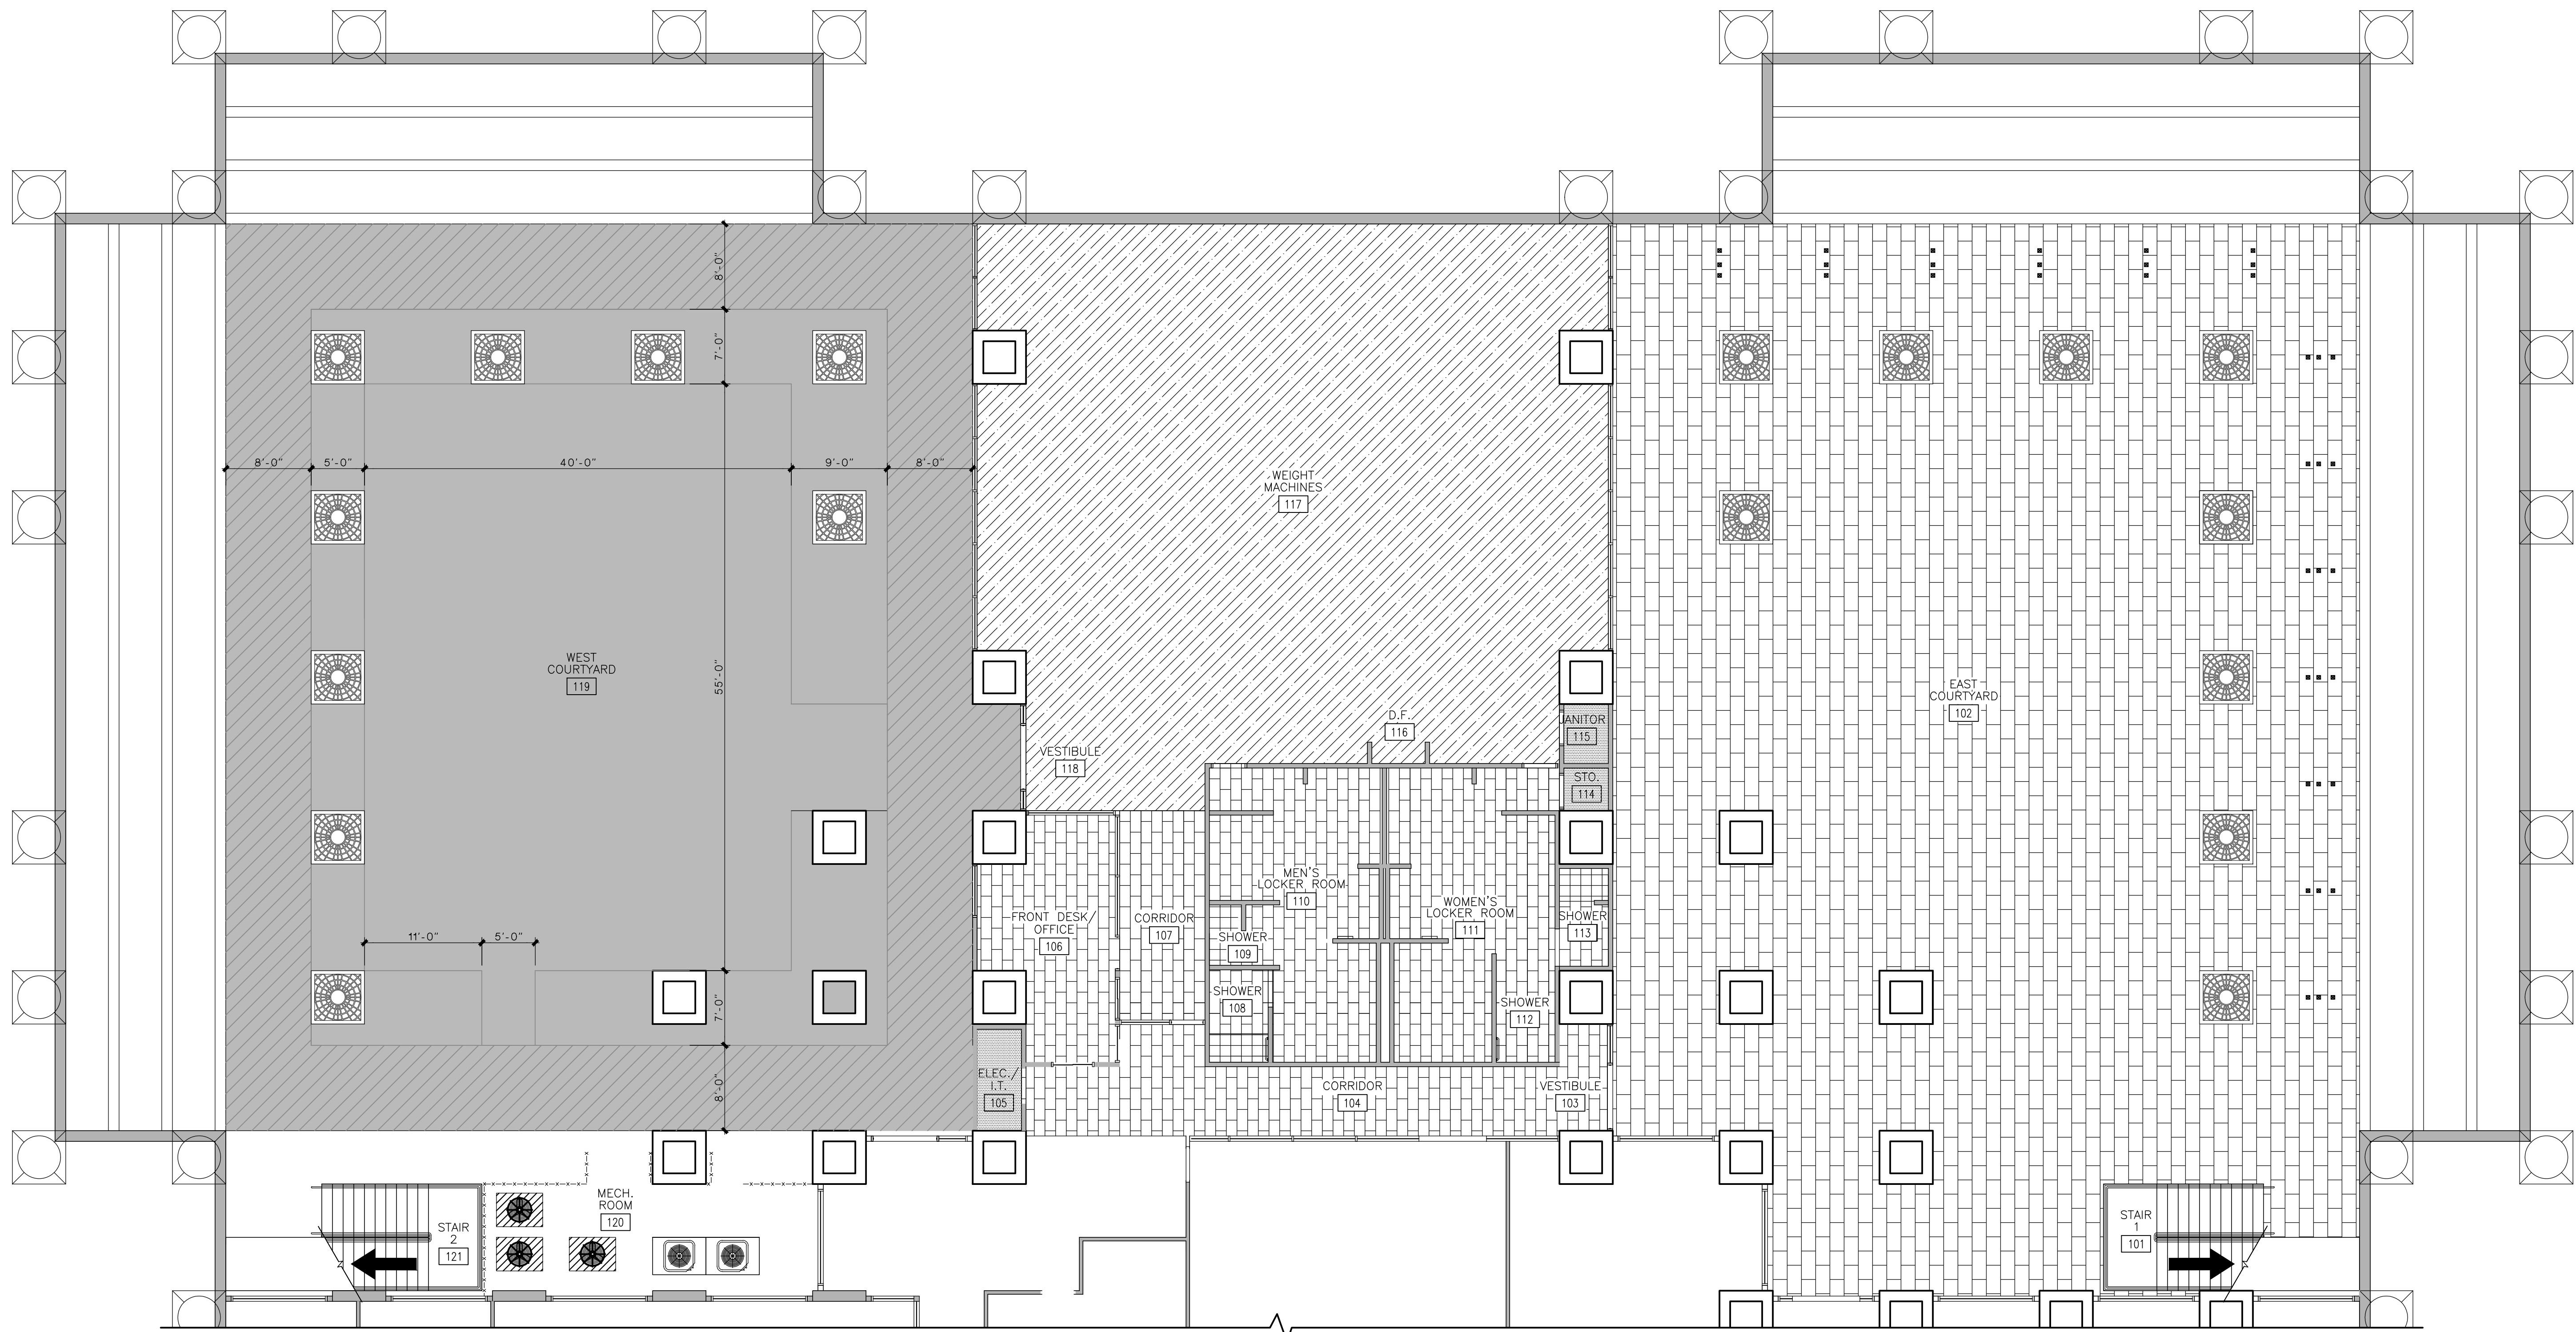
1 LOWER LEVEL FLOORING PLAN
 SCALE: 1/8"=1'-0"

LEGEND	
	RUBBER FLOORING
	RUBBER FLOORING COLOR 1 SELECTED BY OWNER
	RUBBER FLOORING COLOR 2 SELECTED BY OWNER
	SEALED CONCRETE
	12"X24" CERAMIC TILE
	12"X12" CERAMIC TILE

ALT. No. 3
 REMOVE 1/2" CONCRETE TOPPING OVERLAY IN ITS ENTIRETY THROUGHOUT ENTIRE WEST & EAST COURTYARD AREA. WEST-INSTALL RUBBER FLOORING. EAST-FLOAT AND ADD EXTERIOR GRADE TILE.

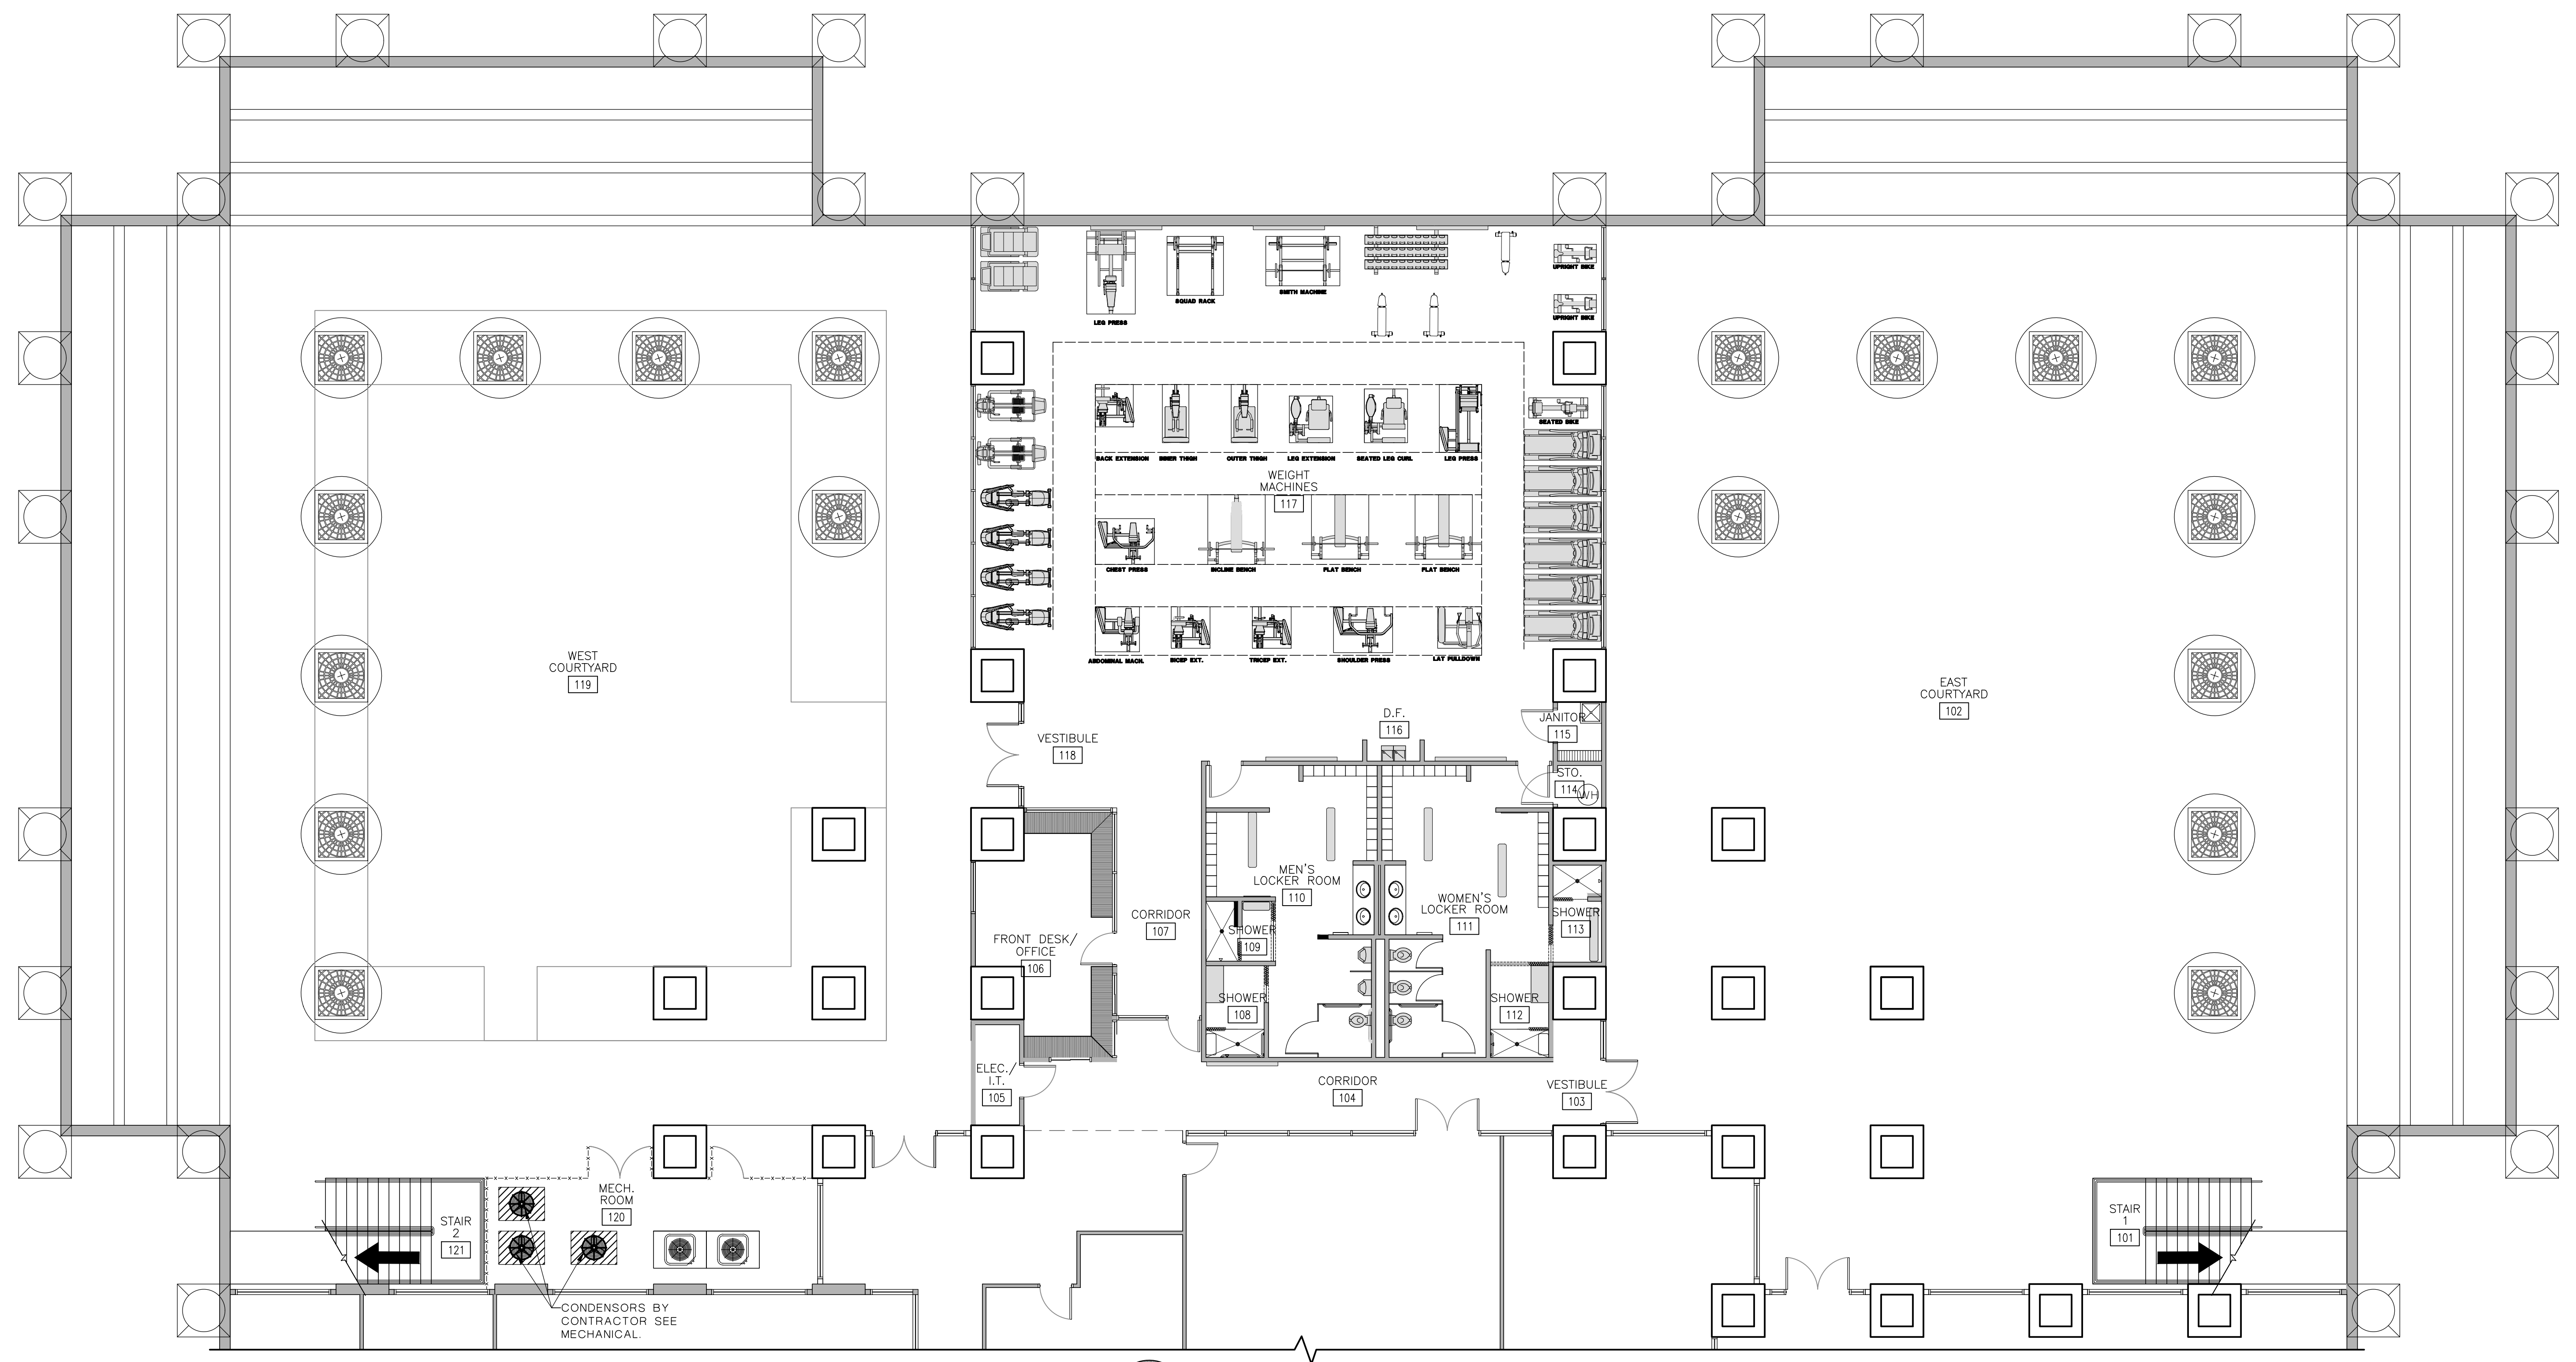
1 LOWER LEVEL EQUIPMENT PLAN (REFERENCE ONLY)
 SCALE: 1/8"=1'-0"
 NORTH
 ALL EQUIPMENT IS SUPPLIED AND INSTALLED BY OWNER.

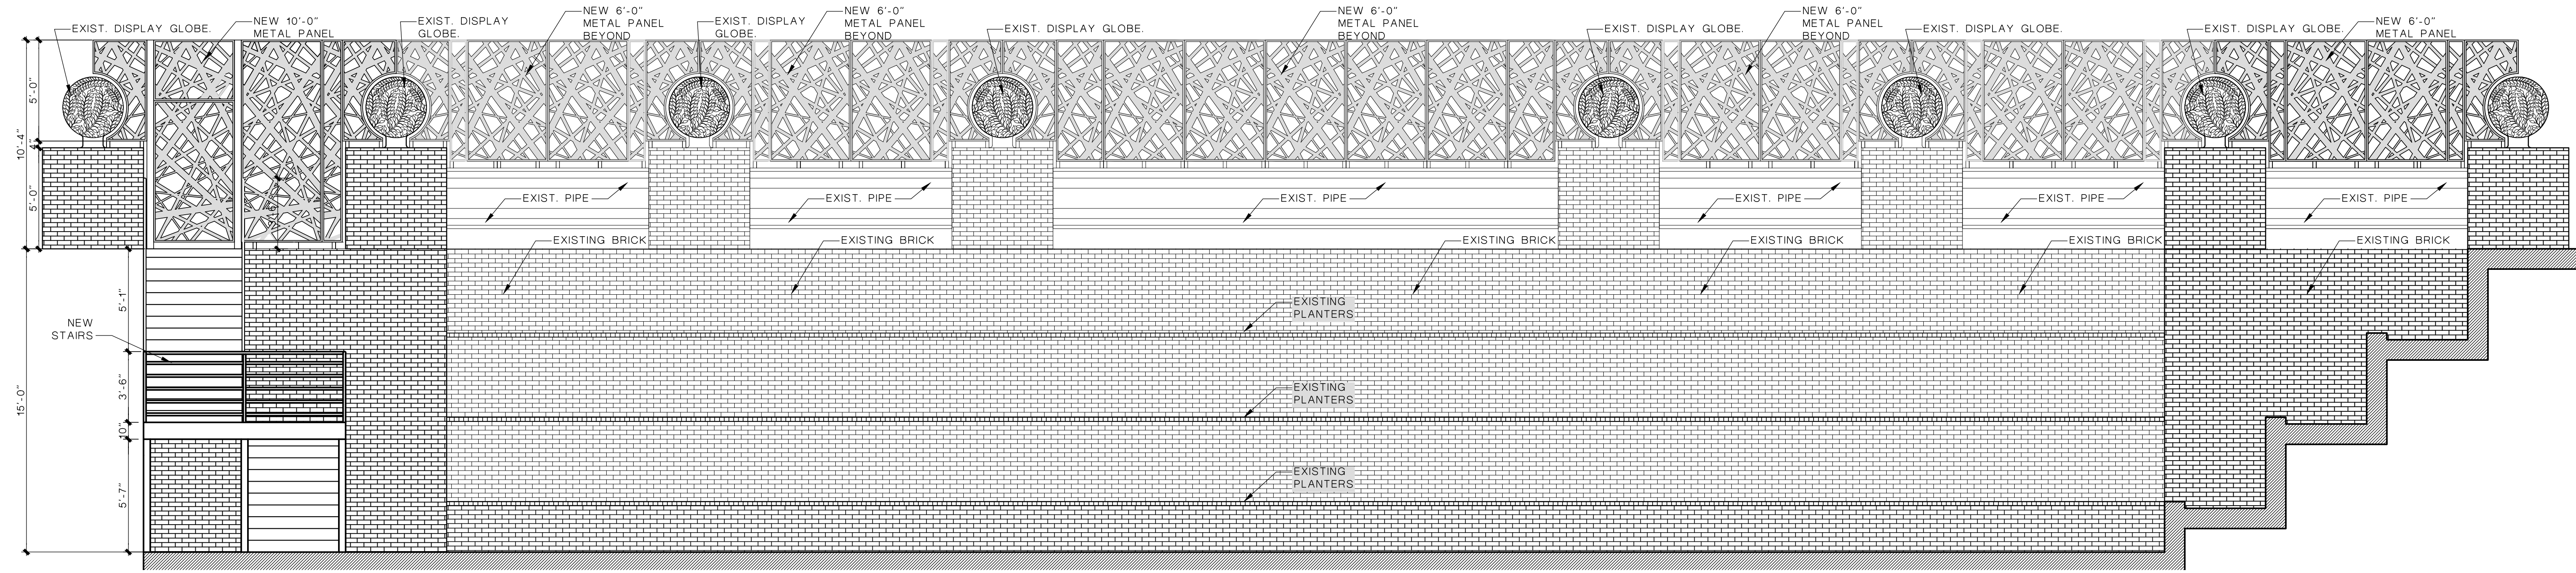
METAL PANEL AS SHOWN SHALL BE INSTALLED AS RECOMMENDED BY MANUFACTURER. **1 COURTYARD ELEVATION**
 WEST COURTYARD SCALE: 1/4"=1'-0"

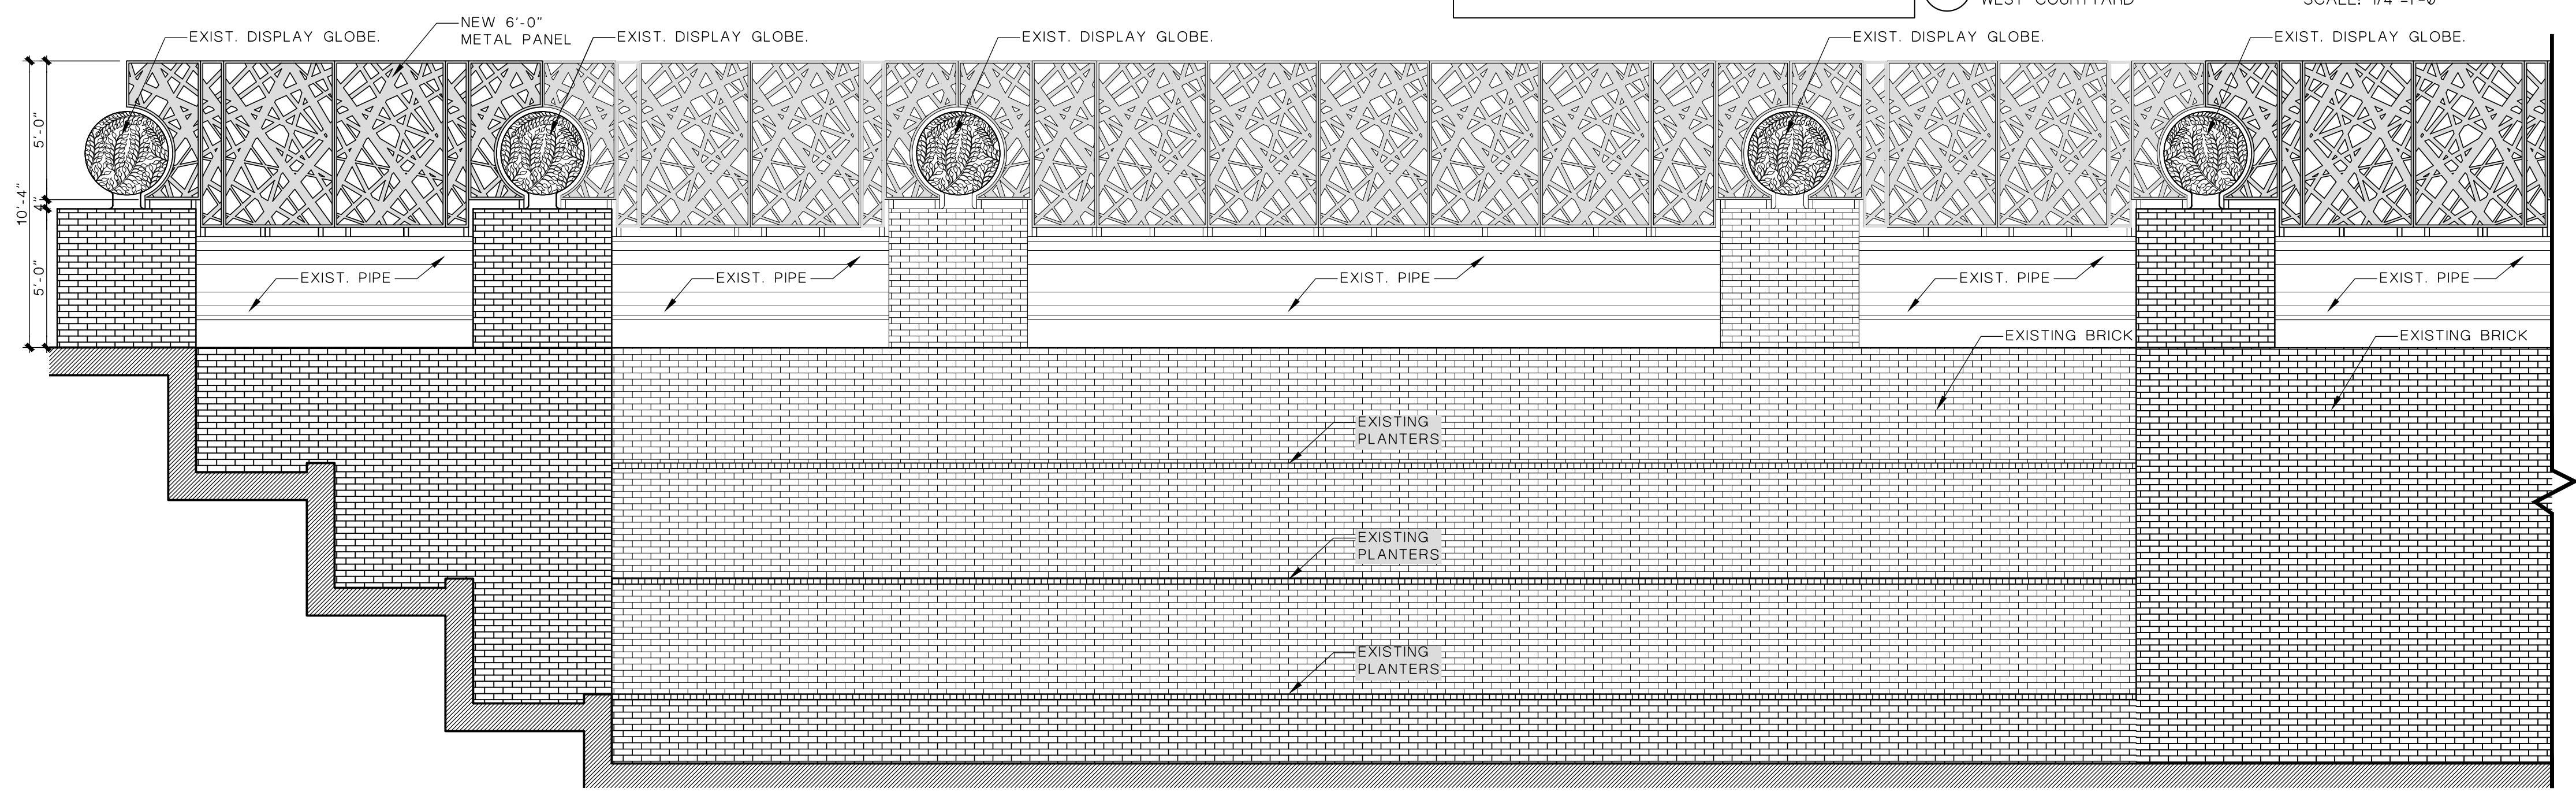
METAL PANEL AS SHOWN SHALL BE INSTALLED AS RECOMMENDED BY MANUFACTURER. **2 COURTYARD ELEVATION**
 WEST COURTYARD SCALE: 1/4"=1'-0"

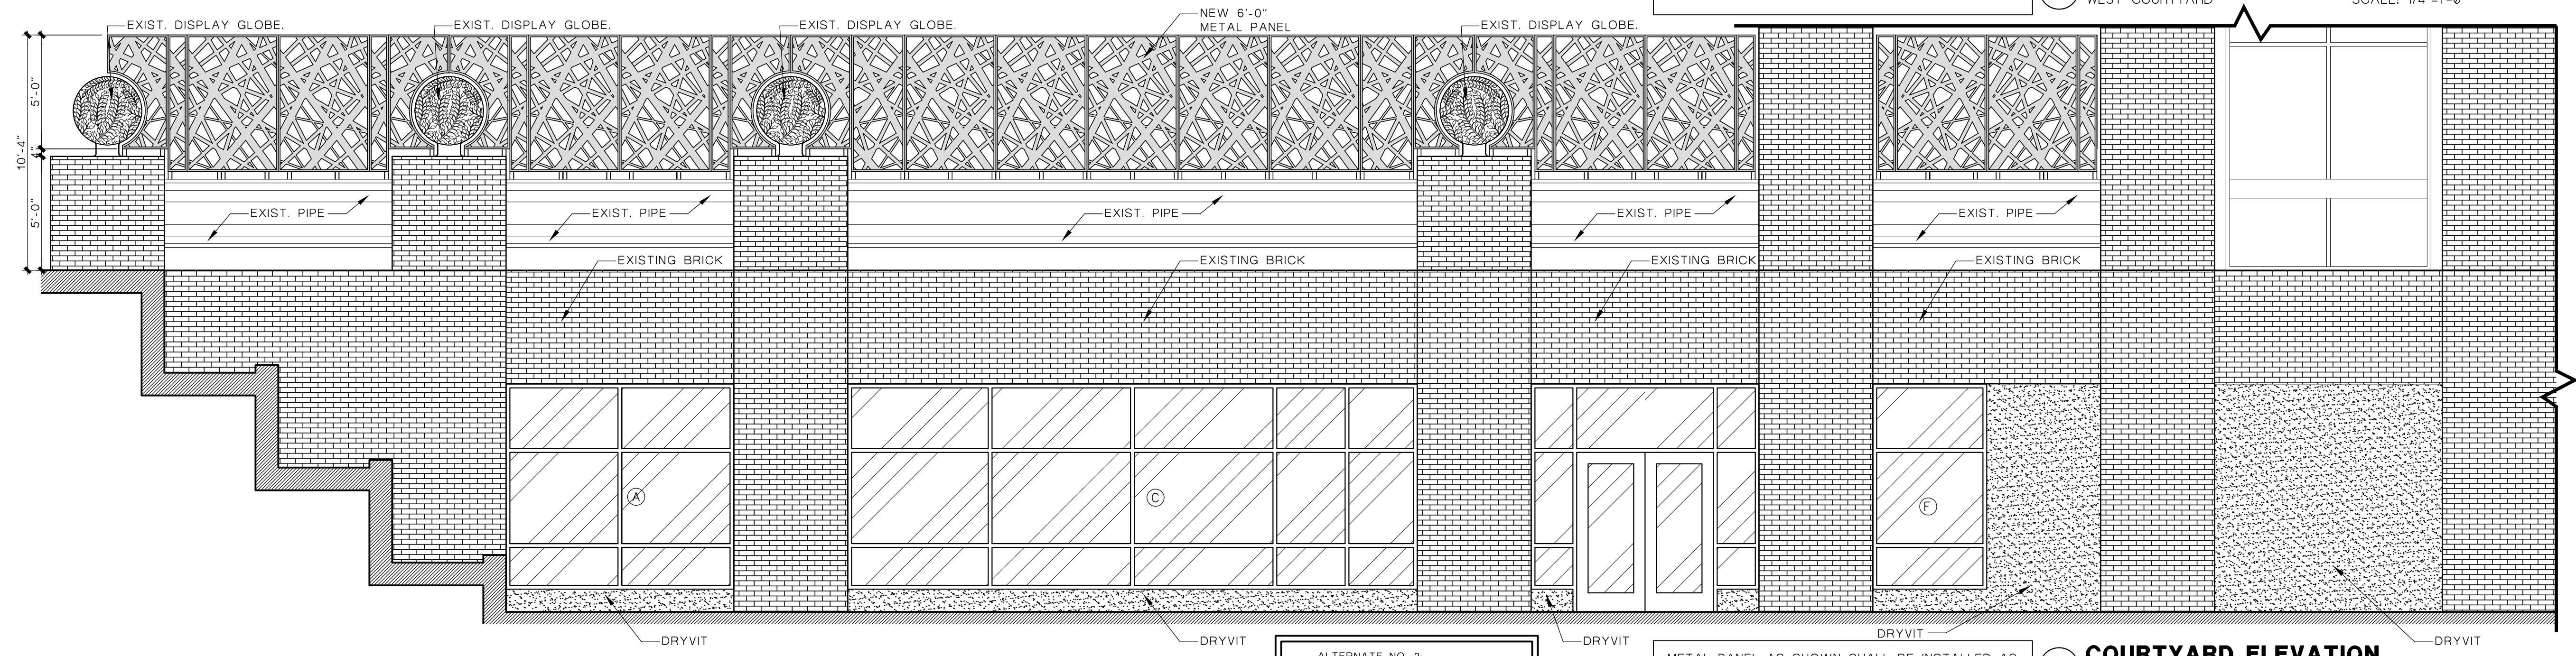
METAL PANEL AS SHOWN SHALL BE INSTALLED AS RECOMMENDED BY MANUFACTURER. **3 COURTYARD ELEVATION**
 WEST COURTYARD SCALE: 1/4"=1'-0"
